# *Bolton Heritage Farm*

## *Bolton, Connecticut*

## **Environmental Review Team Report**

October 2010

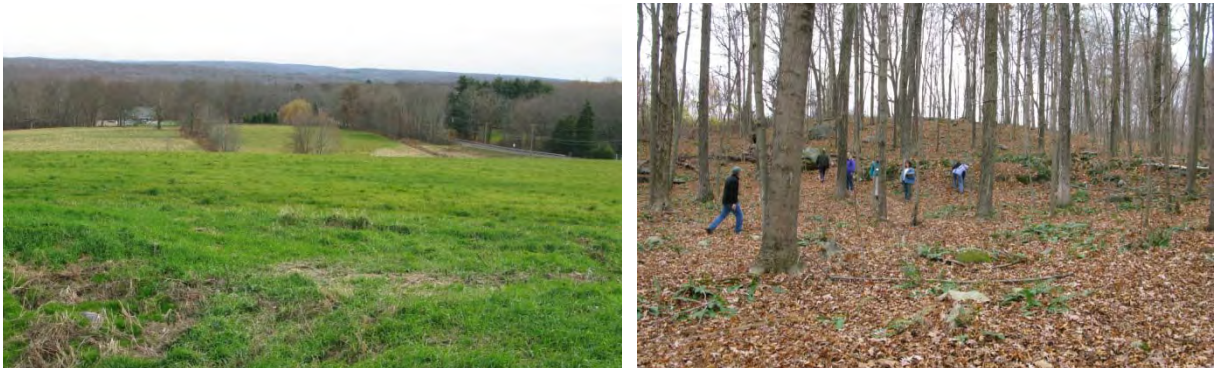
**A.** Rather gentle topography of site. This view looks down slope toward the east from the top of the hill. Hillside was smoothly sculptured by glaciers during the last Ice Age. **B.** A few outcrops are scattered on the portion of the hill that has a more moderate slope. Note that hill-slope retains its smooth, sculpted shape on the moderate slope areas.

**Topography.** The Bolton Heritage Farm lies on an east-northeast facing slope of the upper reaches of the Hop River Valley near the top of the valley side. The valley bottom has an elevation near 400 feet above sea level in this area while the highest elevations on the valley side are 750-800 feet. The Farm extends down the side of the valley to approximately 520'; the upper fields have a maximum elevation of 740'. The Farm sits well up on the side of the valley. The topography is relatively smooth with rounded contours and gentle to moderate slopes (gradients) that vary between 40-70'/mile. A couple of bed-rock terraces are found about half way down the hill. The hill has the sculpted shape of an eastern Connecticut glacial upland.

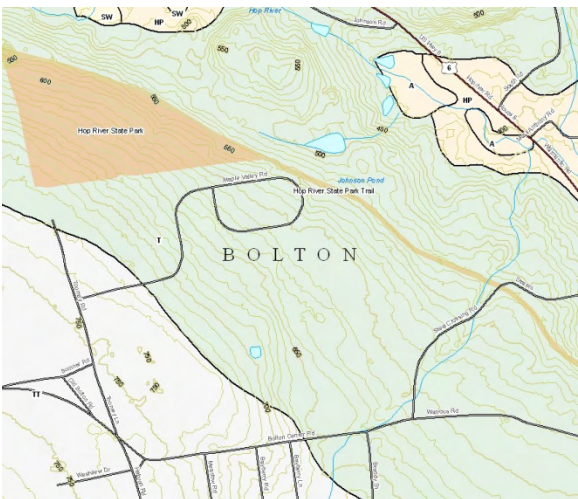
**Figure 2. Quaternary Map of the Farm Site and adjacent areas. Brownish-orange areas denote state park and trail lands. The western boundary of the site parallels Meadow Road; the eastern boundary extends to the state green-belt trail (brownish-orange strip); the northern boundary is just below the word BOLTON. The area is covered by glacial till (green colored) and thick glacial till (uncolored on map). After Stone and others, 2005.**

Sand and gravel deposits (pale yellow on Figure 2) are found along the valley-bottom (not on the parcel).

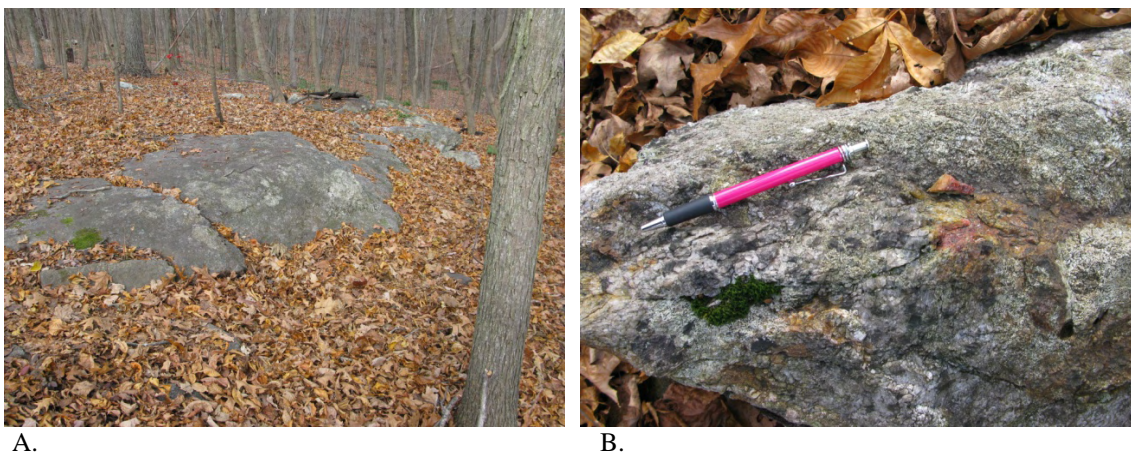
**Figure 4. A. Low bedrock outcrop in wooded portion of Farm Site north of cleared area. Outcrops are typically low and rounded. The rock is gray pegmatitic gneiss. B. Typical pegmatite gneiss with spotty rusty weathered areas.**

north/northeast of the small pond. Outcrops typically are 5' or less in height and may extend several 10's of feet along the strike. The rock exposed is grey granitic gneiss that has large areas of pegmatite (pegmatite is an extremely coarse grained variety of igneous rock....the term is also used for some metamorphic rocks as in this case). The pegmatitic rocks may be interlayered with more easily weathered schistose rocks that contain more mica. Rocks of the same formation are exposed along Rte. 6 (see Figure 5) and contain more schist than is exposed on the Farm site. Pegmatite in these rocks formed as an accumulation of partly molten rock that cooled slowly forming coarse grains. The coarse-grained rock is more difficult to weather and erode than the finer-grained schist and hence, pegmatite forms the outcrops on the Farm site.

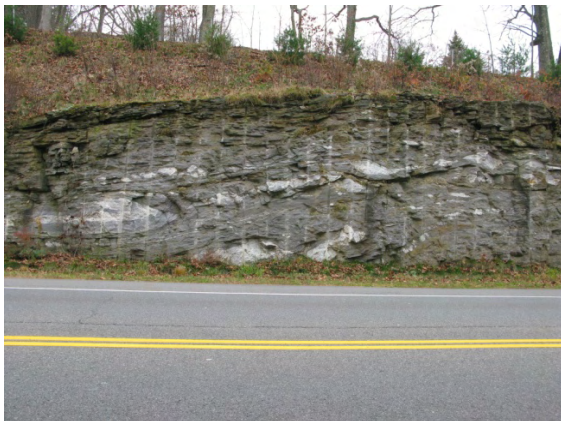
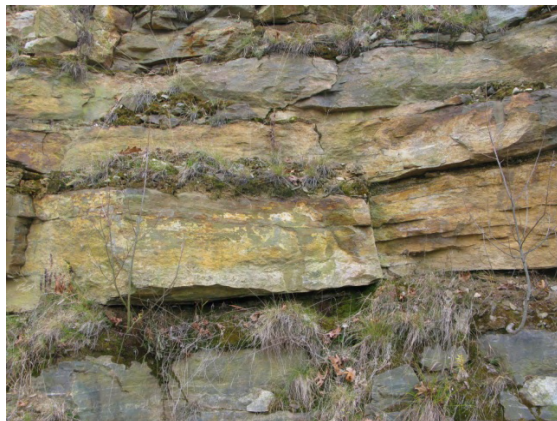
**Figure 5. A. Road cut of Southbridge Formation along Rte. 6 (Wintsch, 1999). This rock consists of gray and dark gray biotite schist and gneiss with “pods” of white pegmatite. In this example the pegmatite formed during the metamorphism when the rock temperature was so high that parts of the rock started to melt. The molten portion was squeezed so that it segregated in to the pods. Here the pods are not very large. Pods on the farm site are thicker and in more extensive layers. B. Rusty weathering layer in Southbridge Formation exposed along Rte. 6.**

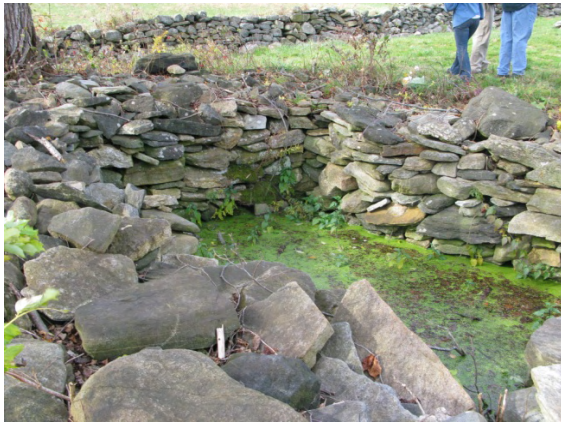
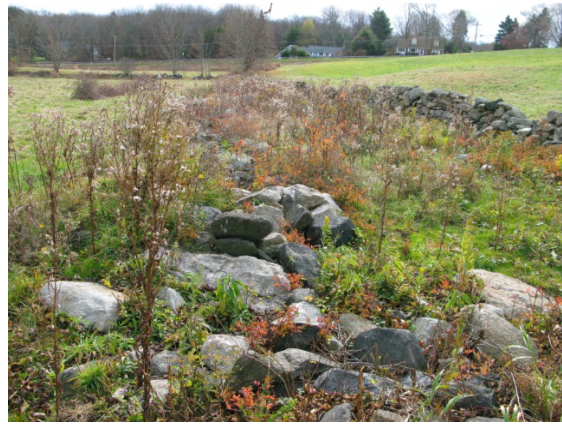
**Groundwater.** The area underlain by the Southbridge Formation is poorly drained. That may be because of the amount of schistose rocks in the formation. Schist does not fracture as well as gneiss and thus there is not as much fracture porosity into which water may seep. It tends then to saturate the lower portions of soil above the buried ledge. The water table is in the soil over large portions of the Farm Site. The water table generally follows the contour of the land but at the base of some steep slopes the water table comes to or close to the surface. If groundwater seeps out at the surface it is called a spring. A low volume spring (Figure 6) is found at the base of the steep slope shown in Figure 1A (spring is out of sight on the left side of the picture; see also Figure 6). At the time of our observation, spring discharge was low. During wet parts of the year the spring discharges enough that a ditch was dug (Figure 6B) to drain the outflow.

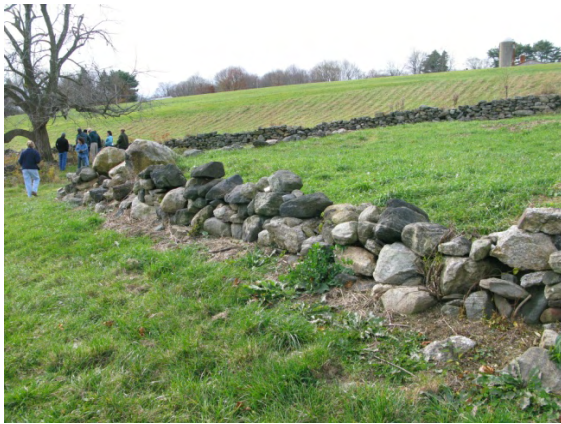
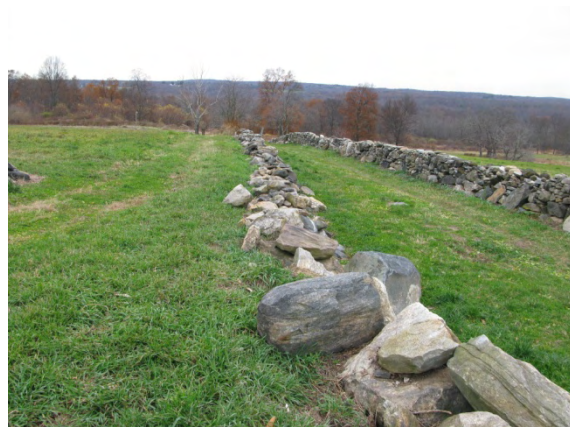
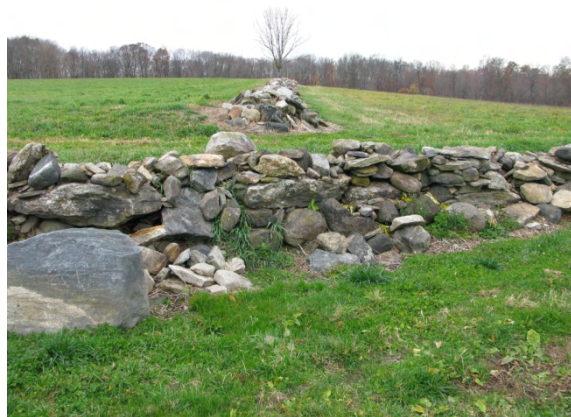
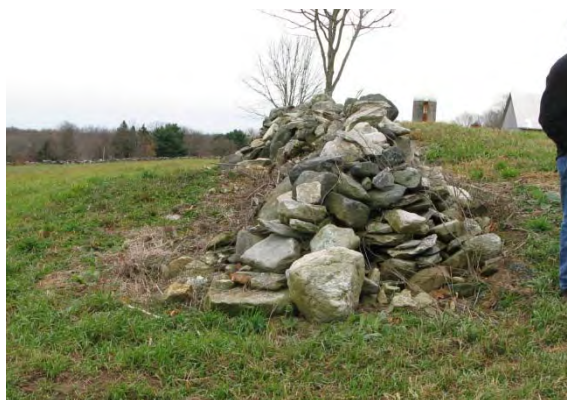
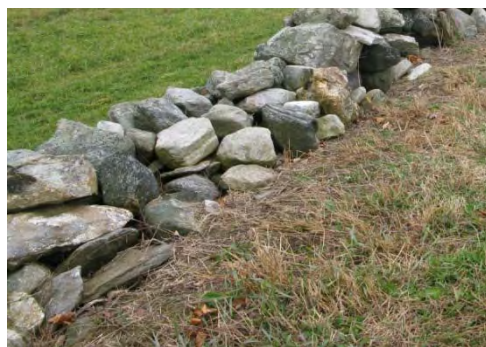
**Soil Disturbance.** Considerable modification to the grade occurred in past farming operations. The volume of disturbed (both removed and filled) soil is difficult to estimate. Certainly fill has been placed around buildings to facilitate their use. Soil has also been dug and filled around many of the stone fences on the site. In some cases it appears to have been dug out to make travel lanes more level (Figure 3A, 7B-C). In other cases it seems to have been filled in, perhaps making fields more level to facilitate row-crop farming (Figure 7C-E).

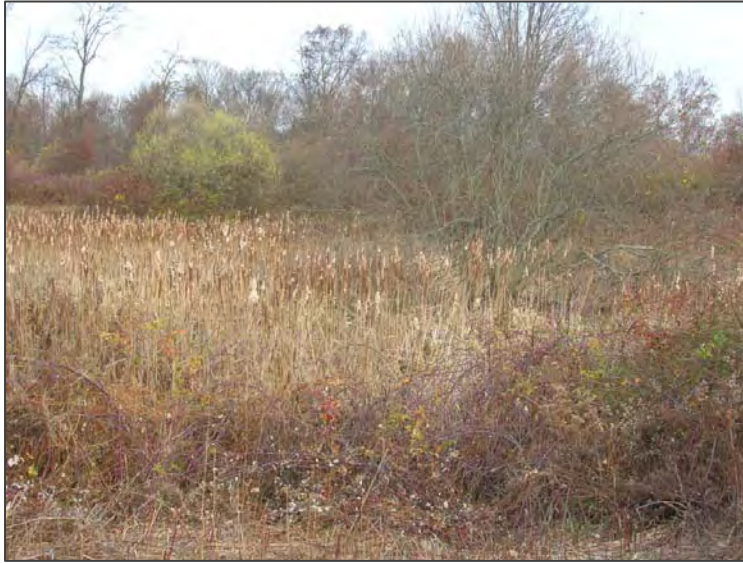
**Dug out pond (wetland area 7 on map)**

Other wetlands include a dug pond (wetland area 7) just east of the large field behind the house and barn. In addition, a short segment of the Hop River crosses the southeast corner of property and there is a small wetland area in the field along Bolton Center Road (wetland area 8). The small wetland in the field is periodically cut for hay. This activity will not have any specific impact to the wetland and management of the field should be based on broader management issues (habitat, appropriate crops etc.). No special management strategies are required for the Hop River, provided that existing buffers are maintained.

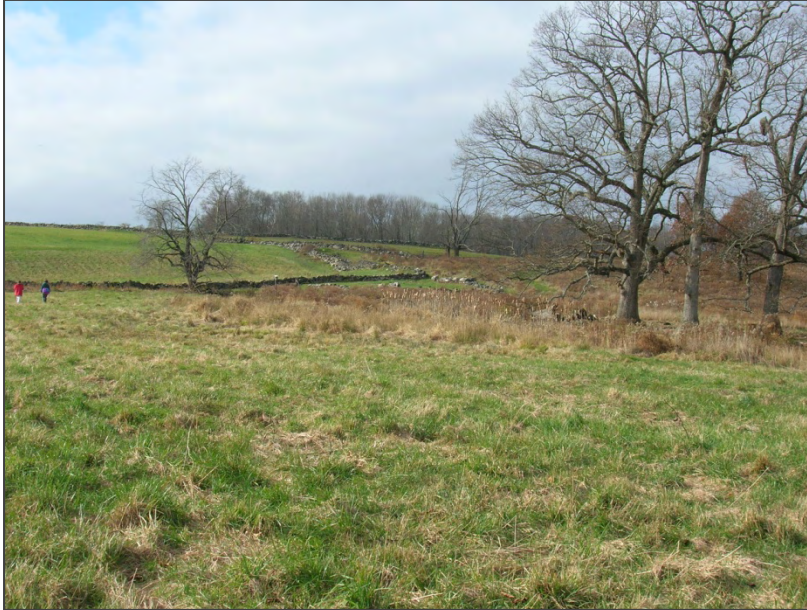
**Drainage Swale (wetland area 2 on map)**

The boundary of the wetland soil, as mapped on the attached NRCS soil survey, is located

approximately 150 feet east of the spring. This area of the wetland (wetland area 2) is predominantly wetland meadow habitat, dominated by grasses. Tussock sedge is dominant.

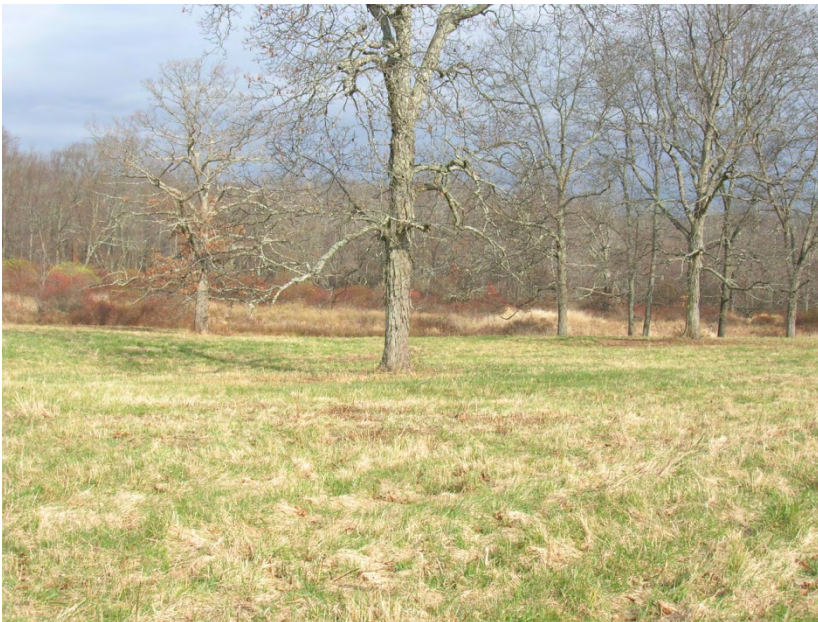
**Grasses and cattails in area 3, shown in the background.**

Area 3 consists of grasses and cattails. Area 4 is a potential vernal pool located at the transition between meadow wetland and wooded wetland.

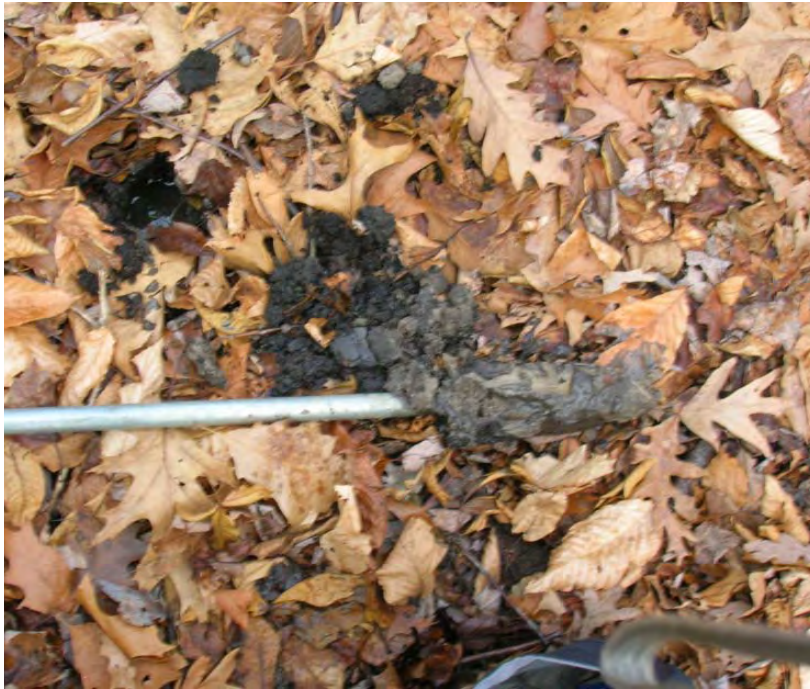
**Very poorly drained Whitman soils found in the potential wooded vernal pool (area 6 on map) have a thick organic surface and a reduced mineral subsurface.**

The soils mapped in the wetland areas on the farm are the poorly drained Leicester and Ridgebury, and the very poorly drained Whitman. These soils all formed in glacial till. Unless cleared, the map units are extremely stony. Some areas are underlain by dense till, which restricts downward water movement. Small areas of somewhat poorly or moderately well drained soils may be present in these units.

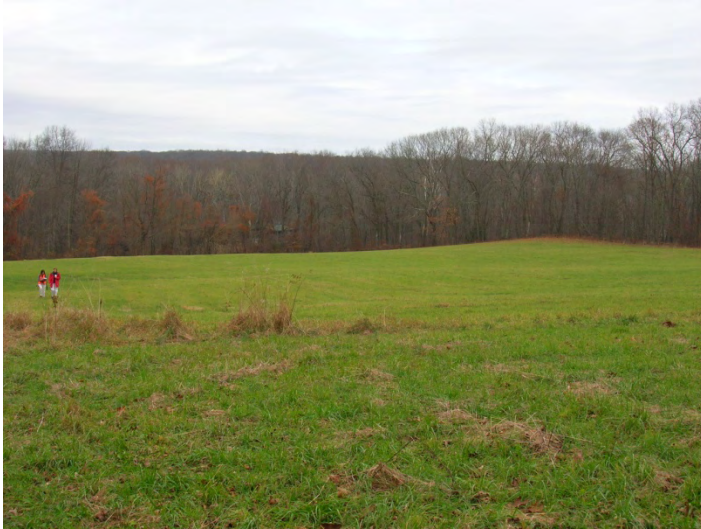
**Steeles Lot: 60C Canton and Charlton soils, 8 to 15 percent slopes Farmland of statewide importance**

The majority of open land on the property is classified as either prime or important farmland. See attached map labeled “Farmland Soils”, updated to reflect additional clearing and slope corrections. The prime farmlands on the property are mapped 84B; gently sloping Paxton and Montauk soils, 45B; gently sloping Woodbridge soils, and 60B; gently sloping Canton and Charlton soils. Areas classified as important farmlands are 45C, strongly sloping Woodbridge soils, 60C; strongly sloping Canton and Charlton soils, and 84C; strongly sloping Paxton

and Montauk soils. The important farmland areas are limited by slope. The Montauk, Paxton and Woodbridge soils have dense till, a layer that restricts root penetration and water movement, within 20 to 40 inches of the soil surface. Woodbridge is moderately well drained, with a seasonal high water table within about 18” from late fall to early spring. This restricts some agricultural uses where early or late field operations are required. It is a good soil for hay and pasture. The soils on the property that are not classified as prime or important have abundant surface stones and/or very poor drainage.

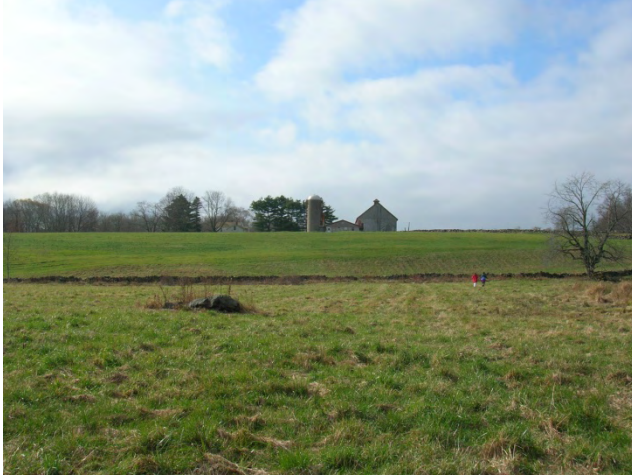
**View of the barn from the east. Soils in the foreground, Woodbridge on a B slope, have seasonal high water tables in the spring. In the background, Paxton and Montauk soils occupy a strongly sloping hillside.**

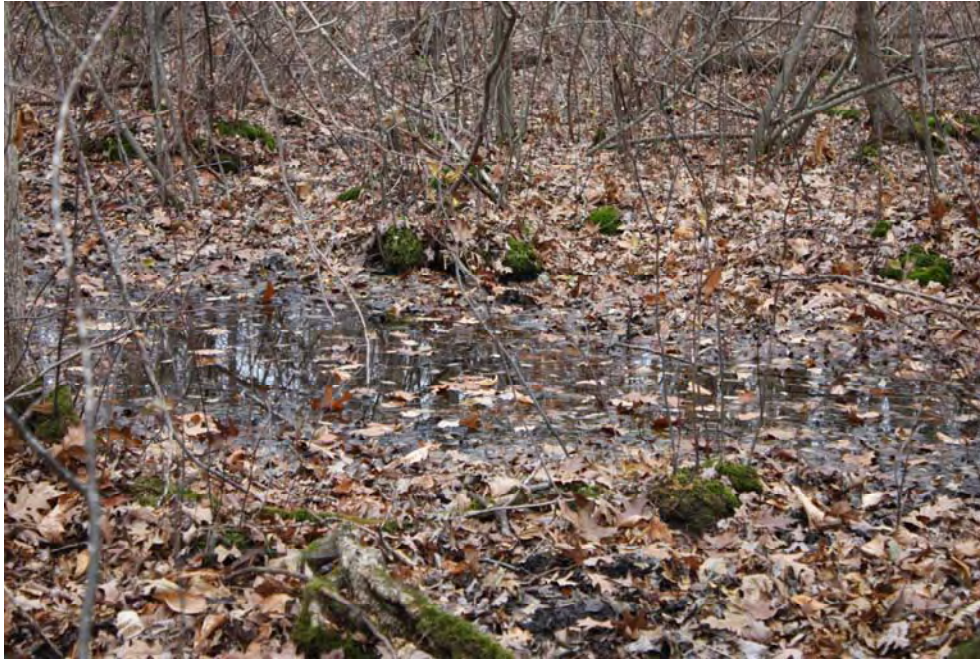
#### Large Pool in the Woods Needs to Be Checked for Obligate Species

The pool in the woods appears to be a likely candidate for a functioning vernal pool in that it appears to hold water in a basin and lack fish. Note that although the classical vernal pool is a

small depression that holds water for at least two months and dries up during some portion of the year, a wooded swamp also can be treated as a vernal pool if it provides habitat for vernal pool obligate species. Note also that not all wetlands that function as vernal pools dry up every year.

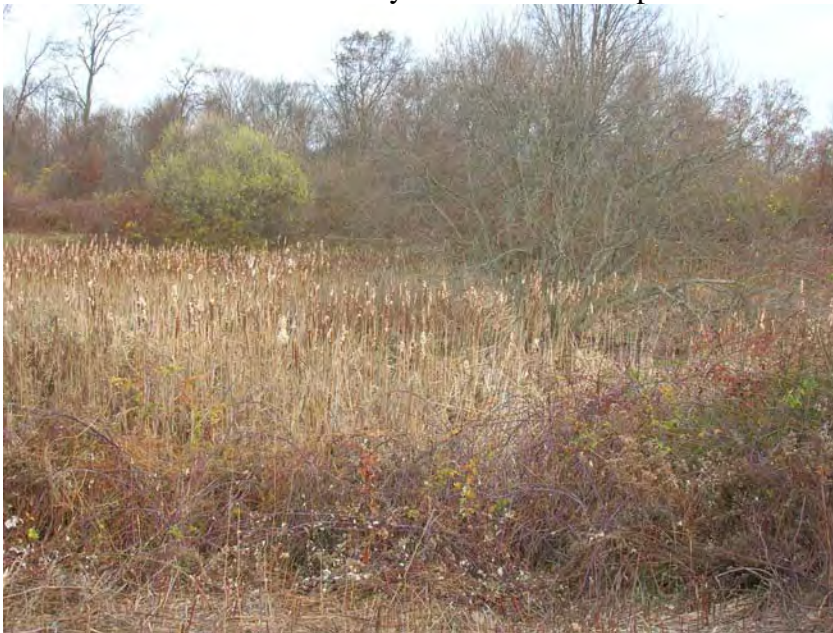
## Dug Pond

The thick growth of cattails suggests (A) the possibility of an excess of nutrients in the water (from agricultural run-off), (B) altered hydrology (less water than previously coming in to a pond), and/or (C) the presence of an aggressive type of cattail. This reviewer was not able to positively identify the species of cattail.

Regardless of species, the cat-tails are spreading. If nothing is done to the pond vegetation, it is likely that the cattails will continue to increase in both number and density. This is undesirable for bird diversity.

[http://www.dnr.state.wi.us/invasives/fact/com\\_cattail.htm](http://www.dnr.state.wi.us/invasives/fact/com_cattail.htm) . If chemicals are used in an aquatic situation in Connecticut, a state permit must be obtained. Note that rather than eradication (complete removal of the population), a possible management strategy might be reduction in (A) the number of stems or (B) the overall size of the cattail patch.

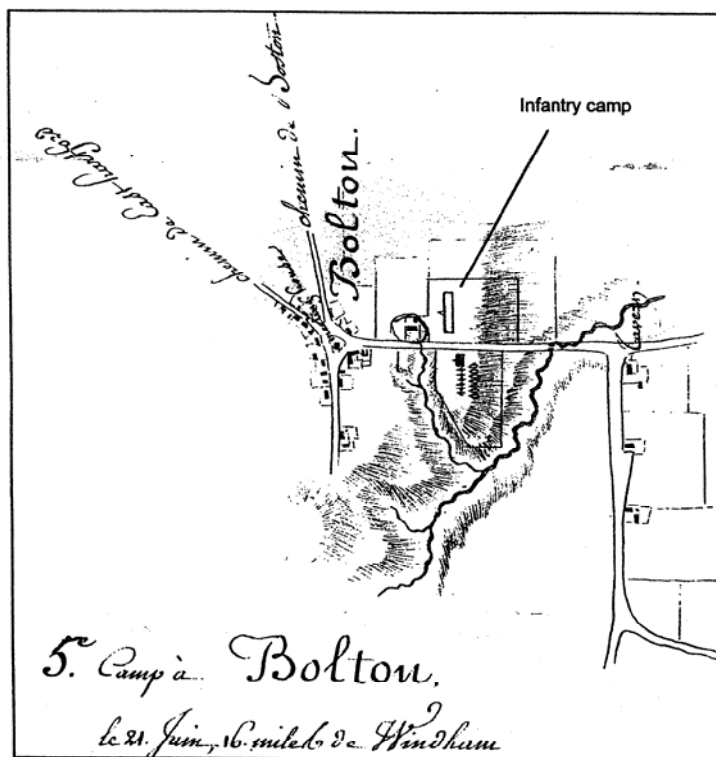
**Fifth camp of Rochambeau's Infantry, Bolton, Tolland County, CT, as drawn by Louis-Alexandre Berthier, military engineer for the French army. The artillery was parked across the road (present-day Bolton Center Road) from the infantry encampment (from Rice and Brown 1976)**

Revolutionary War artifacts had been collected from the campsite by members of the Rose family through the years. A systematic metal detecting survey was conducted by the Public Archaeology Survey Team, Inc. within and beyond the site limits as indicated on the French maps. While initial expectations were not high, within two days of testing over 50 diagnostic artifacts were uncovered, including musket balls, halfpennies, buttons, buckles, numerous aspects of material culture associated with the French encampment. The artifacts were recovered from a well-defined area within the camp boundaries indicated in the French maps. A portion of the site has been previously disturbed by construction of a manure ditch, driveway and barn structure.

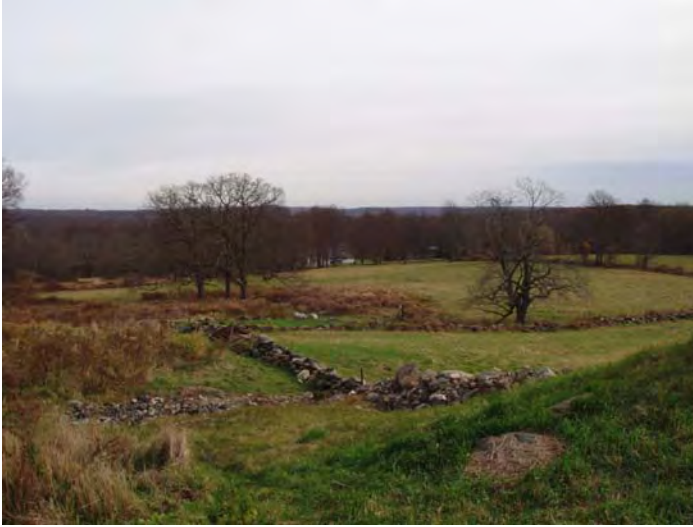
The stone walls on the property are extensive and some are the same walls that were mapped by French engineers. The OSA and SHPO are in full agreement with Dr. Robert Thorson that the walls have cultural and historic value. They add immeasurably to the historic landscape and require preservation. Such stone walls are a tangible connection between the historic landscape and the Rose Farm of today. While little is known about the history of the stone-enclosed impoundment area, it, too, should be considered historically sensitive.

In regards to the preservation of the stone walls, we would recommend some common sense suggestions. No one should be allowed to climb onto or remove stones for any reason. Replacement of fallen stones from the wall should be considered if you are very sure as to where the stone toppled from. Do not build new walls where you think former walls may be located. Patterns of farming land use and pastures change over time, so even if a portion of former wall can be identified, tell the story, but, don't "recreate." The stone walls correlate well to the French maps.

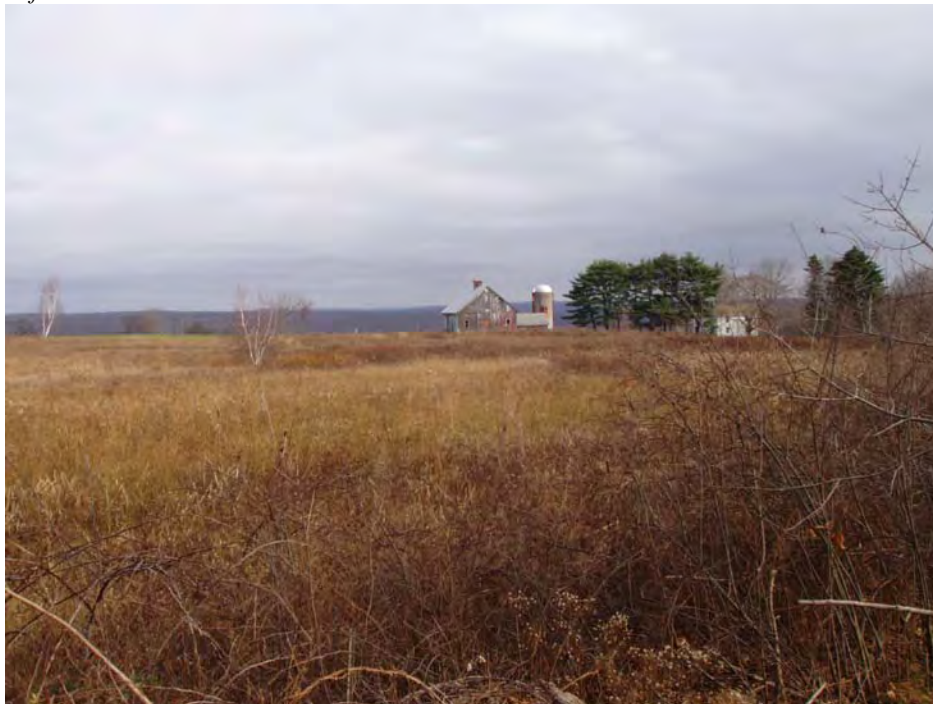
*View from rear of Bolton Town Hall.*

Reportedly an expansion of town hall is proposed, action which would also address the current shortage of parking and presumably utilizing part of the adjoining tract as well as locating needed septic facilities. The former farmland on this site already provides visual linkage to the Rose Farm and to the hills beyond, offering opportunity for a physical linkage via trail to the Rose Farm farmstead complex. Also this reviewer would recommend locating any community gardens here, rather than at the farmstead complex to minimize impact on that area. Furthermore the presence of some good agricultural soils here makes it appropriate for such potential use.
