**MOUNT  
PISGAH  
OPEN SPACE**

**DURHAM,  
CONNECTICUT**

## **ENVIRONMENTAL REVIEW TEAM REPORT**

**January 2007**

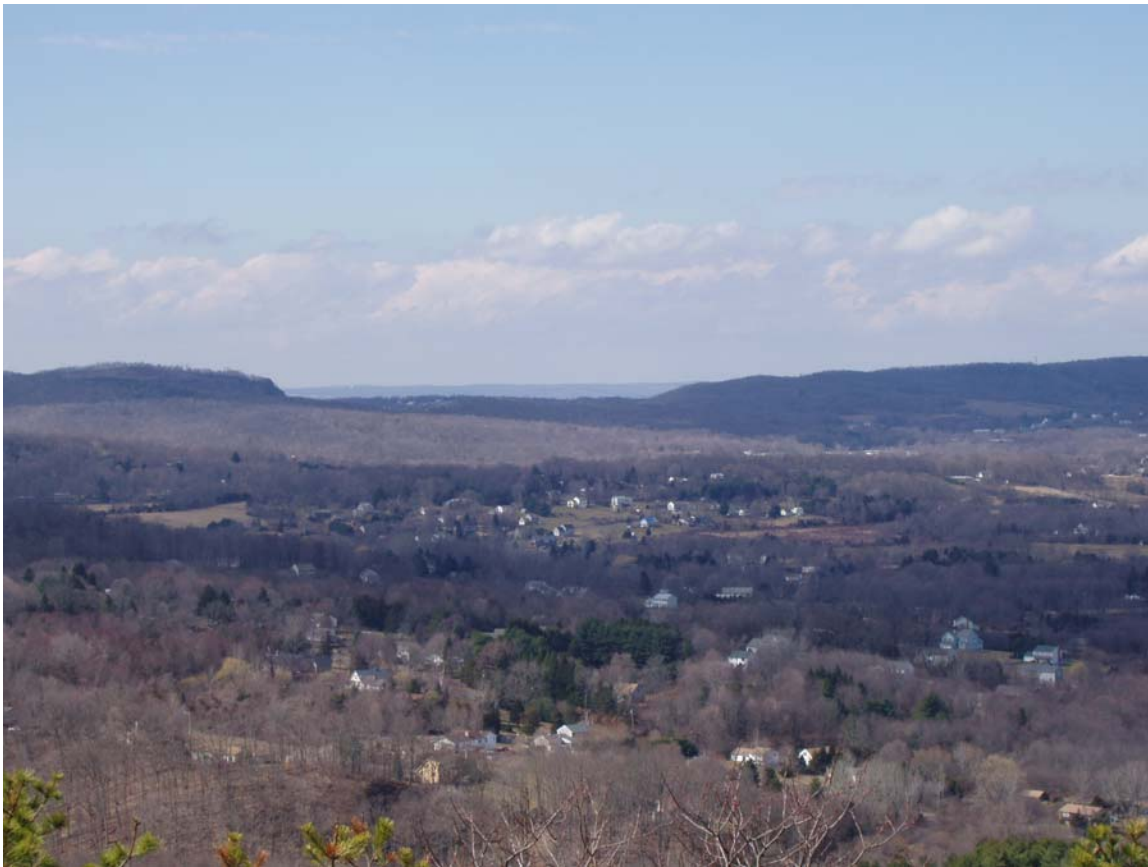
Figure 2. Looking west from the top of Mt. Pisgah towards Reeds Gap and into the eastern part of the Central Valley. The Coginchaug River lies out of view at the base of the drop-off. Rocks in the central valley are both sedimentary and volcanic in origin and Mesozoic (about 210-180 million years) in age. The Metacomet Ridge forms the skyline and in the far distance and through Reeds Gap lies the western edge of the central valley near Cheshire, CT. The hills seen through the gap are probably part of the western highlands and composed of metamorphic rocks of mid-Paleozoic age. (Photo by E. Sych.)

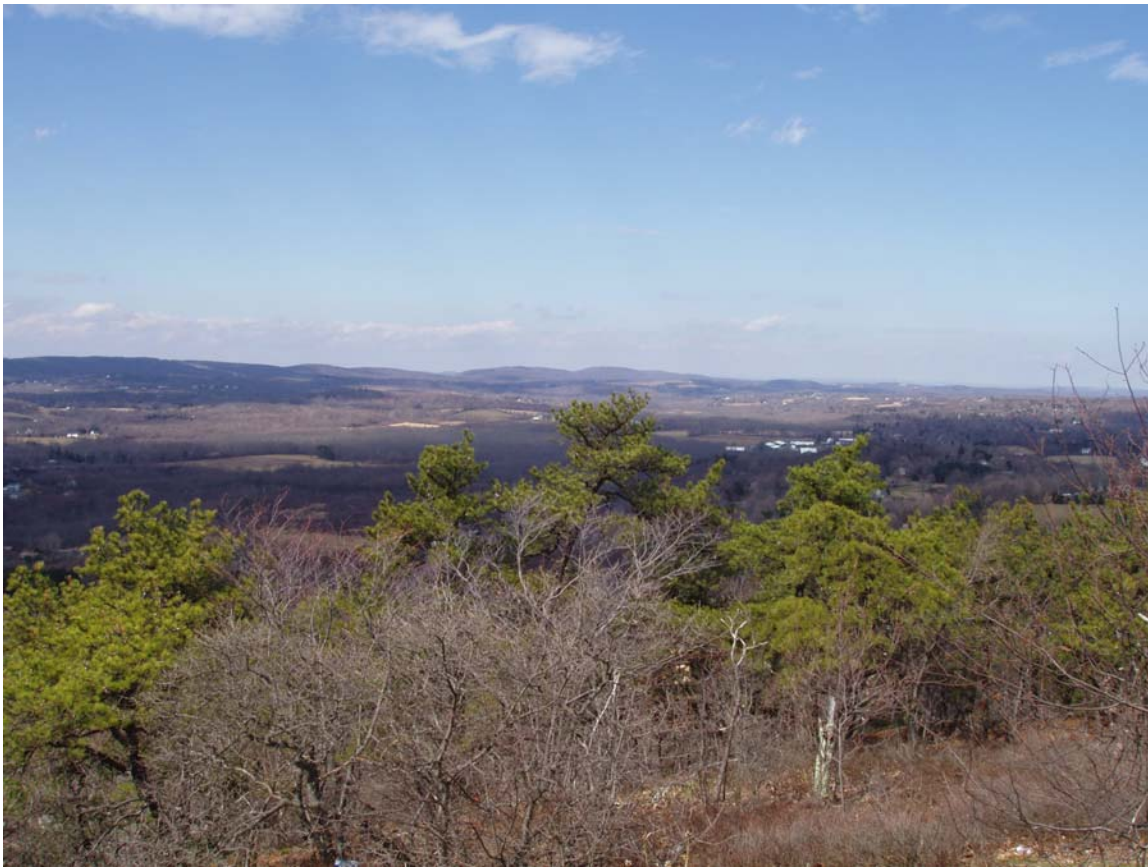
Figure 3. View toward the northwest from the top of Mount Pisgah. The grey hills on the center skyline are Higby Mountain (on the left) and Lamentation Mountain. On a clear day the Hanging Hills of Meridan can be seen to the left of Higby Mountain. The Hartford skyline can be seen on a clear day. The Metacomet Ridge forms the skyline headed north behind Hartford. Possibly Talcott Mountain also is visible on a clear day.

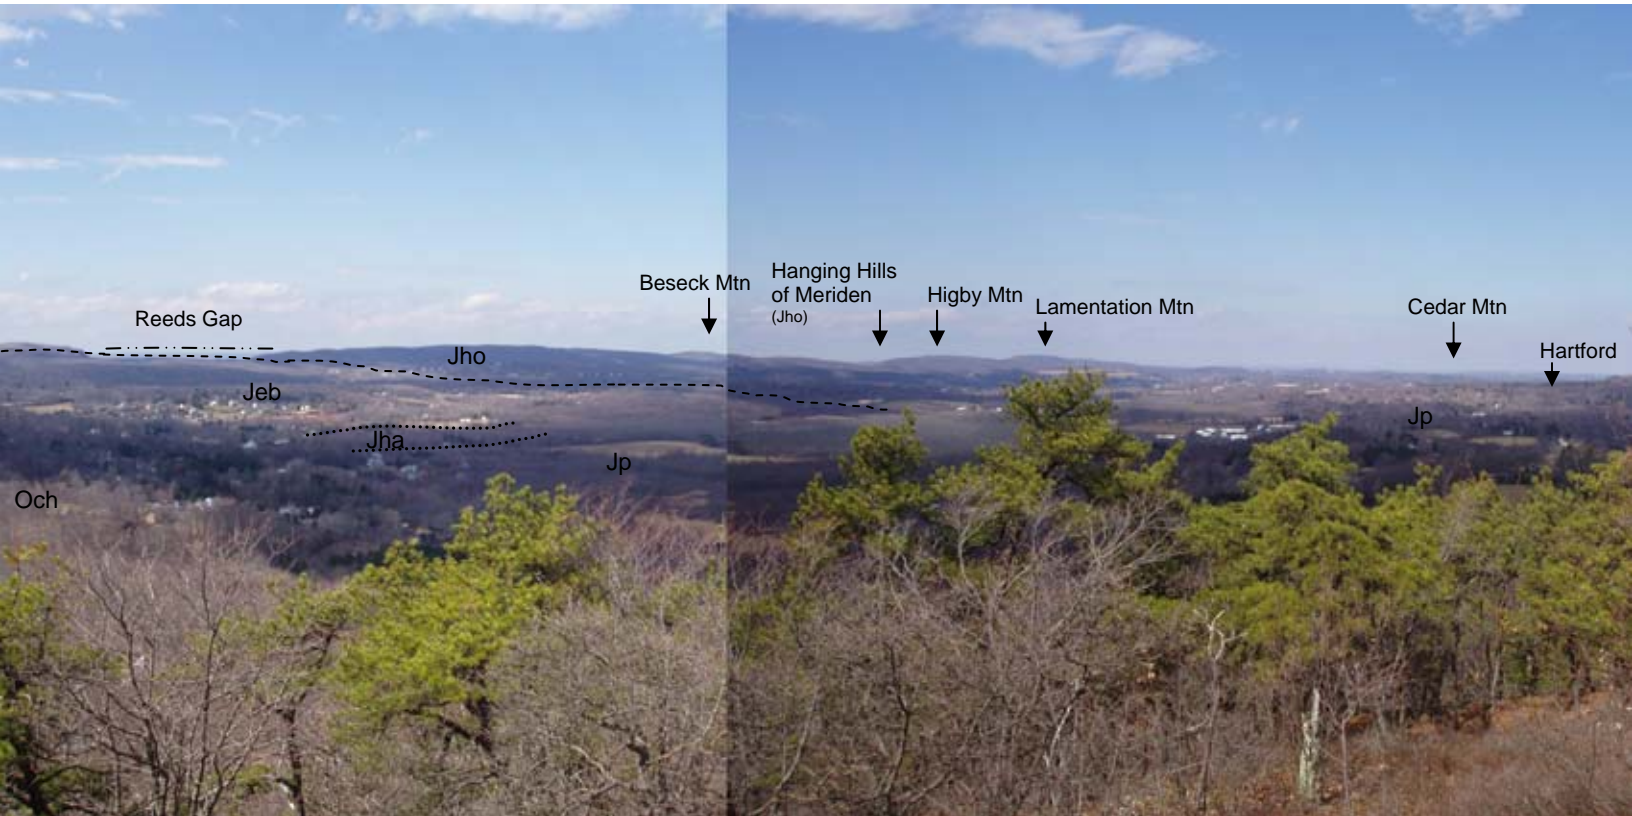
# Mt. Pisgah

Abbreviation	Name
Jp	Portland Fm
Jha	Hampden Basalt
Jeb	East Berlin Fm
Jho	Holyhoke Basalt
Och	Collins Hill Fm

The Mount Pisgah Open Space tract is in the southern part of Durham; its southern boundary is actually at the boundary with the Town of Guilford. It has a fairly moderate to rough topography (see Figure 1). Relief is slightly greater than 400' within the tract and near 500' if the nearby adjacent area (Coginchaug River Valley) is considered. Mount Pisgah has an elevation of 644' above sea level; Chalker Brook has an elevation of about 240' where it flows north out of the open space parcel; the Coginchaug River has an elevation of less than 160' just northwest of the parcel. The local area has a distinct north-south topographic grain. Roughly north-south elongated hills, many oval shaped in map view, are flanked by rather steep sided drainages and saddles. Immediately to the southeast the topographic grain changes to more northeast-southwest. Rather concentric shaped hills, in map view, are flanked by northeast-southwest oriented drainages and saddles. To the north and west the topography drops dramatically into Connecticut's central valley (see Bell, 1985, Ch. 2), such that there is a magnificent vista toward the north and west from the top of Mount Pisgah (see figures 2 and 3). The central valley is host to several rivers: the Connecticut River flows southeastward through the northern part of the valley and the Quinnipiac River in the southern part. The Coginchaug River flows northward in the southeastern part of the central valley and it is into the Coginchaug River valley that the vista (Figure 2 and 3) begins. The topography of the central valley is composed of rolling hills and a prominent ridge, the Metacomet Ridge, which runs practically the length of the valley and into Massachusetts. The change in topographic grain is a reflection of the underlying bedrock geology.

Figure 1: Map of Mt. Pisgah open space parcel, Durham CT, showing bedrock and surficial geology. Because a thin (0-10ft.) veneer of glacial till covers most of the area, only the distribution of sand and gravel is shown on the map.

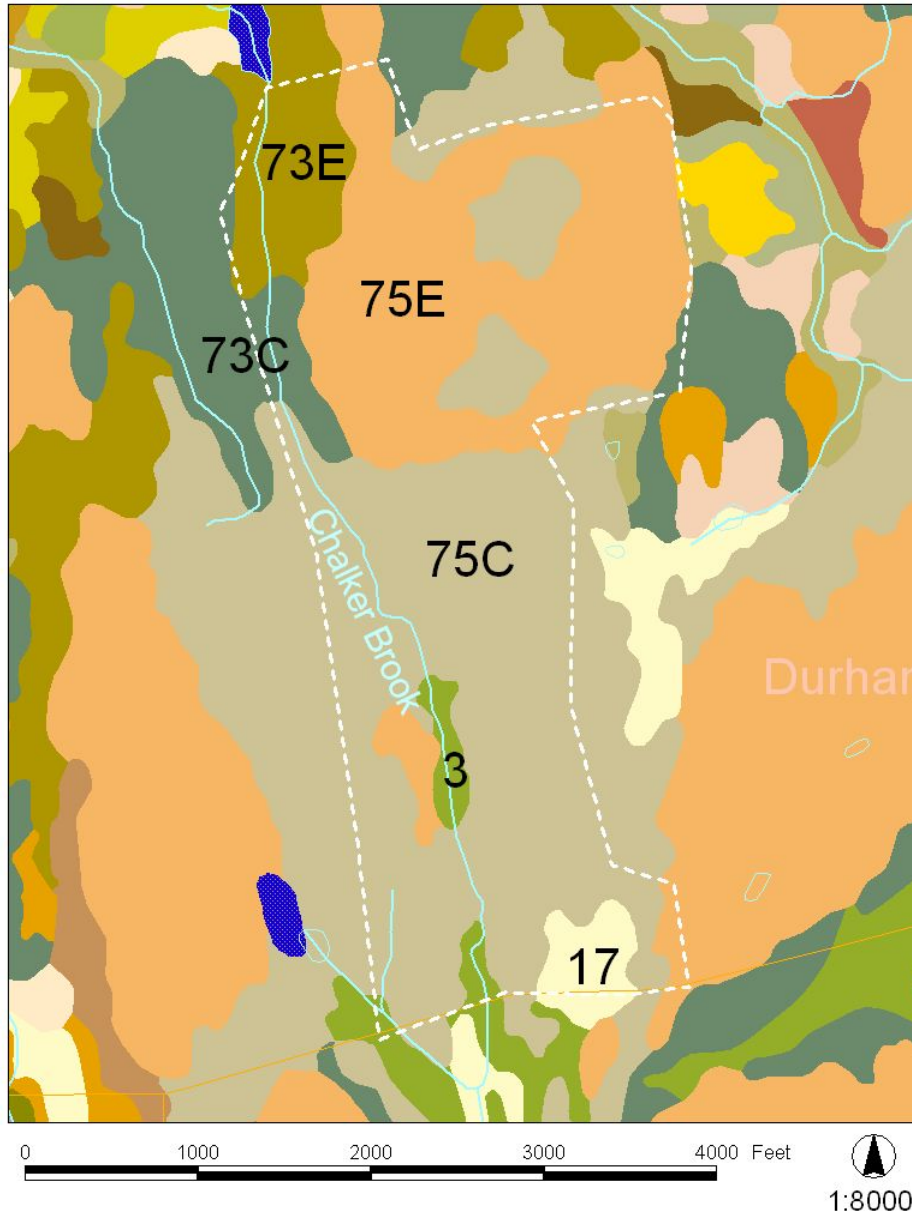
Mapping of the soil type boundaries is shown in Figure 3. These data are from the USDA/NRCS soils GIS coverage and are at a 1:12,000 scale, with the smallest area (polygon) delineated of approximately 3 acres. Caution should be taken when using soil survey mapping for site-level planning since at this scale soils in a single mapped unit can differ in slope, depth, drainage, and stoniness.

**Figure 3.** Soil map units boundaries shown on the USDA/NRCS soils mapping (1:12,000-scale GIS data).

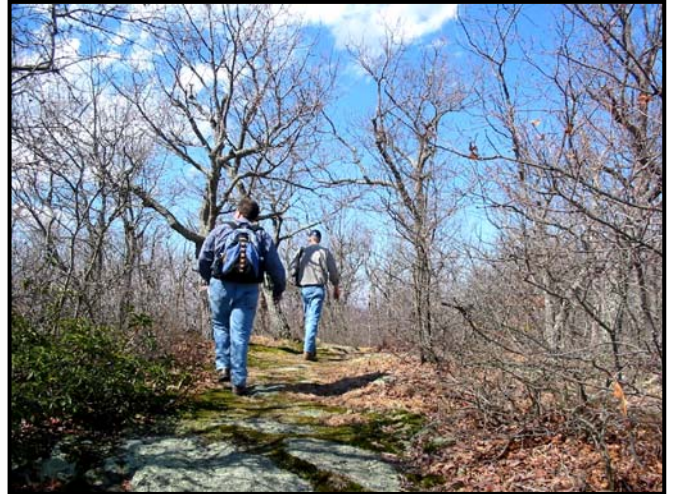
Much of the Mount Pisgah property is moderately to very steep, with upland soils limited by shallow depths to bedrock, slope and stoniness. In addition, upland soils on the property have a moderate hazard of soil rutting. Recreational or forestry activities of any intensity should be located in areas with as moderate slopes as possible. The booklet “*A Practical Guide for Protecting Water Quality While Harvesting Forest Products*” prepared by the CT RC&D Forestry Committee (1990) provides a number of practical recommendations for minimizing potential impacts from forestry activities. In general, proper erosion and surface water control measures, sedimentation traps and barriers, and time of the year restrictions should be considered for forestry management or trail building/maintenance projects.

**Photo 1.** Climbing to the summit of Mount Pisgah over exposed bedrock.

- Proper erosion and sedimentation control measures, e.g., hay bale barriers, wood chip or compost berms, temporary fill berms or diversions, and water bars should be used for any projects causing earth disturbances.
- Stabilization of disturbed areas by seeding or mulching (hay or wood chips) should be initiated as soon as projects are completed.

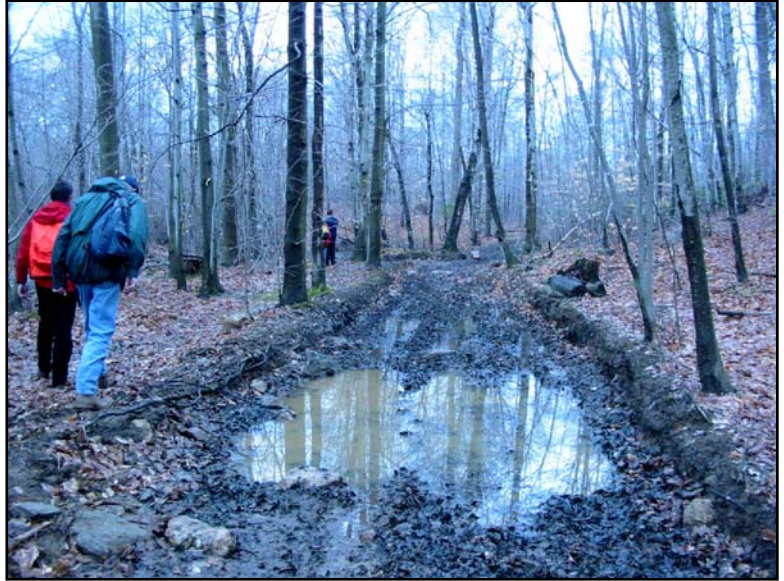
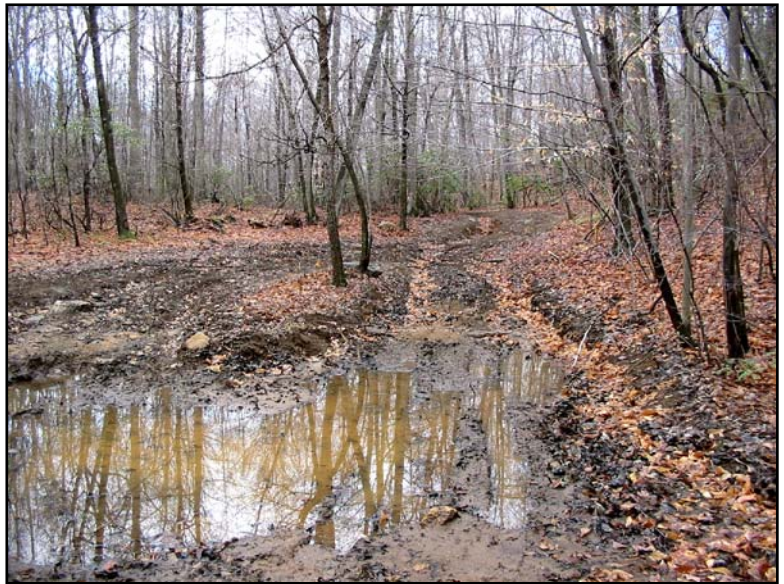
Evidence was observed during the field walk of significant damage from off-road vehicles. Deep ruts, ponded water, and ongoing erosion were observed especially in the southern portion of the property. Some areas of woods road appear to be chronically used by motorized vehicles and are becoming further eroding by concentrated surface runoff flows carried in the roadway.

**Photos 2 & 3.** Deeply rutted areas with poor drainage where water is chronically ponding in the southern portion of the property.

Enforcing restrictions against motorized vehicles, improving drainage on existing woods roads and trails, and closing off/restoring areas where there is the greatest damage should be considered.

- A restriction on forest management activities to when the forest floor is completely frozen or completely dry may be considered.

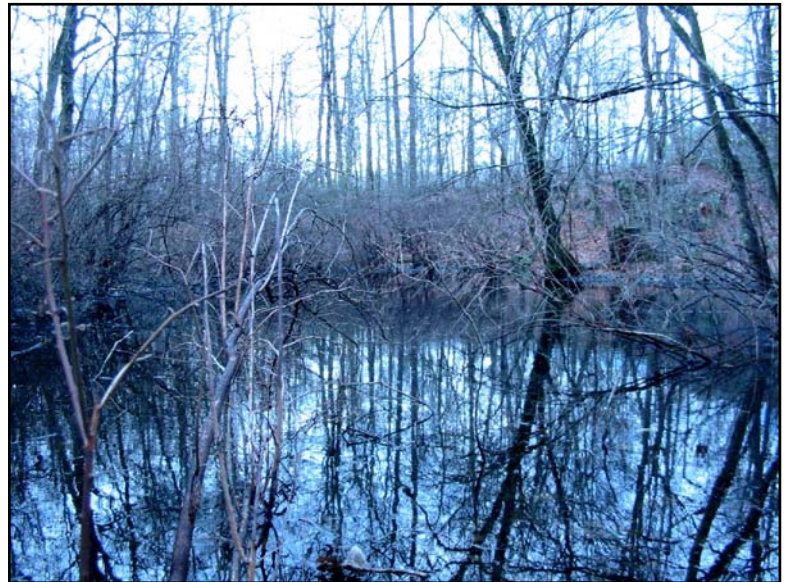
A shallow pond was observed in the south east portion of the property in an area shown as very poorly drained soils on the NRCS/USDA soils maps. Wood frogs were heard calling and were observed congregating in and near the pond during the field walk held on March 14<sup>th</sup>. As there was not yet any evidence of breeding activity (i.e., egg masses), the quality of the pond as vernal pool habitat could not be determined. A number of shallow depressional areas were observed in close proximity to the pond. Unfortunately, due to the dry nature of the current spring season, none of these areas were holding water. Accumulations of water stained leaves did however suggest that some of these areas may seasonally hold water, and therefore may support vernal pool breeding amphibians especially in wet years. Further field investigation in this portion of the property in a wetter spring, or possibly even in the late fall, may reveal the presence of other vernal pool habitats. Appropriate forestry management, trail creation and maintenance, soil erosion control, and sediment trapping techniques should be used in and near observed vernal pools to reduce potential impacts.

**Photo 4.** Pool where wood frogs were heard and observed to be congregating during the ERT field walk.

- Recommendations provided in “*Forestry Habitat Management Guidelines for Vernal Pool Wildlife in Maine*” written by A.J.K. Calhoun and P. deMaynadier (2003) should be considered for land in an near any observed vernal pools. Some key considerations include;

- g) Avoid conversion of one forest cover type to another in and near vernal pools. Organic inputs (e.g. leaf fall) from surrounding trees serves as the base of the ecological food web, and changes in the type and quality of this resource can shift vernal pool community structure.

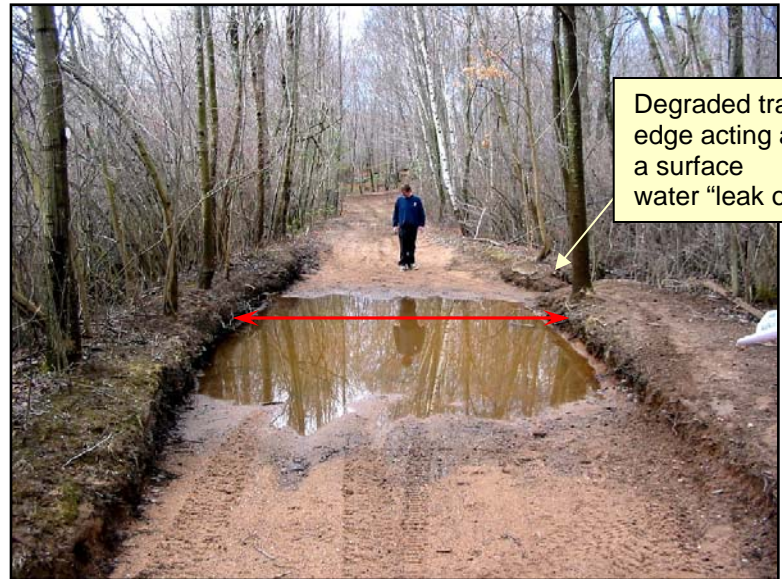
The second crossing is in the southern edge of the property in the vicinity of where the woods road/trail turns to the north. In this location a watercourse that is assumed to be Chalker Brook was observed to pass under the trail in an approximately 18 inch diameter metal pipe. This pipe culvert connects the watercourse and its associated wetlands which extend to either side of the trail. The woods road in this area is deeply rutted, and a substantial amount of ponding, possibly due to seepage, was observed in the center of the trail. A degraded area on the road edge was also observed which is acting as a leak off point, where concentrated surface flows are entering the watercourse. The functionality of this pipe culvert to adequately carry flow velocities and volumes should be evaluated as well as if it is partially crushed or blocked. The pipe was fully submerged at the time of the field walk, so the upstream and downstream conditions were not readily observable. In addition, if there are beaver active in the area, retrofitting the pipe culvert with a "beaver deceiver" device may be prudent.

**Photo 5.** Chalker Brook passes through a culvert that is in need of improvement and repair. Seepage across the trail was observed suggesting either the culvert located in the vicinity of the red arrow is either undersized or is partially crushed or blocked.

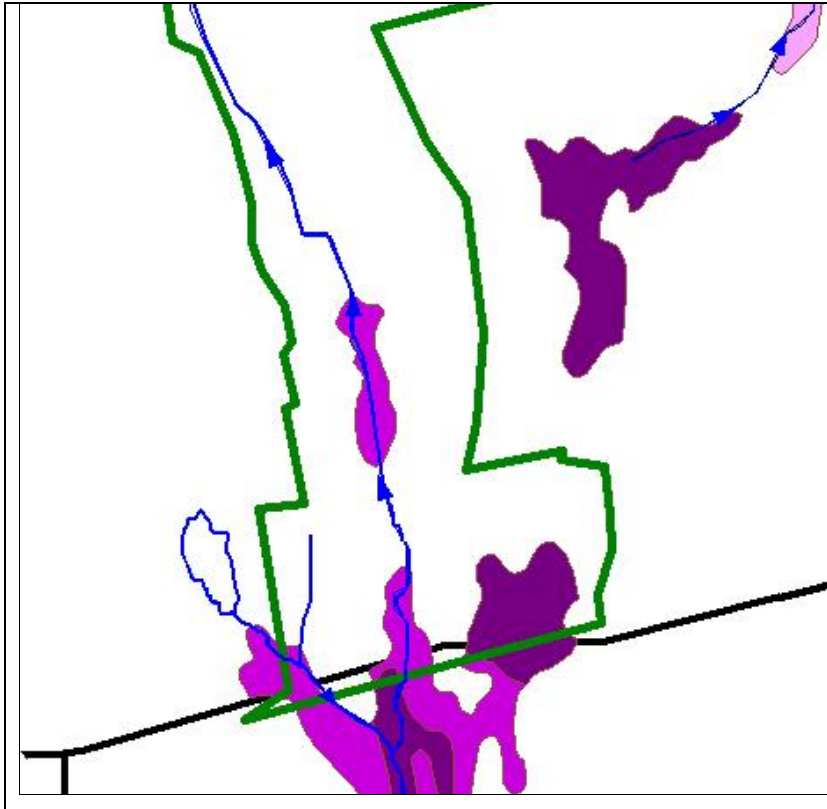
*This graphic shows the wetlands mapping done by the NRCS for the southern part of the parcel. The wetlands are found along Chalker Brook with the darkest areas being very poorly drained and the lighter color being poorly drained.*

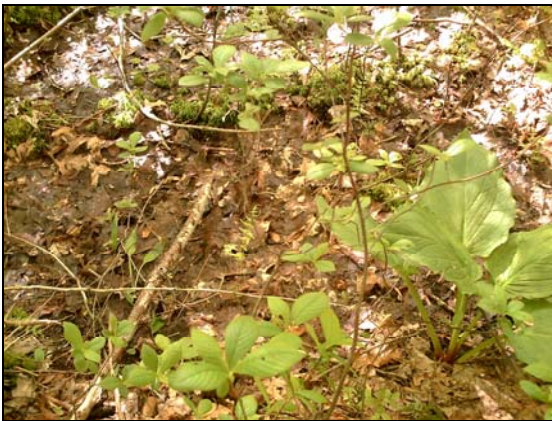
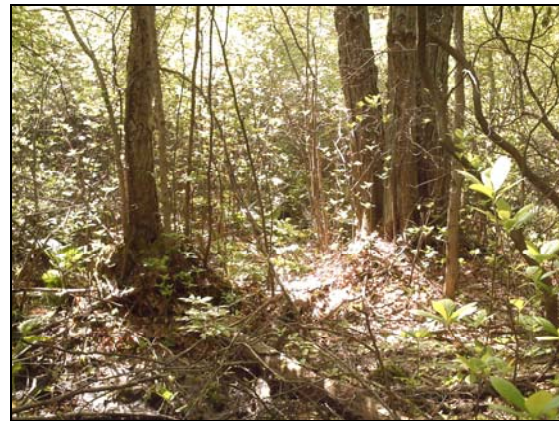
The wetlands are three tiered with numerous upland interspersions. The herb layer is diverse, the shrub layer is well established, and the canopy varies in percentage of cover from woodland to forest category.

Typical forested wetland scene showing the vegetated forest floor, a healthy shrub layer and mature trees which provide 80% and greater ground shading.

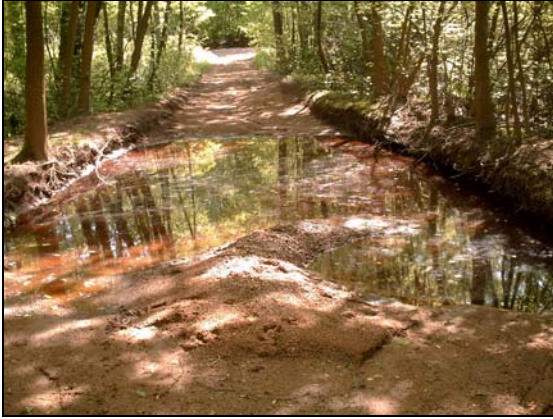
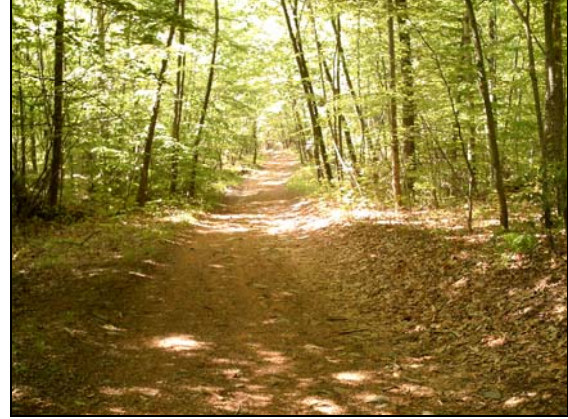
*Forest or woods roads provide access around the property. In the left hand photograph above is the forest road flooded along the southern boundary of the parcel. This is where the road crosses the stream and in high water apparently covers the road. To the right is a typical forest road scene heading north along the west side of the parcel. As discussed in another section of the report, the forest shows a healthy diversity of species which provides wildlife habitat and cover for a songbird population distinguished by the abundant variety of their calls.*

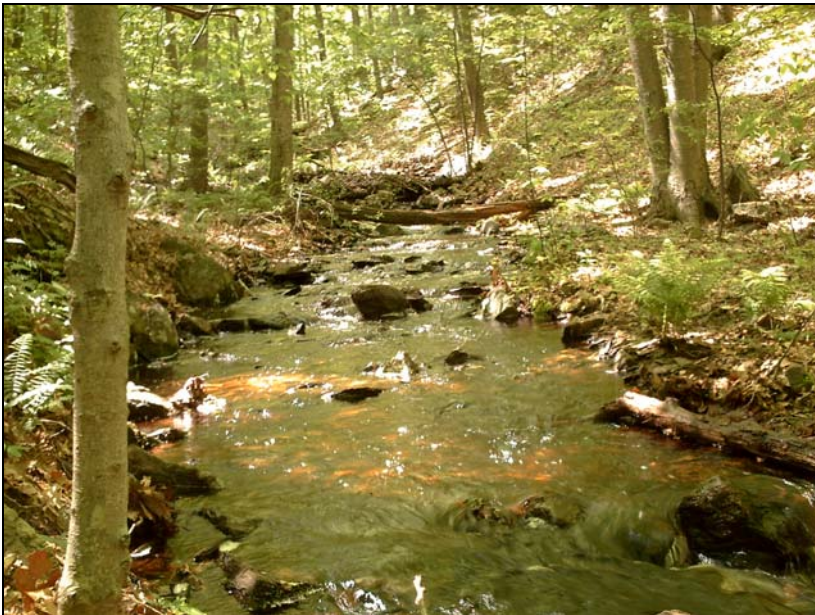
*This photograph depicts Chalker Brook as it flows along the western border of the property just below Mount Pisgah.*

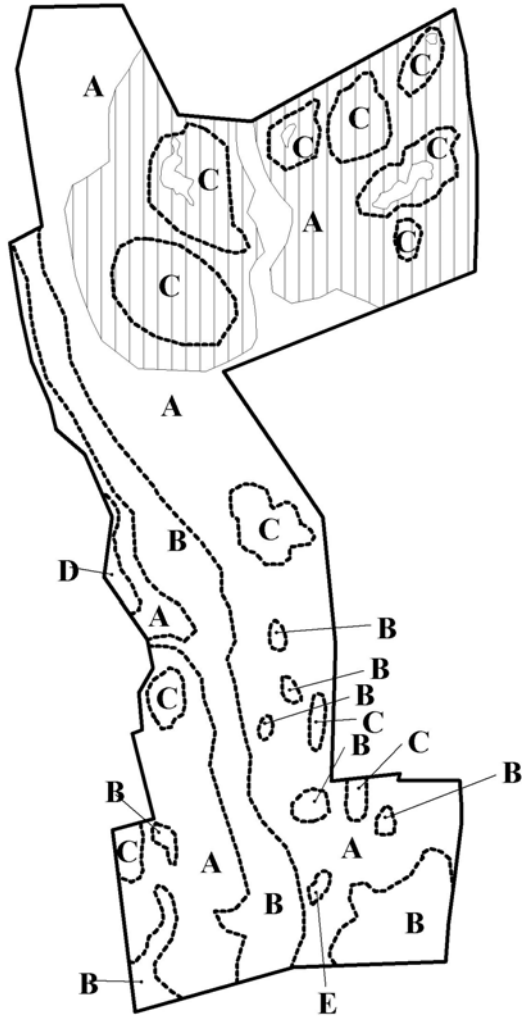
**DURHAM OPEN SPACE  
MOUNT PISGAH  
DURHAM, CT  
VEGETATION TYPE MAP**

A. Mixed Hardwoods	122+- Acres
B. Hardwood Swamp/Streambelt	29+- Acres
C. Oak Ridge	28+- Acres
D. Softwoods/Hardwoods	1+- Acres
E. Mixed Hardwoods/Burn Area	0.3+- Acres

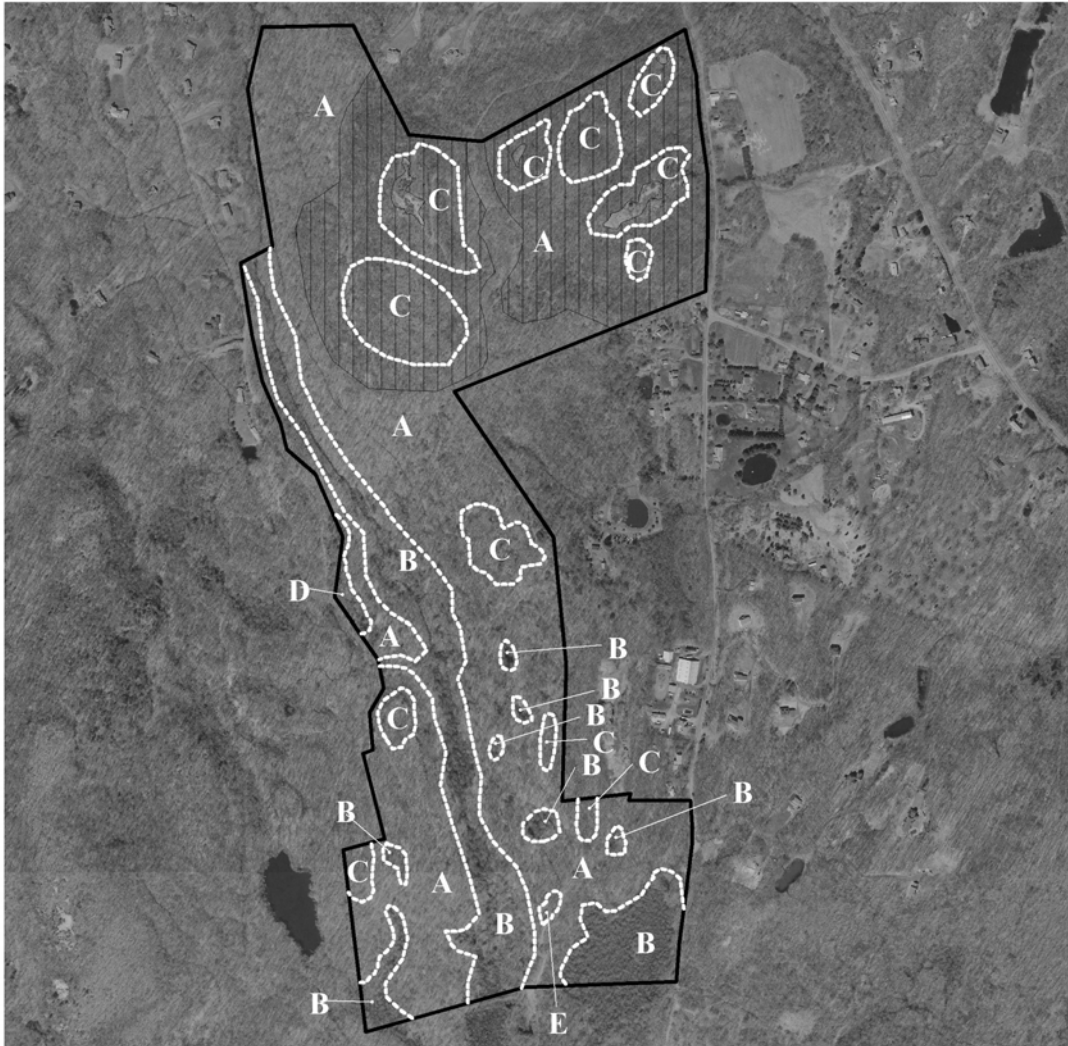
**DURHAM OPEN SPACE  
MOUNT PISGAH  
DURHAM, CT  
VEGETATION TYPE MAP**

A. Mixed Hardwoods	122+- Acres
B. Hardwood Swamp/Streambelt	29+- Acres
C. Oak Ridge	28+- Acres
D. Softwoods/Hardwoods	1+- Acres
E. Mixed Hardwoods/Burn Area	0.3+- Acres

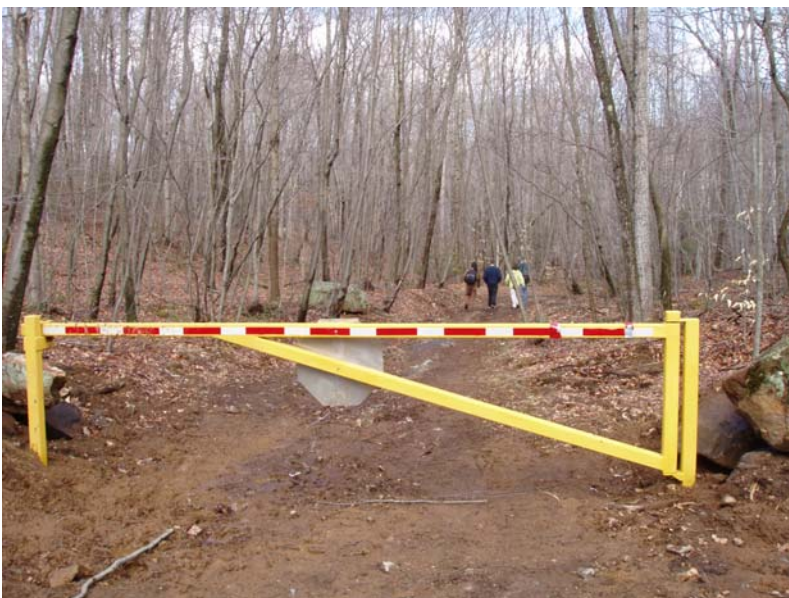
Historically Mount Pisgah in particular has been subject to vehicular issue, as seen in the visible erosion damage. Fortunately this problem has now been controlled by barriers to prohibit further impact. Because of its physical character, management as passive open space seems most appropriate, as well as providing the previously mentioned routing for the Mattabesett Trail, a proposed National Scenic Trail. Silvicultural potential seems limited by poor site quality on Mount Pisgah itself, although some active forestry may be feasible on the southern Chalker Brook section with appropriate stream protection measures. In this reviewer’s opinion, hunting seems a debatable use because of the property’s limited size and proximity to homes on Creampot and Dead Hill Roads. Therefore the issue of hunting should be subject to local determination of feasibility and acceptability.
