Mystic Woods Active Adult Community Groton, Connecticut

Eastern Connecticut Environmental Review Team Report

Report #612

March 2007

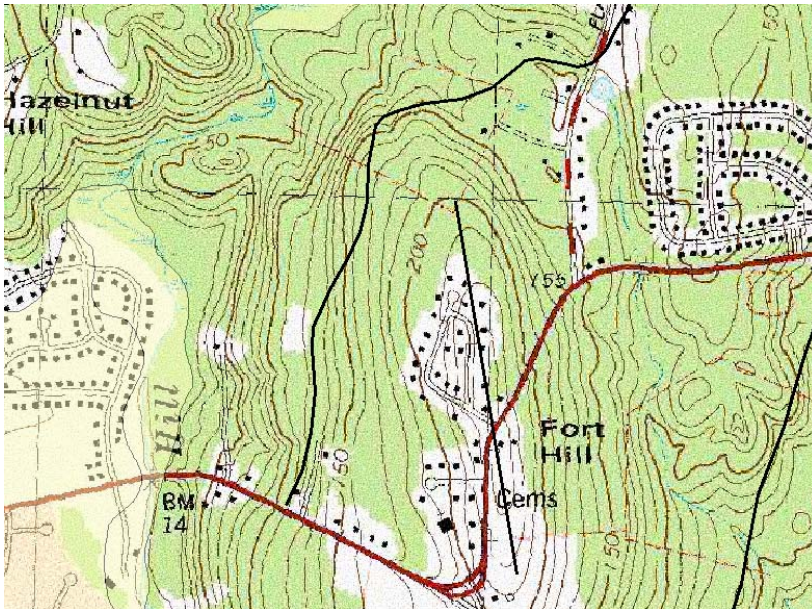
Figure 1. Topographic map showing Quaternary geology (from Goldsmith, 1962, and Stone et al, 2005). Yellow area in the southwest part of the map is underlain by Modern and Quaternary stratified deposits. Remaining areas underlain by till. Long straight line through Fort Hill depicts axis of drumlin and is parallel to direction of ice movement when the drumlin was being shaped. Wavy black line through center of map is inferred ice margin approximately 18,000 years ago during the recession of the last glacier based on abundance of boulders. Ice existed at that particular time north and west of line. Similar line shown in southeastern corner. Here, however, ice existed east of the line. Thus, ice melted off top of Fort Hill sooner than in adjacent lower areas.

The proposed development is planned on the north and west facing slopes of an elongate hill, known as Fort Hill (Fig.1). It is oval shaped in map view, being elongated in north-northwest to south-southeast direction. The maximum elevation of Fort Hill, located off the parcel, is just over 230' above sea level. The western part of the parcel drops to an elevation of less than 20' in a wetland. Fort Hill has relief of over 200 feet. The slopes on the hill are gentle to moderate and will pose little hindrance to development. Steeper portions of west and northwest facing slopes are avoided in the plans. The slopes are persistent which may pose a potential erosion hazard during development when the topography is cleared, in phases, of most vegetation. Erosion and sedimentation is addressed on the plans but were not evaluated by this reviewer.

All the area is underlain by a veneer of Quaternary deposits associated with the last Ice Age. Most of the area is covered with sandy "melt-out" till. A more compact basal till was only locally encountered in some test pits. In at least one location (TP-4), stratified gravel separated the two tills. Fort Hill is a drumlin, a stream-lined hill shaped by glacial movement and covered by till that is thick in some places. The elongation of Fort Hill (NNW-SSE) is interpreted to reflect the direction of movement of the last ice-age glacier. The north end of Fort Hill has abundant large and small boulders scattered across the surface (Fig. 2). The area is just north of the mapped Mystic Recessional Moraine (Fig. 3, see Stone and others, 2005) and the concentration of boulders here was similarly formed at the margin of glacial ice (Stone and others map an ice margin position as shown in topographic map (Fig. 1 and Fig. 3). Large stones will be a nuisance to development of the north end of the project.

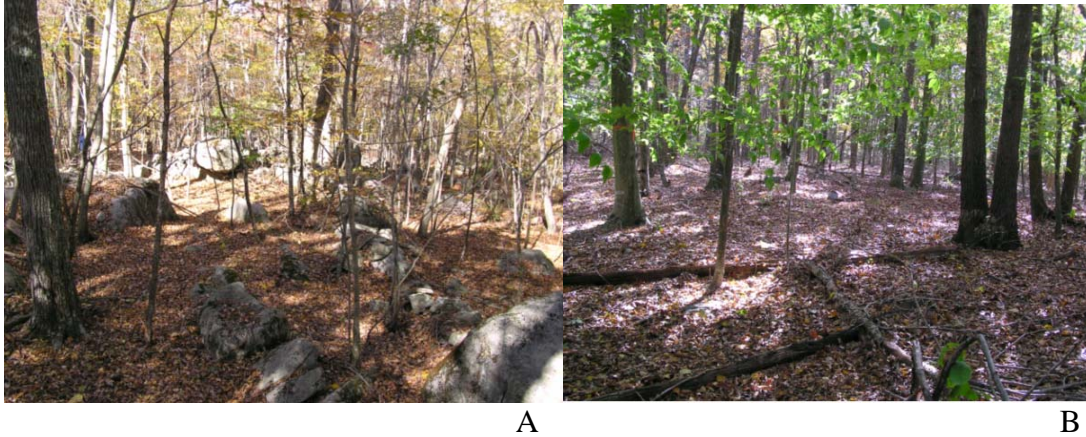
Figure 2a. North end of Fort Hill showing a large bouldery area. Large and small boulders are abundant, in some places covering 50-75% of the ground surface. Largest boulders (not shown in this image) are 3-5 m. in maximum dimension. This area mapped as an inferred ice-margin position (Stone and others, 2005) because it lacks associated collapsed, ice-margin melt-water stream deposits, it is not mapped as an end-moraine. Boulders were concentrated in the shear zone where active ice over-rode thin stagnant ice at the margin of the glacier. The ice position did not remain in the area very long before melting northward. Hence, diagnostic melt-water stream deposits that are associated with end-moraines are lacking.

Figure 2b. Looking southward near the crest of Fort Hill south of the location of Fig. 2a. Note the smooth surface with few boulders on the surface. This is typical of a drumlin surface.

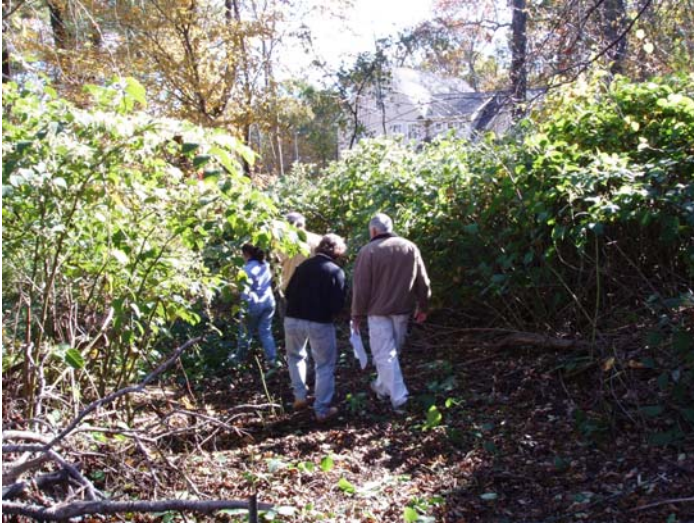
There is an area within the project that has been overrun by a non-native invasive plant species, Japanese knotweed (*Polygonum cuspidatum* Sieb. & Zucc.). Not only should this plant be eradicated to the extent possible, but also, steps should be taken to ensure that construction activities do not spread the plant further. One concern is that seeds and plant fragments will be mixed in with the topsoil when it is stockpiled. Japanese knotweed can

regenerate from seeds or the tiniest fragment of plant, and many seeds and stems will likely still be viable when the stockpiled soils are used to restore the site at the conclusion

Team members walking through area of Japanese Knotweed near Flanders Road entrance.

of construction. ECCD recommends keeping the topsoil stockpile(s) from the Japanese knotweed area separate from other stockpiles, and take appropriate steps to prevent this weed from spreading. Also, while the topsoil is stockpiled, proper erosion and sediment control measures will help prevent seeds and plant fragments from being transported to another area.

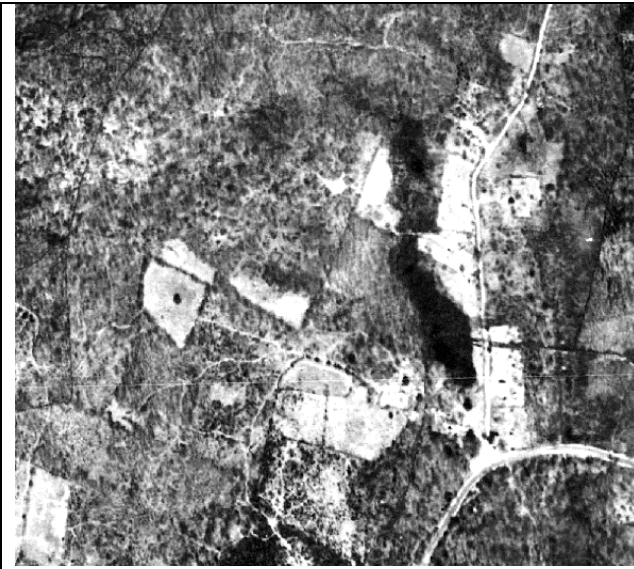
This is a section of the 1934 aerial photograph of the area. The view is concentrated on the wetland near Flanders Road. At the time the wetland displayed more open water and there were farmed fields upslope of it.

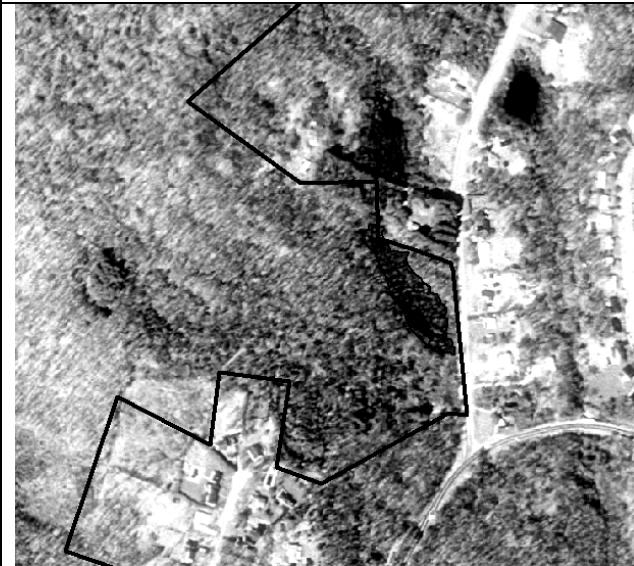
In this section of an aerial photo taken in 1990 land use changes are readily apparent. The wetland is much more vegetated and the farmed fields have reverted to woodland. Both photographs were taken in the spring of their respective years.

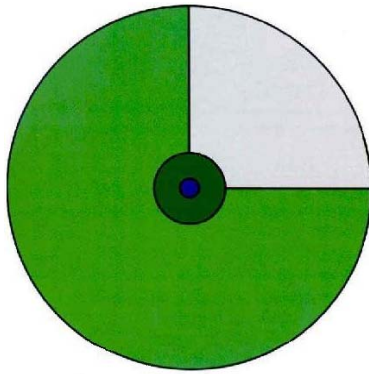
Example of 25% development in critical
terrestrial habitat

Vernal pool depression:
No disturbance
-

Vernal pool envelope (100 feet from pool):
No development and implementation of
management recommendations
-

Critical terrestrial habitat (100-750 feet from pool):
less than 25% developed area and implementation of
management recommendations
-

Dr. Michael Klemens suggests in his book, co-authored with Dr. Aram J.K. Calhoun, entitled: "*Best Development Practices - Conserving Pool Breeding Amphibians in Residential and Commercial Developments in the Northeastern United States*" that there be no development in the 100 foot buffer around the vernal pool. In addition that there be no more than 25% in the critical terrestrial habitat, the distance from 100 feet to 750 feet away from the pool.

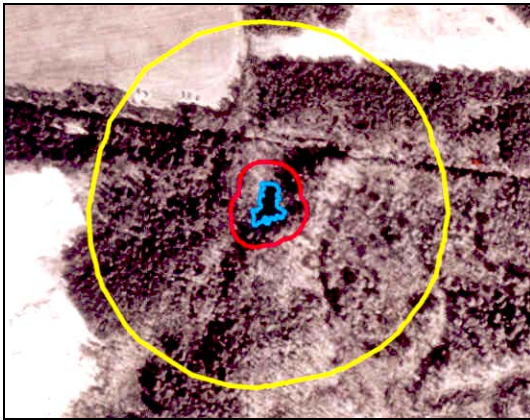
Vernal pool shown in blue with undisturbed envelope in red and less than 25% of the critical terrestrial habitat developed as bounded by yellow. Existing amphibian populations will likely remain viable in this pool.

*(The above graphics are taken from Dr. Klemens' document which may be obtained from the DEP Store:
<http://www.dep.state.ct.us> .)*

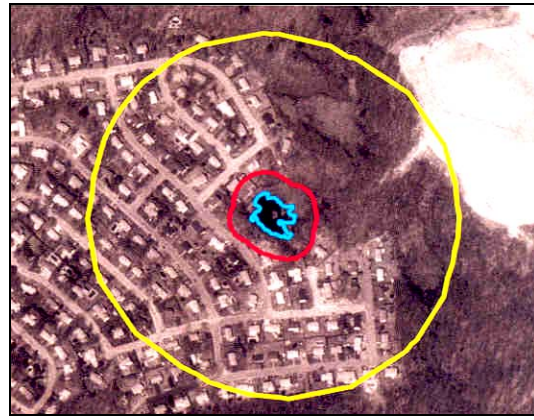
Vernal pool shown in blue with some disturbance in the envelop shown in red and more than 25% of the critical terrestrial habitat having been developed, within the yellow line. It is highly unlikely that this pool will probably be able to support viable amphibian populations.

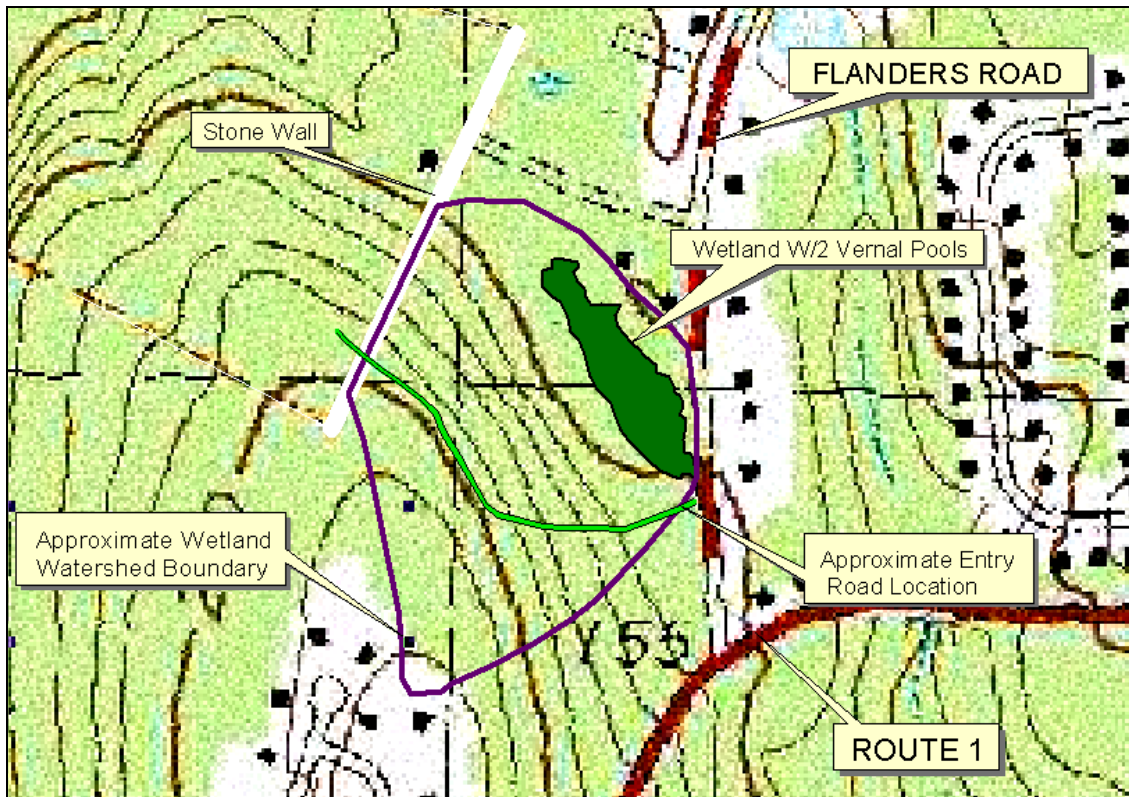
As depicted on the graphic below, this reviewer has estimated the total watershed for this vernal pool/ wetland system to be ± 14 acres. Almost the entire watershed is to the west and southwest of the wetland. Just a small portion of the watershed is to the east and north/northeast. The ten or so acres that feed the wetland from the west and southwest will be divided roughly in two by the entry road. And this is the quandary of the matter. Given the information Dr. Klemens et al supplied above, and the fact that these are breeding vernal pools, the applicant would need to show how best to preserve this documented resource.

The base map for this graphic is the United State Geological Survey 7.5 minute New London topographic map

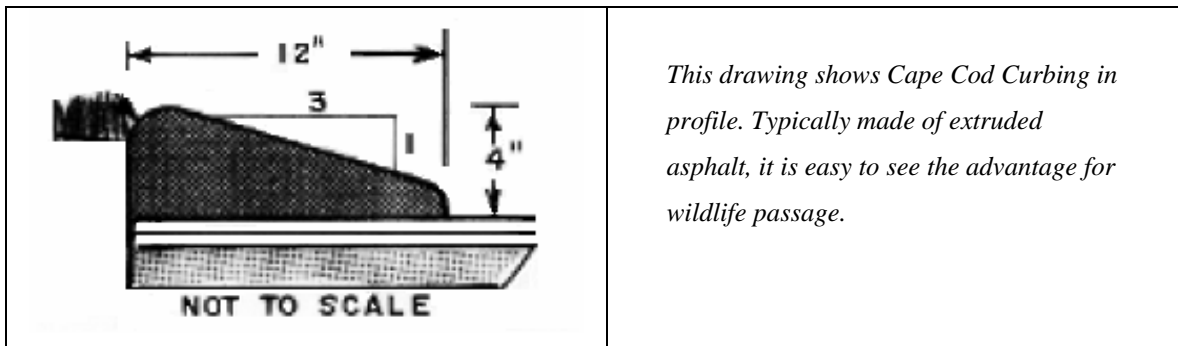
In addition, the main road way in the vicinity of the vernal pool wetland will cut across amphibian migration paths. Vertical curbing does not allow for the passage across the road way of small amphibians. The curb walls are cliff-like to them and form an insurmountable presence. Cape Cod Curbing however, because of its gentle profile does allow for the migration from the pool to the upland and back because of its lower over all height and low gradient slope.

Use of Curbing - Curbs often function as a means of channeling water to storm drains. To minimize the flow to the storm water system, where possible, the applicant should be encouraged to use no curbs (typically in low gradient areas). This allows runoff to more easily infiltrate in non-point locations. It also serves to take the pressure off of the
