LOVER'S LANE KILLINGWORTH, CONNECTICUT

EASTERN CONNECTICUT ENVIRONMENTAL REVIEW TEAM REPORT

ENVIRONMENTAL REVIEW TEAM REPORT

REPORT #611

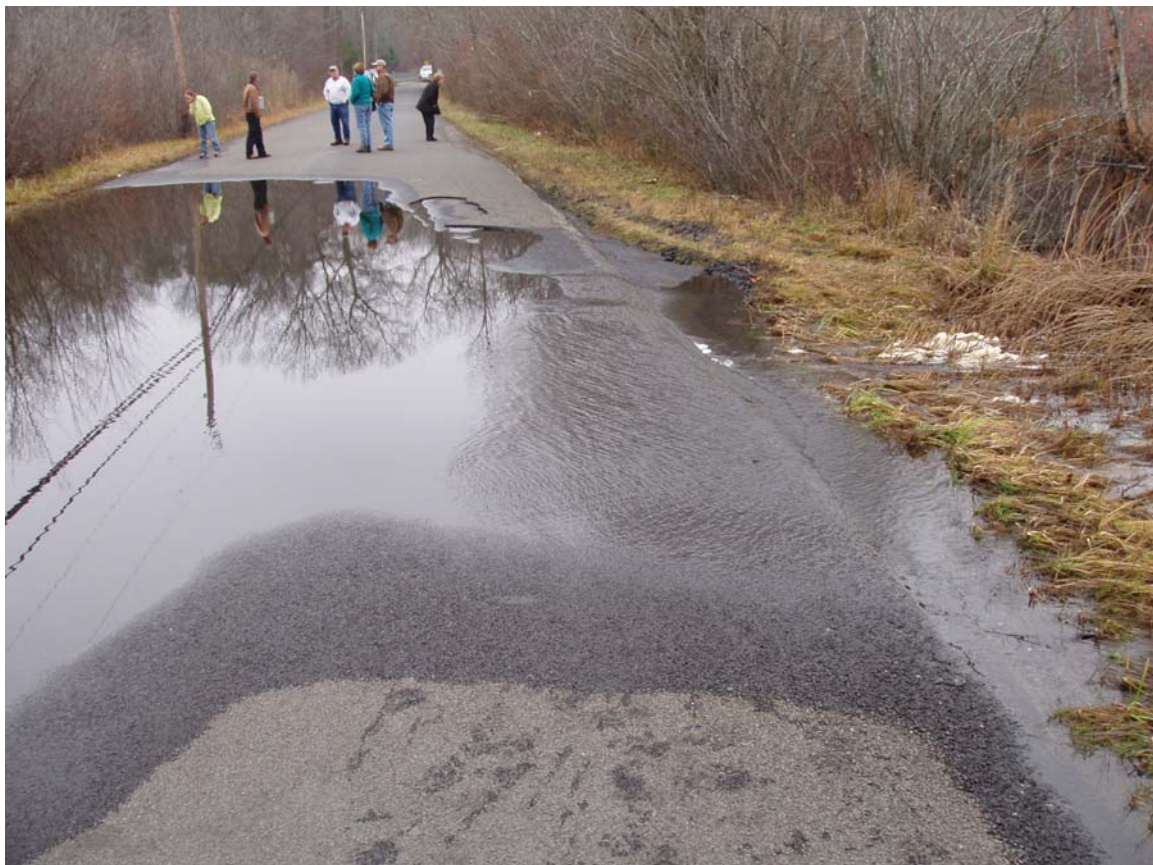
Water running over road surface in area of pipes under the road. (11/28/06)

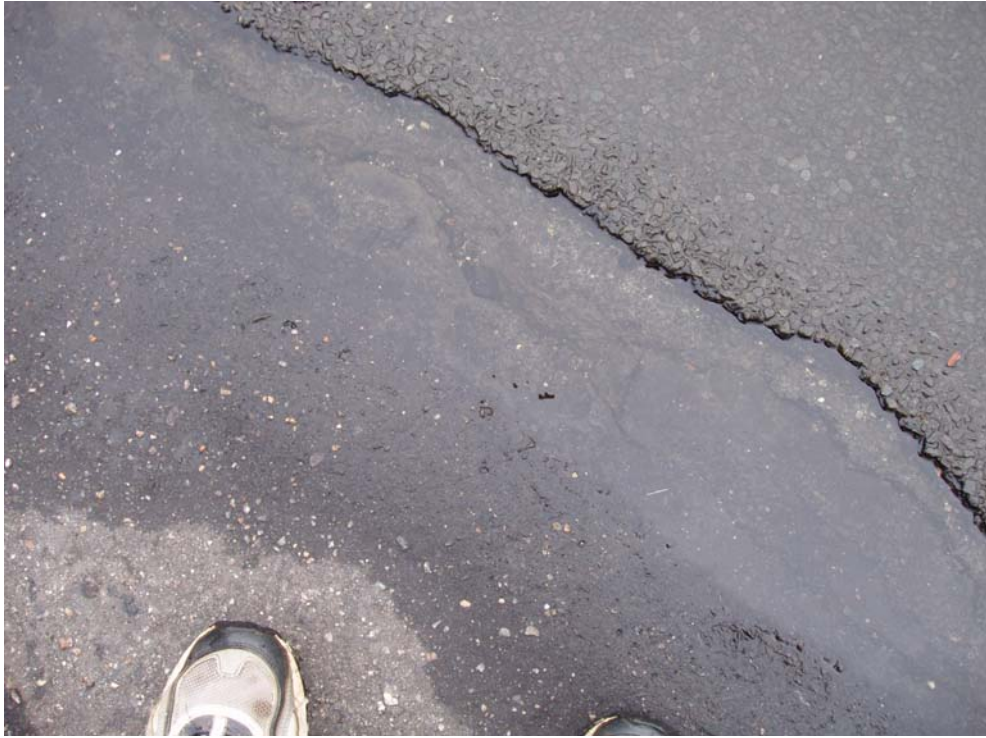
Many layers of asphalt.

The road has a history of sinking into the organic materials on which it was constructed. It is readily apparent that over the years several layers of asphalt have been added to maintain the elevation the road surface above the water level. Seemingly, the weight of the new asphalt and the continued compression of the traffic cause it to subside again. Stop gap drainage efforts have been employed to keep the north to south flow of water *under* the road, but those efforts too have sunken with the road bed.

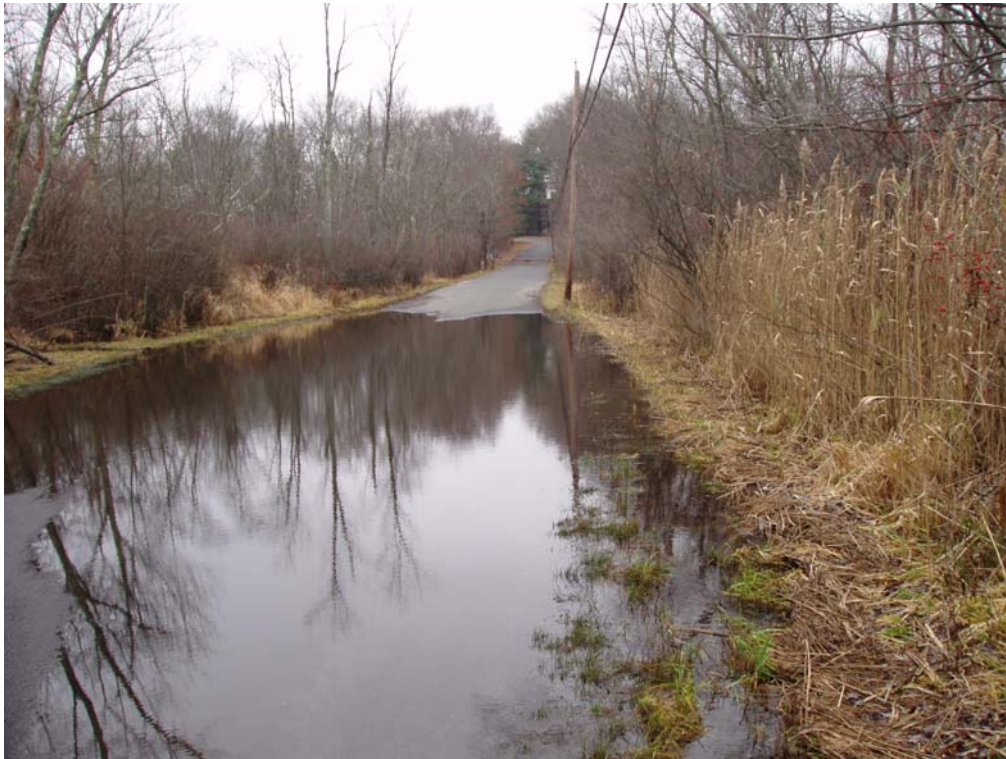
Second area of flooding on north/westernn section of Lover's Lane.(11/28/06)

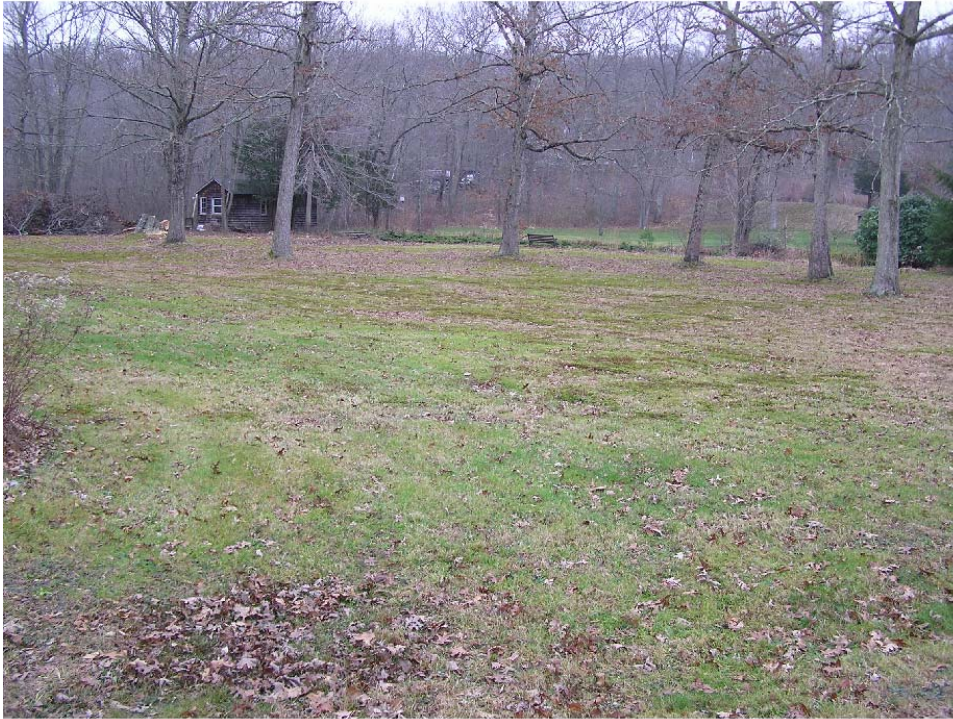
Figure 3. Flat terrace on east side of bog. Although its elevation is only a few feet higher than the bog, it is inferred to be a Pleistocene (ice-age) ice-contact deposit rather than modern river alluvium (Flint, 1978).

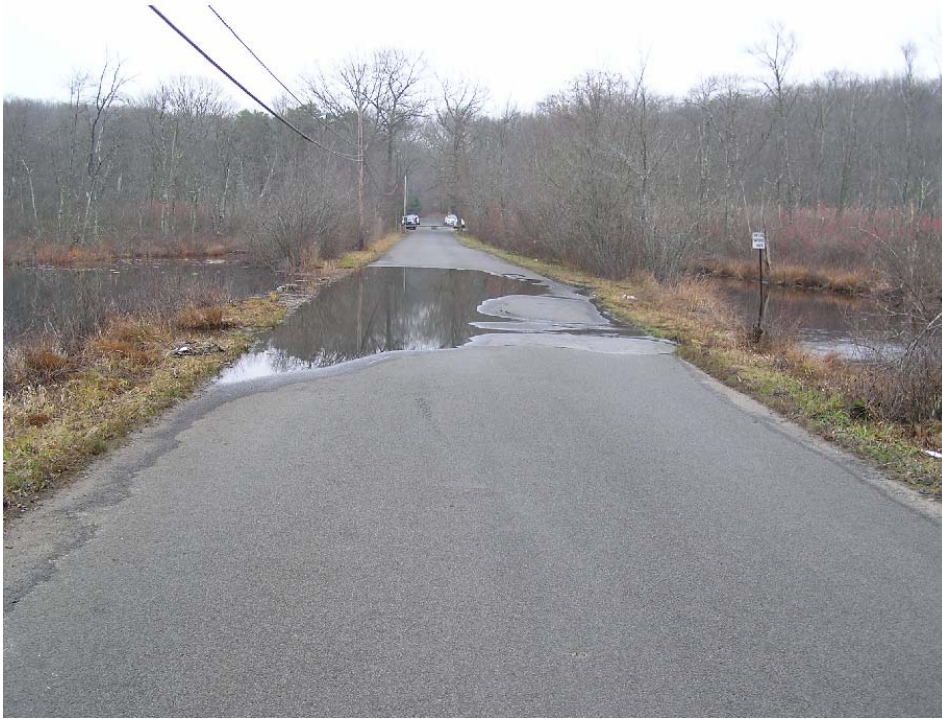
Figure 4. Lovers Lane bog-crossing, looking east. Several small culverts underlie the road opposite sign on right. Note unequal water levels on the upstream (left) vs. downstream side of road. Note also level of road varies, presumably a function of roadbed subsidence caused by compaction and/or displacement of underlying peat.

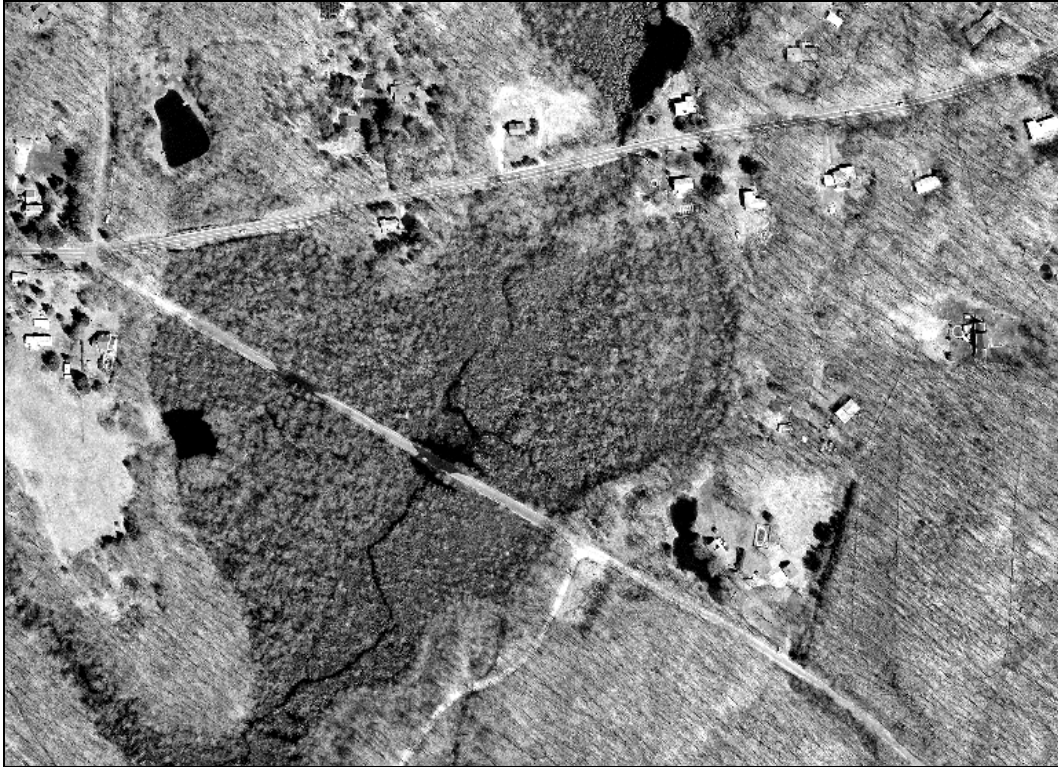
In this April, 2004 aerial photograph Lovers Lane runs from the mid-left center to bottom right. This photograph shows the wetland very clearly along the well defined, meandering stream channel. It is considered a palustrine wetland with a small area of open water by the road, scrub shrub parallel to the water course, and forests further away from the water course. The image shows the road flooded (dark/black areas on road) in two distinct locations, just as it was when the Team visited. In the right hand inundation the stream passes over the road flowing rapidly. The inundation to the left was still/quiet water but deeper than the flowing water. In the larger inundation, the ponded open water at the road measures ~a quarter of an acre in size.

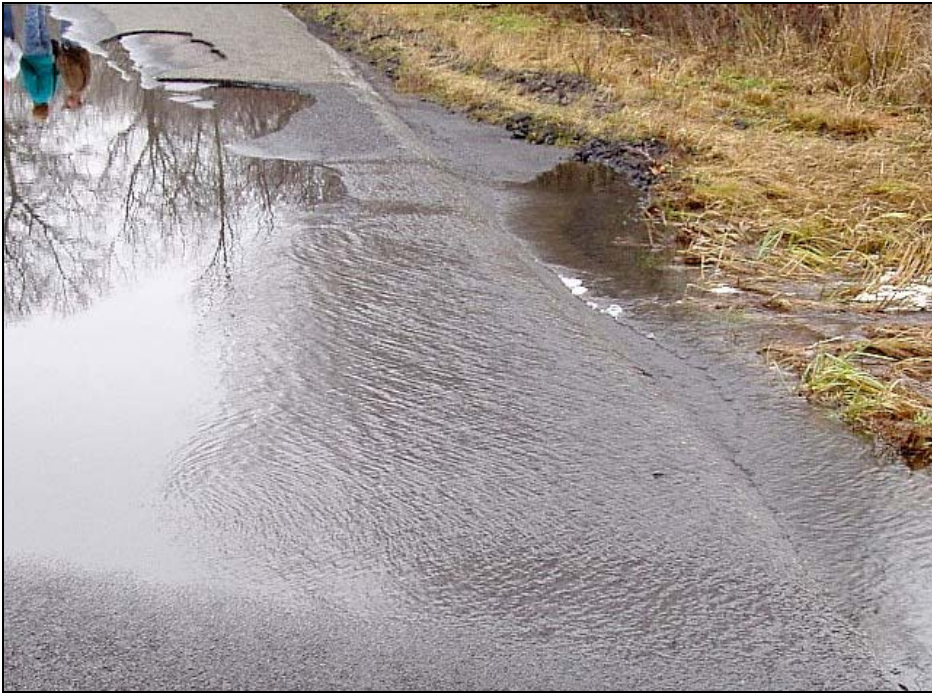
Water is seen flowing freely over the road from north (left) to south. The road bed in general dams the water flow and only where the road has sunk does the water have its downstream outlet.

- Closer inspection of the above photograph shows the absence of chunks of asphalt from the road surface especially easy to see just to the right of the team members' reflections. It should be noted that broken up chunks of asphalt from a road or parking lot is "considered clean fill" by DEP Waste Unit. It is generally not a problem as fill material so long as it is not placed in wetlands or around a well. Milled asphalt is a different story as it presents a worst case condition from a standpoint of leaching. The missing asphalt in the photo above may have been initially broken up by freezing and thawing and subsequently washed downstream in smaller pieces.

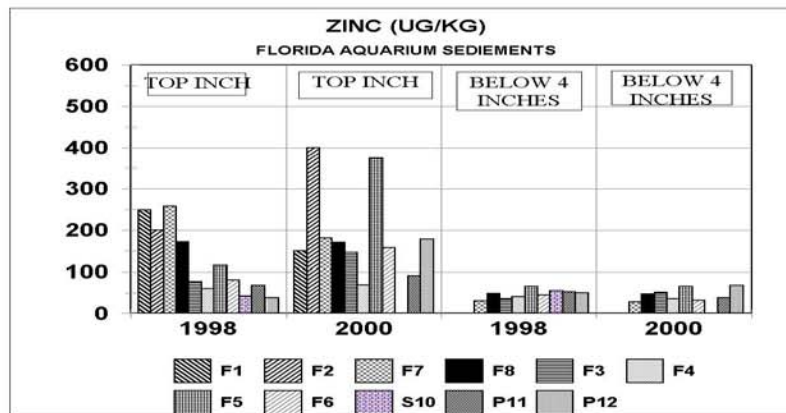
Figure 3. Sediment samples for zinc collected in 1998 and again in 2000 at the outfall of each drainage basin as well as in the swale and pond.

Metals - Consistent results were seen for 1998, with metals usually measured at higher concentrations in basins paved in asphalt (F1, F2, F7, F8) compared to basins paved with concrete (F3, F4) or porous paving (F5, F6). Aluminum, iron and copper concentrations measured in the strand and pond only occasionally showed concentrations as high or higher than the asphalt basins in the parking lot even though most of the 10-acre parking lot is paved in asphalt. Results indicate that the swales, strand and pond are effective for sequestering metals near the source. An example with zinc is shown in Figure 3.

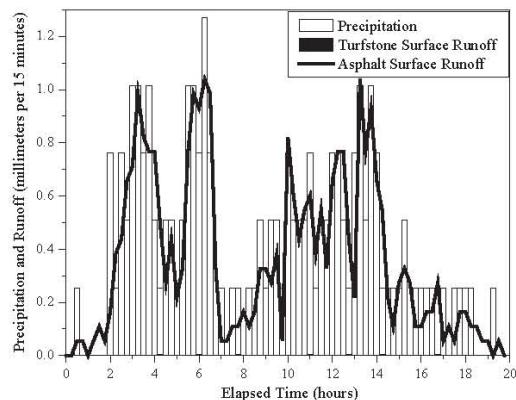
Fig. 2. A comparison of precipitation rates and surface runoff from a permeable pavement stall and the asphalt stall during a storm beginning at 16:00 on 6 January 2002. Minor surface runoff from the permeable Turfstone[®] stall occurring around 4, 6, 8, 11, 13, 14, and 17 h is attributed to leaks in the piping used to capture water.

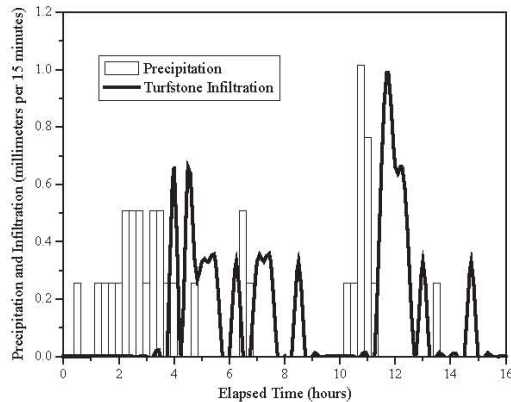
Fig. 3. A comparison of precipitation and subsurface infiltration during a storm beginning at 2 pm on 20 November 2001.

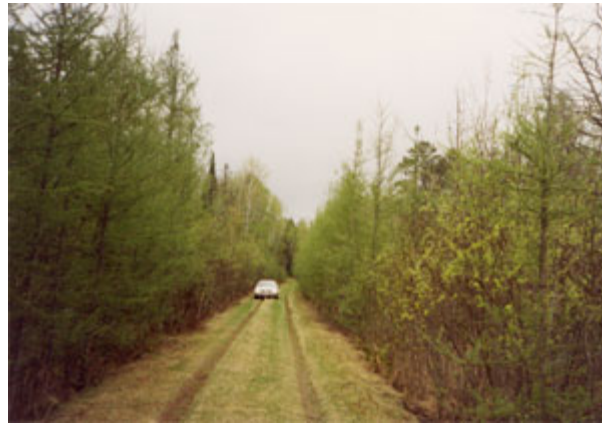
Figure 10—This road still maintains a free flow of water through the roadbed while providing a stable road surface.

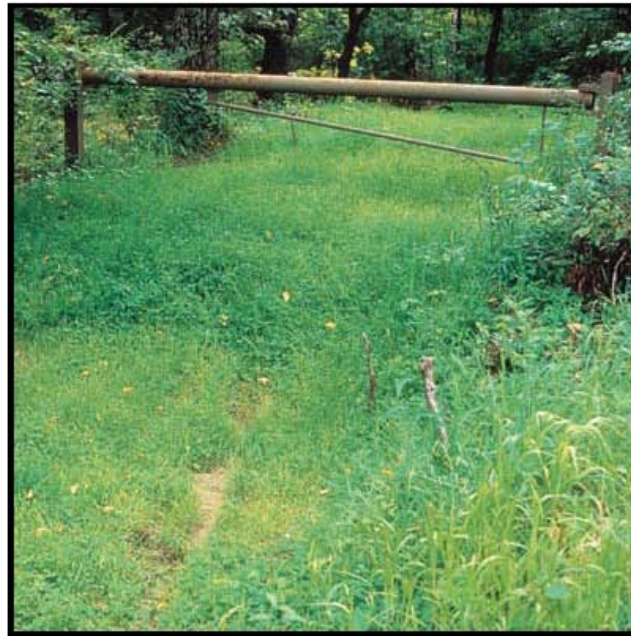
Seeding forest access roads after completion of use provides multiple benefits, including stabilizing the road and protecting it from erosion, and providing food and cover for wildlife. Seeding also eliminates negative visual impacts. *Photo courtesy of Minnesota DNR*

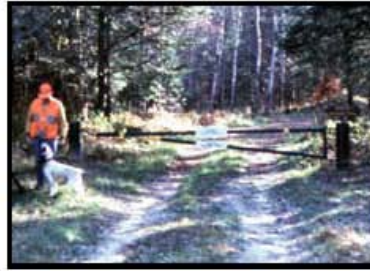
Providing appropriate access control eliminates motorized vehicle use (which can lead to erosion) while also encouraging hunters and hikers. *Photo courtesy of Itasca County Land Department*
