Jonah Center for Earth and Art  
**Walking Trail and Kayak Launch**  
Middletown, Connecticut

**Eastern Connecticut  
Environmental Review Team  
Report**

# Jonah Center for Earth and Art Walking Trail and Kayak Launch Middletown, Connecticut

**Report #595**

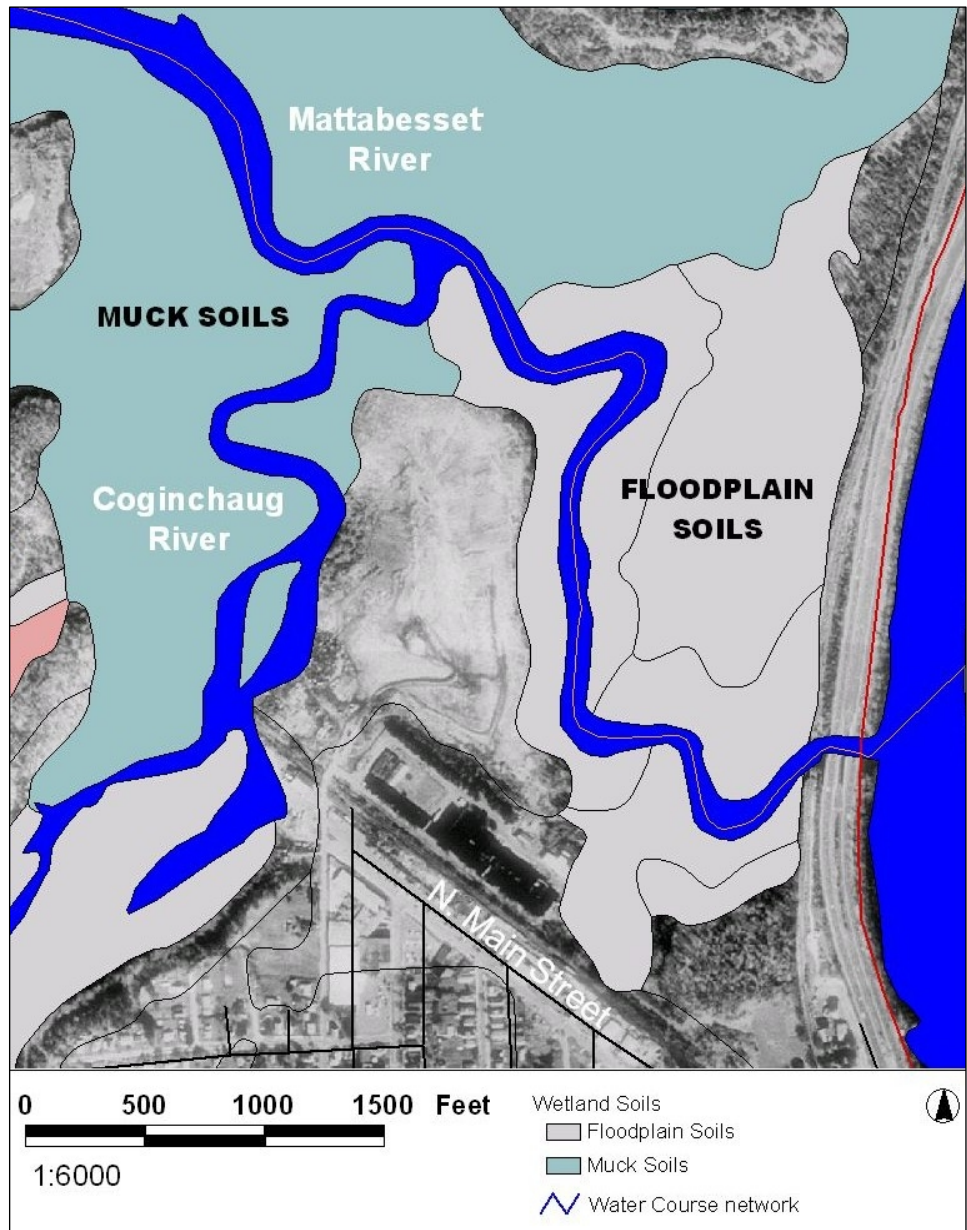
Catden and Freetown muck soils are broadly associated with the Mattabesset and Coginchaug river corridors to the north and west. A band of alluvial and floodplain soils are associated with the Mattabesset south of its confluence with the Coginchaug River to the Connecticut River. Floodplain soils are also shown associated with the Coginchaug River south of North Main Street. Soil map units from the USDA/NRCS GIS coverage are at a 1:12,000 scale, with the smallest area delineated approx. 3 acres. Caution should be taken when using the soil survey maps for site-level planning since at this scale soils in a single mapped unit can differ in slope, depth, drainage, and stoniness.

**Figure 3.** Extent of muck and floodplain soils shown on the statewide GIS soils mapping (1:12,000-scale datalayer USDA/NRCS).

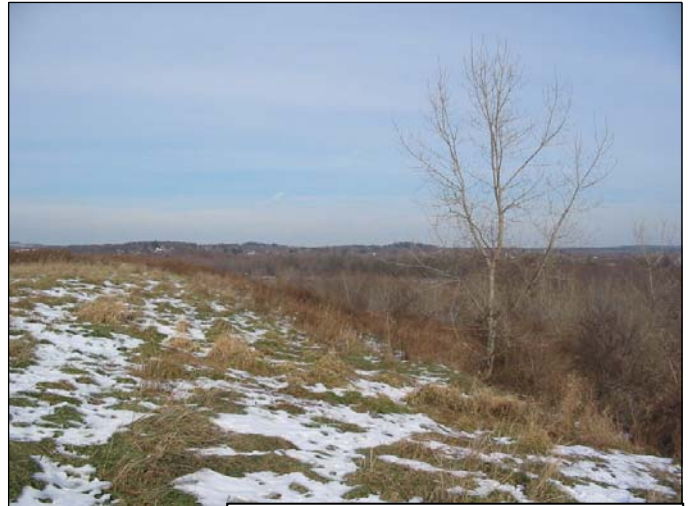
Additionally, some areas of the landfill's side slopes were observed to be slumping or failing slightly and there was evidence of water ponding in a small depression on top of the landfill. Careful consideration to where and how the trail system is established and maintained will help minimize any potential impacts due to adverse soil conditions.

**Top of the landfill looking north.**

3. Use of the trail should be restricted if/when soils are seasonally saturated or flooded.
4. Trail areas that are chronically wet should be rerouted if possible. Otherwise, spanning structures or cross drainage can be used to help improve trail condition.

8. Consider posting "no entry - conservation area" signs in areas with critical slopes or where there is observed slumping or erosion.
9. Minimize concentrated stormwater flows on steep trail sections by using water bars at controlled points to direct excess runoff to stable vegetated areas on the side slope. In very steep areas discharging flows to a small riprap splash pad or stone check dam may be necessary.

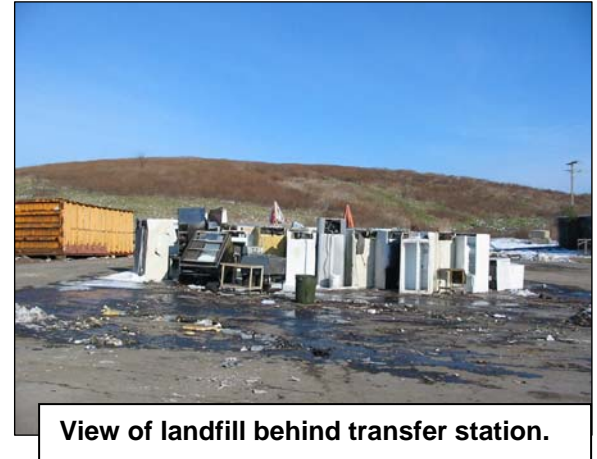
**View of landfill behind transfer station.**

1. Signs should clearly identify approved parking areas and natural areas to remain undisturbed.
2. Pervious surfacing materials should be considered for parking areas and any new access drives in order to encourage stormwater infiltration.
3. Drainage from parking areas and access drives should not discharge directly into either river or inland wetlands on-site.
4. Access to trails and the launch site should not conflict with transfer station activities. A win-win solution should be sought that will minimize conflicts and improve environmental conditions through implementation of best management practices that will also reduce and control pollution.

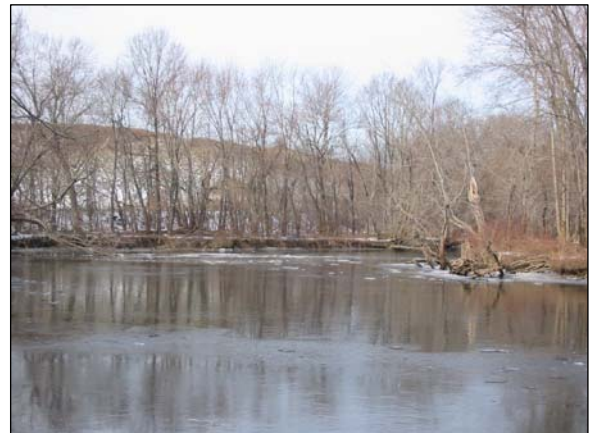
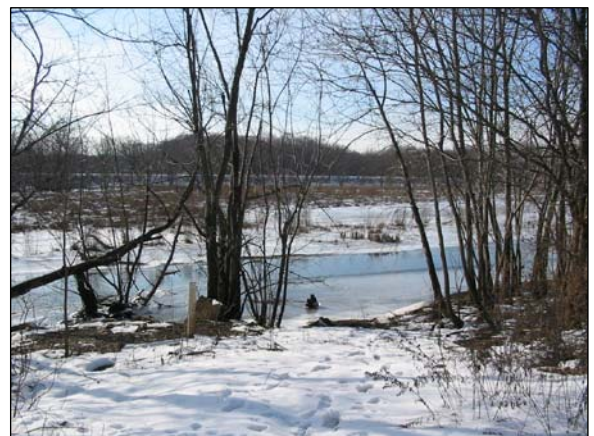
*A car-top kayak and canoe launch has been proposed. There are two potential locations for the launch site, to the east of the landfill on the Mattabesset River or to the west on the Coginchaug River. Areas with discolored flows were observed in the vicinity of the proposed launch site on the Mattabesset, and a number of known seeps are also present on this side of the landfill. Based on these observations, and the broad floodplain topography of the Mattabesset at the potential launch site, the alternative location on the Coginchaug River should be explored first.*

**Possible launch sites on the Mattabesset (above) and Coginchaug (below).**

1. Information outlining the rules for use of the launch should be clearly posted.
2. Due to the muck nature of the soils associated with the Coginchaug River in the vicinity of the proposed launch, a stabilized surface should be provided that will allow boaters to enter and leave the river at a variety of high/low water conditions.
3. The launch areas should be designed to prevent bank erosion in both the upstream and downstream direction, i.e., flows/flood forces should not be deflected to nearby banks.

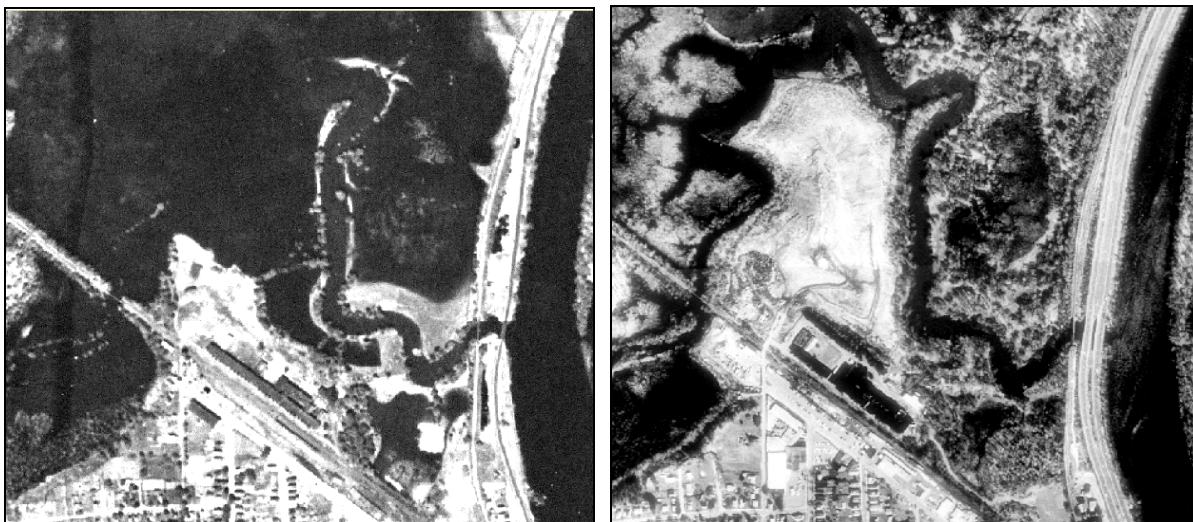
As can be seen in the comparison photographs below, the geography of the area, and the accompanying wetland regimes, have been greatly altered in the last several decades due to the establishment and growth of the landfill.

Figure 1- the April 1934 aerial photograph on the left and the same area depicted in 1990 show the massive amount of alteration to the landscape that the landfill had.

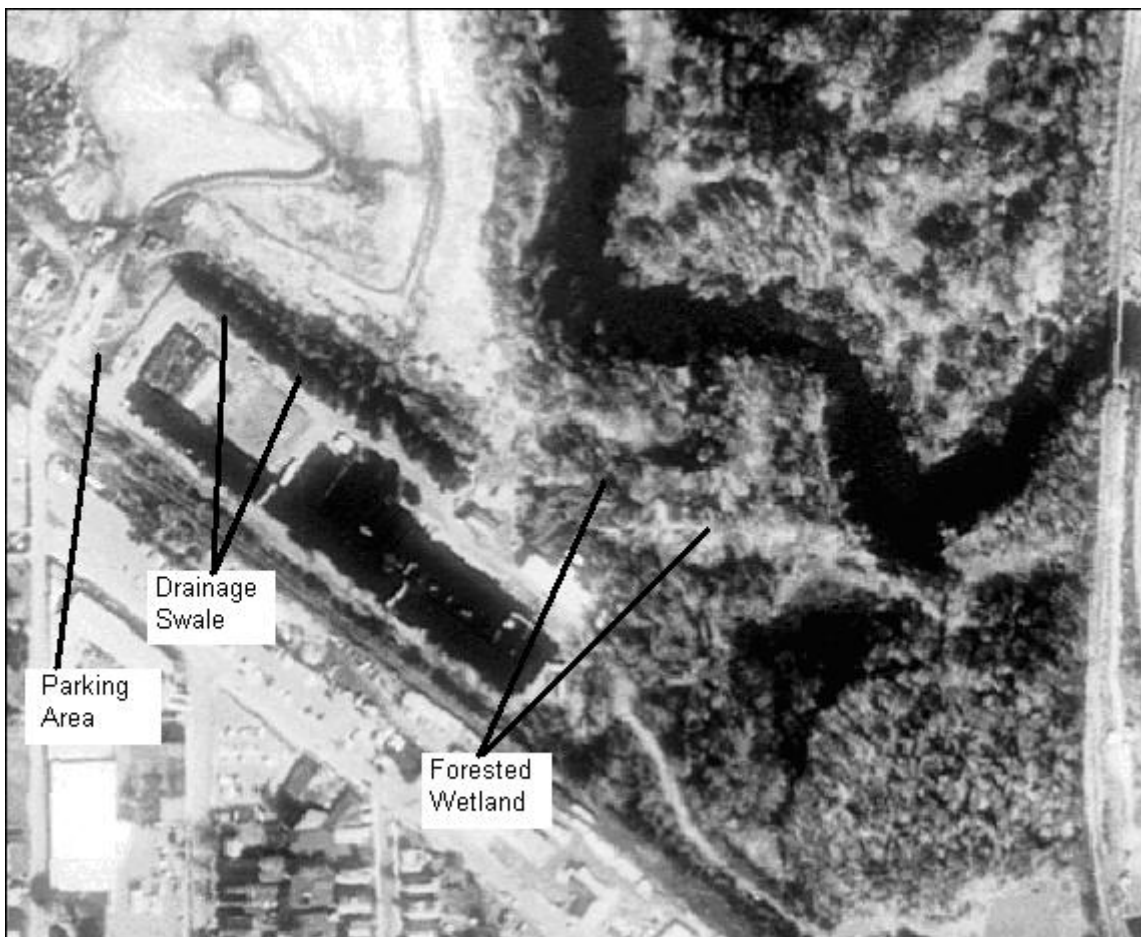
Figure 2 - The drainage swale depicted above empties into the forested wetland of this floodplain. The stream was actively flowing, not frozen.

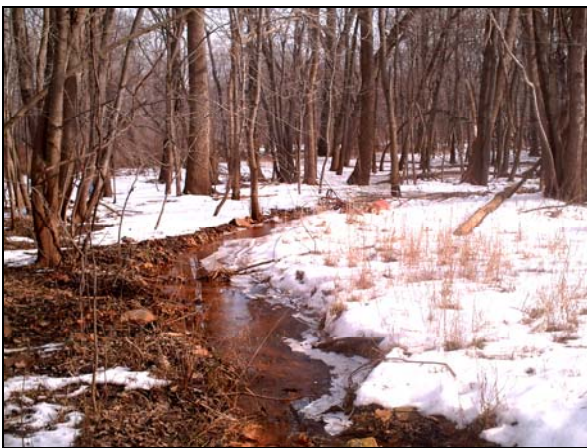
*Figure 3 - This is where the drainage swale empties onto the floodplain. A colorful iron bacteria film was present along the shoreline. Iron bacteria is sometimes visually confused with oil floating on water; but the iron bacteria “breaks” when disturbed, while the oil swirls.*

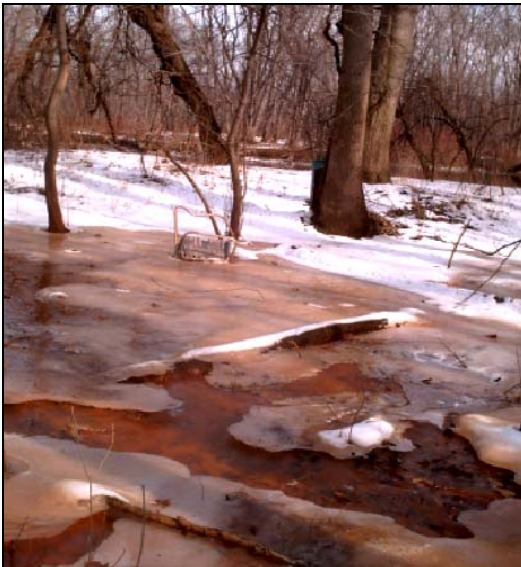
In the areas that were free of snow, the soil could be seen as reddish-brown in color. There was some surface movement of water over the open ground, and below the ice layer, as the water moved gradually downslope toward the river (Figure 4).

*Figure 4 - Red brown soils can be seen in the foreground with runoff occurring under the thin layer of surface ice.*

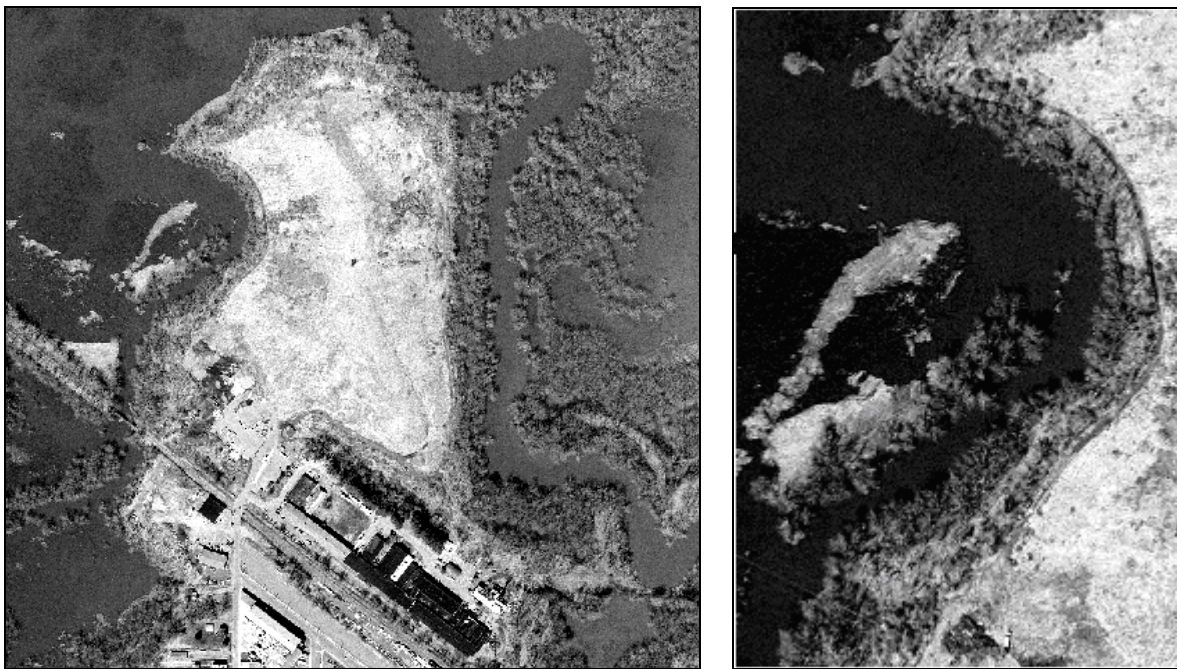
The Coginchaug River abuts the property along the west side as can be seen below in this 2004 image of the area (Figure 5). It is clear from the photograph that much of this floodplain was in flood condition when this photo was taken. The half circle, arc-like indentation along the west side of the peninsula is paralleled by a single lane road, just to the east of the tree line. This road would be the general vehicle access to the rear carry-in launch site. The image also provides the opportunity to visualize the variable 60 - 80 foot wide riparian buffer that lies between the river and the road.

Figure 5 - this 2004 image shows the landfill site in its entirety with a closeup of the west side indentation. The dark color, single lane road is visible to the right of the tree line in the right hand image.

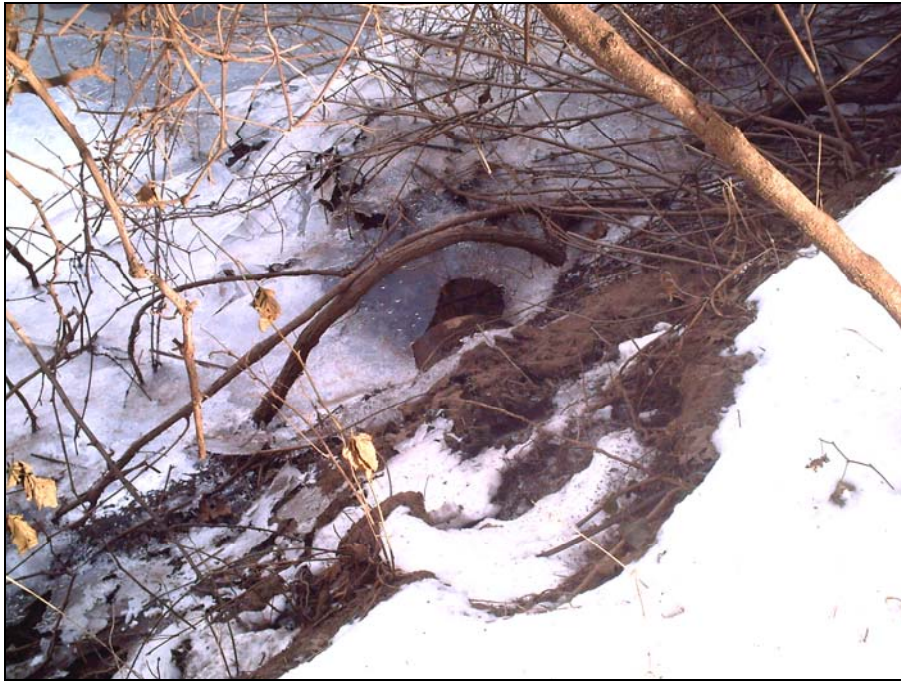
Figure 6 - this is a view looking down slope into the Mattabesset. Notice the 5 or 6 inches of concrete pipe emerging from the bottom of the bluff. The discharge from the pipe, though small, was constant and fell with sufficient energy to form a little plunge pool which kept the water open and ice free.

In addition, the Mattabesset launch is closest to the entrance, and might yield the biggest 'bang' for the low budget buck in this early planning. It also has the advantage of proximity to the roadway that leads to the top of the mound and offers the spectacular views. It would mean a carry of about 300 yards however, unless a small parking area was planned at the bottom of the road the parallels the swale.

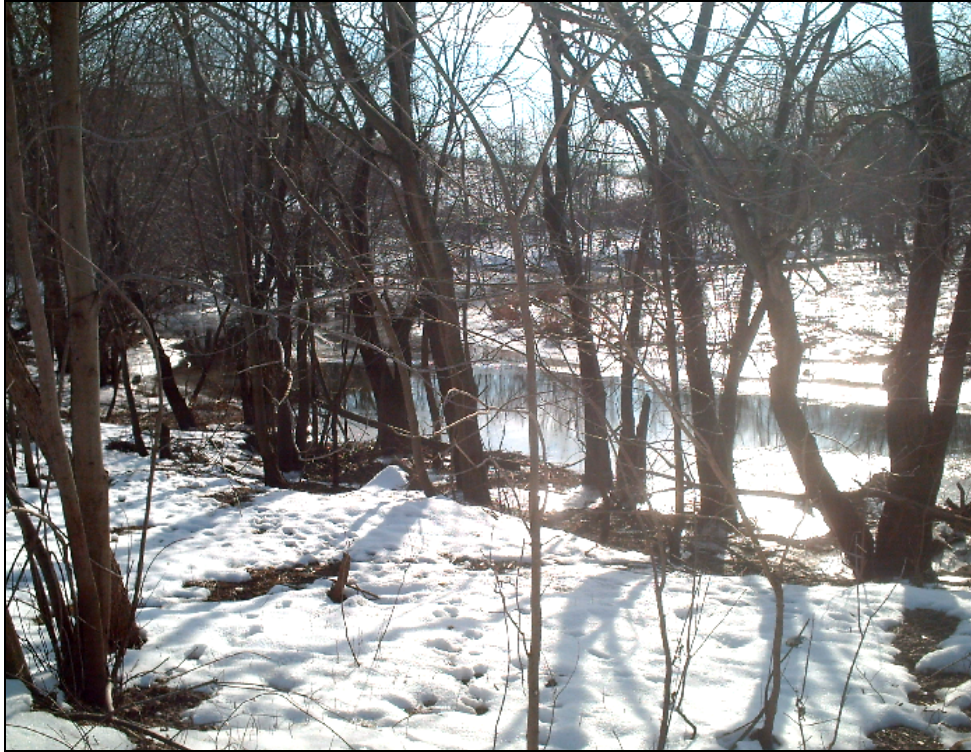
Figure 7 - this is the view from the single lane road through the trees to the Coginchaug River. This is the distance of the carry-in for the potential west side launch.

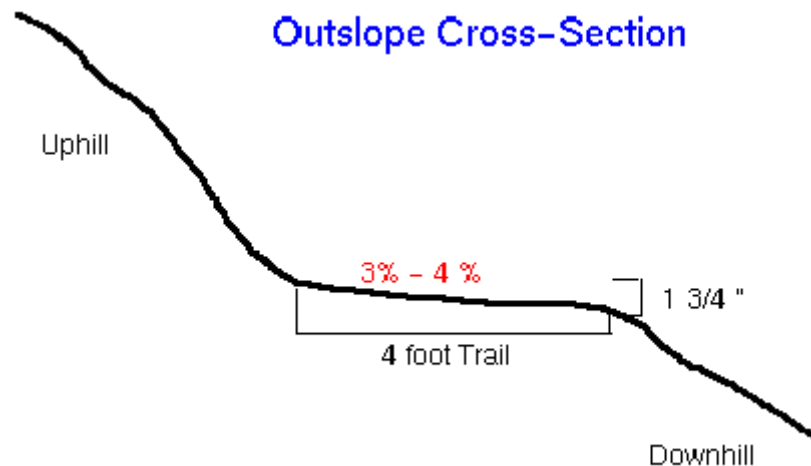
### 3. Outslope

A well-designed trail should be constructed to have a 3% to 4% cross-slope to get the water off the trail as soon as possible. This explains why it is difficult to construct an effective trail in a flat meadow. You can not merely cut out sod and call it a finished trail. It will always be easiest to construct an outsloped trail if the original trail alignment traverses the natural slope as in Trail B, above.

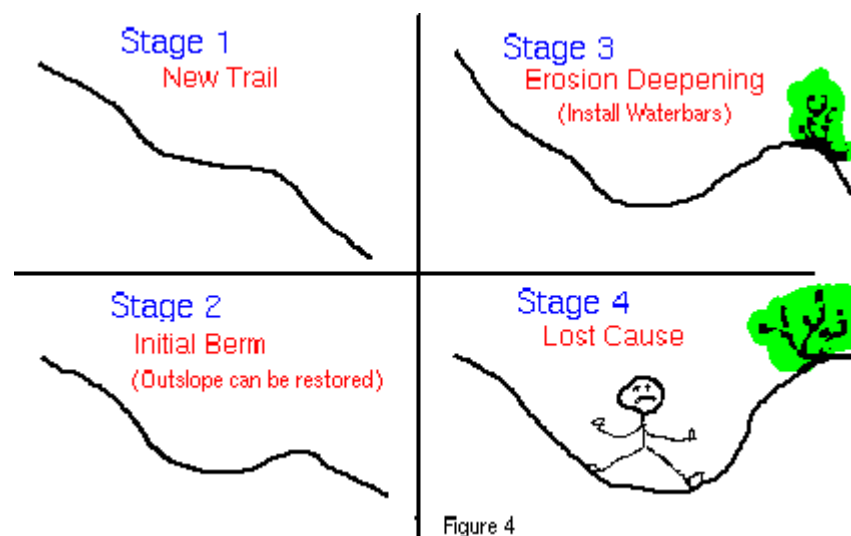
Normal trail use will build up a berm along the outside (downhill) edge of the trail (Stage 2 of figure 4). If allowed to continue, the berm will grow and prevent water from flowing off the trail, causing gullying down the centerline of the trail (Stage 3). If this centerline gullying is allowed to continue unchecked, the trail will trench deeper and deeper until it is both unusable and unredeemable (Stage 4).

The outslope is maintained at Stage 2 by simply pulling the small 4" - 5" berm back into the trail tread. This unglamorous work must be performed again and again by trail crews, but in many cases, if the outslope is restored on a regular basis, little or no maintenance is needed of any other kind. However, some use patterns (extensive equestrian use), soil conditions (sandy) and climate conditions (high precipitation) combine to minimize the effectiveness of this maintenance tool; it just has to be done too often to make it worthwhile.

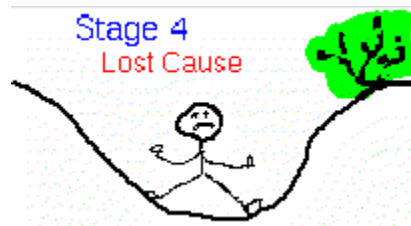
The telltale signs of a trail that needs to be relocated are: deep trenching and a gradient exceeding 20% over about 100 feet of trail.

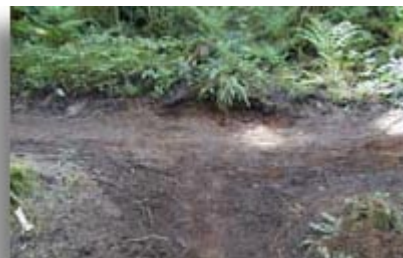
A **drain-dip** or **grade-dip** is a wide, shallow depression sculpted into the tread. Grub hoes and McLeods are great for making drain-dips. The dip should completely cross the trail and be cut at an angle with the outside edge end of the drain-dip further down-trail than the other end. The dip should have an **outslope** (the outside edge should

be lower) to carry water off the trail. The up-trail side of the dip should have a gradual slope. A McLeod or shovel is good for doing this. A well constructed drain-dip is often not even noticed by hikers. It appears to be a shallow, naturally occurring dip in the trail. If the dip is expected to carry a lot of water it's a good ideal to build a small rock **spillway**. Piling rocks at the outlet of the drain-dip will slow the erosion of the outside edge of the trail.

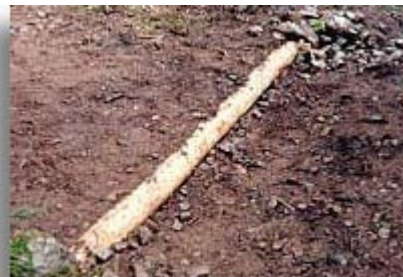
To build a wood **waterbar** dig a deep trench across the trail at somewhere between a 45 and 60 degree angle. The angle is important to reduce the rate at which the waterbar collects silt. If the waterbar is placed straight across the trail it will collect silt quickly and stop working. Next place a peeled log between six to eight inches in diameter in the trench. The log should be embedded at least a foot deep into the hill on the inside edge of the trail. This will help hold it in place. The log should be long enough to span the entire width of the trail. The outside-edge end of the log should be held in place either by wooden stakes, the weight of a large rock, or even steel rebar passing through the log. The down-trail side of the log should be completely back-filled with mineral soil so that no more than one or two inches of the log appears above the surface. The uphill side of the log should have a wide, shallow dip with an outslope much like a drain-dip. At low volumes water will follow the drain-dip off the trail. At higher water volumes the log itself will catch and direct water off. Waterbars should also have a rock spillway to slow erosion.

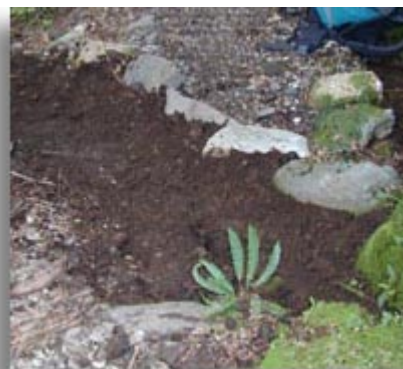
**Rock Waterbars** last much longer than wood water bars but can be more time consuming to build. First you must construct a trench at a 45 to 60 degree angle across the trail as with a wood waterbars, then place rocks in the trench to re-enforce the down-trail, water-catching side. Finding and positioning the rocks is the challenge. The ideal waterbar rock is a solid rectangular shape about .5 meters long by .3 meters high and .1 meters thick. Rocks like these don't exist in the back country. Nothing even close to this exists in the back country, but it pays to invest some time in finding rocks that are as rectangular as possible.

The rocks should be placed in the drainage ditch so that they are 2/3 buried and they should be overlapping such that the outside-edge-most rocks are fit behind their

inside edge most neighbor. This will reduce the chance of the water sneaking through any cracks between the rocks. The rocks should be fit as closely together as possible and any gaps between them should be filled in with smaller rocks, gravel and mineral soil.

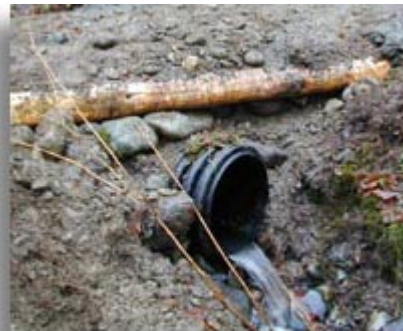
When large volumes of water need to be moved across the trail at a single spot, culverts are used. Culverts are often used in conjunction with **turn pikes**. The culvert must be buried at least 8" deep and packed in a surrounding layer of rock and gravel to keep them from being damaged by trail traffic. Water is fed into the culvert by uphill ditches running parallel to the trail. When a turnpike isn't used, the ends of the culvert must be covered with arches of large rock to prevent them from being dented. Today, most culverts are made from attractive stealth-black plastic so they don't show up on radar. Older culverts may be made of aluminum or even wood. Culverts require extra work to maintain and should only be installed in heavily used or heavily impacted areas.

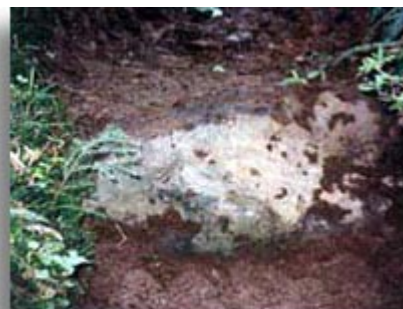
When a trail becomes so badly eroded that it has turned into a deep trench, it can be difficult to divert the water off the trail. This is when we need to get water to work for us by building a **check-dam**. Check-dams (also known as **check-steps**) can be made by building a sturdy wall from large rocks across the trail. The rocks should be large and securely embedded into the ground with as much as 2/3 of the rock buried to insure it won't move. Fill behind the wall with rocks and **mineral soil**. Large flat rocks should be embedded in the trail beneath check steps to prevent erosion from trail users when they step down. The completed project will look like a step. Water will continue to run down the trail, but the check-dam will trap sediment behind it keeping it filled. When a long stretch of trail is badly eroded it is best to build a long series of check-dams like a staircase. Make sure none of the steps are higher than 9".

Rock check-dams are very natural in appearance and will continue to do their job for many years. If you're an avid hiker you've probably stepped over hundreds of them with out realizing it.

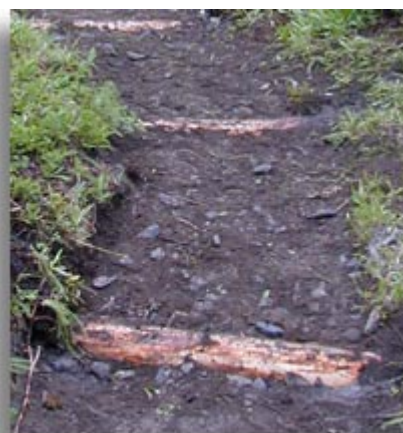
Check-dams are often built out of wood. Begin by

selecting a log about 12" in diameter and 2' longer than the width of the rutted trail. Cut notches a foot back into the banks on either side of the trail. Place the peeled log into cuts. It should be spanning the trail at a 90° angle. Place stakes on the down-trail side of the logs or use rebar to hold the log in place. Fill in behind the log with rock and **mineral soil**. Large flat rocks should be embedded in the trail beneath check steps to prevent erosion from trail users when they step down.

When several wooden check-dams are built in a series the final effect is a handsome flight of steps that will withstand years of water running down the trail.

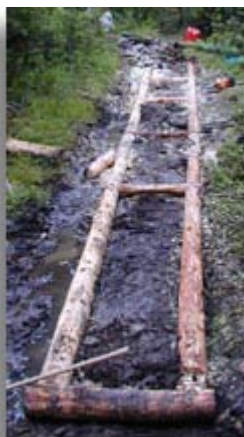
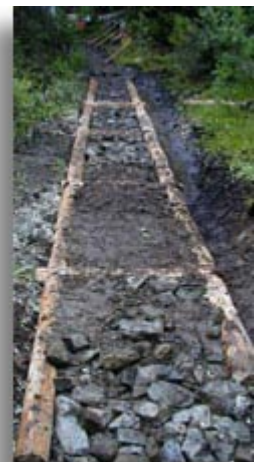
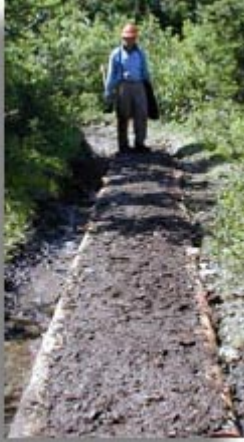
Big mud-holes or boggy areas are ideal locations for a **turnpike**. A turnpike is an elevated walkway constructed of two parallel logs or rock walls filled in with rock and **mineral soil**.

**Note: Only a twit would build a turnpike without end caps**

Fill the turnpike with large, flat rocks as big as you can carry, but not so large that they stick up higher than the logs. Next fill the turnpike with smaller rocks and then even smaller rocks filling in the empty spaces between larger rocks as you go. Finally fill the turnpike with fine mineral soil putting enough to form a crown higher than the logs on either side. This will keep water from pooling in the turnpike.

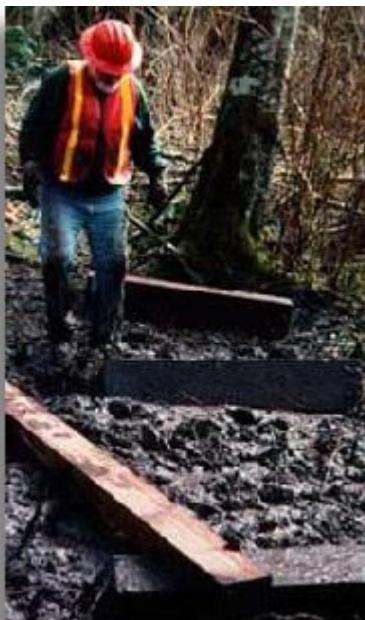
When drainage structures just don't work, when the ground is just too wet and muddy for a turnpike, it's time to build some puncheon. Puncheon is an elevated wooden walkway built to cross swampy or boggy areas. In the back country they're often built from felled logs. Building a piece of puncheon this way is challenging and time consuming. If the puncheon to be built is close to a trailhead it's often easier to bring in dimensional lumber. The puncheon shown below is built from treated cedar -- the material of choice.

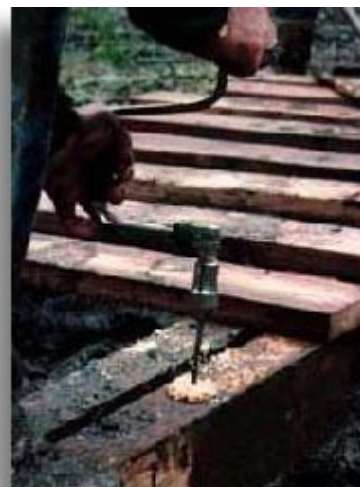
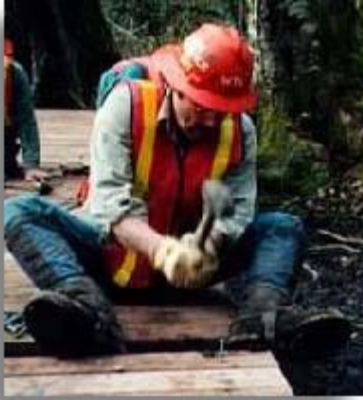
**Stringers** are placed on top of the sills. They run lengthwise along the puncheon. Stringers are connected to the sills by drilling through the stringer into the sill and then nailing it down with a large nail. Sometimes a drill hole is made all the way through the sill and a piece of steel **rebar** is pounded deep into the ground as well.

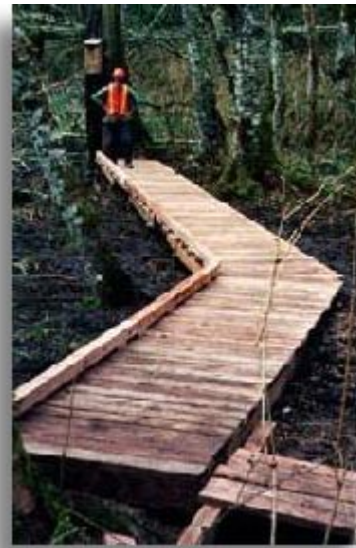
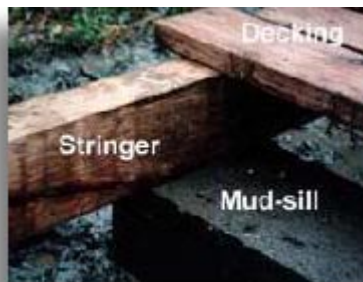
### A review of basic puncheon terminology

showing the relationships between **sills**, **stringers** and **decking**.

This piece of puncheon built by the WTA on March 20-21 1997 can be found on the Champion Tree Farm Nature Trail near lake Kapowsin just south of Orton. The trail is being built with the help of WTA volunteers to allow Champion's wildlife biologist to give disadvantaged youth a chance to enjoy some of the great outdoors that those of us who are avid hikers often take for granted.

The trail leads into an environmentally sensitive wetland area set aside by Champion. The puncheon itself runs along the edge of a pond traveling over several inches of water and mud. It will allow young nature-lovers to get a closer look at ducks, cat-tails, water bugs and a chorus of Pacific Tree frogs.

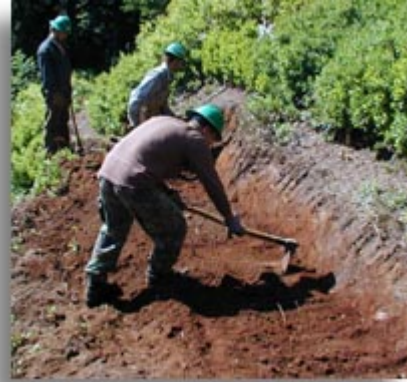
To keep a trail in good shape we need to keep water off of it as much as possible. Our job is made much easier if we build the tread properly in the first place. A typical hiker trail should be two feet wide and have a gentle **out-slope**. This means the **outside edge** of the trail should be lower than the **inside edge** of the trail -- about two inches lower for a two-foot wide tread. This will encourage water to run off the trail rather than down it. The forces of nature don't care much for this design and are continually working to undermine it.

Three major factors work together to ruin a trail. First, mud and other debris slide down onto the trail. This is called **slough**. Slough blocks or narrows trails. Second, plants growing along the outside edge of the trail cause the formation of **berms**. Berms trap water on the trail leading to erosion. Lastly, trail users whether wheels, hooves or boots wear down the tread with heavy use.

When rebuilding trails we use McLeods, Pulaskis, grub hoes and shovels to remove slough, dig out berms and widen the path and restore the tread to its proper design. The completed tread should be two feet wide with the outside edge of the trail being about 2" lower than the inside to facilitate run-off. All **duff** should be removed from the trail leaving behind only **mineral soil**. Duff is the term for the organic matter that litters the forest floor: leaves, pine needles, twigs, bark, etc. Mineral soil is soil that is low in organic content. Soil high in organic content holds water and forms boot-sucking **mud-holes**.
