Newington Walk

Open Space Residential Subdivision

Eastern Connecticut Environmental Review Team Report

Environmental Review Team Report

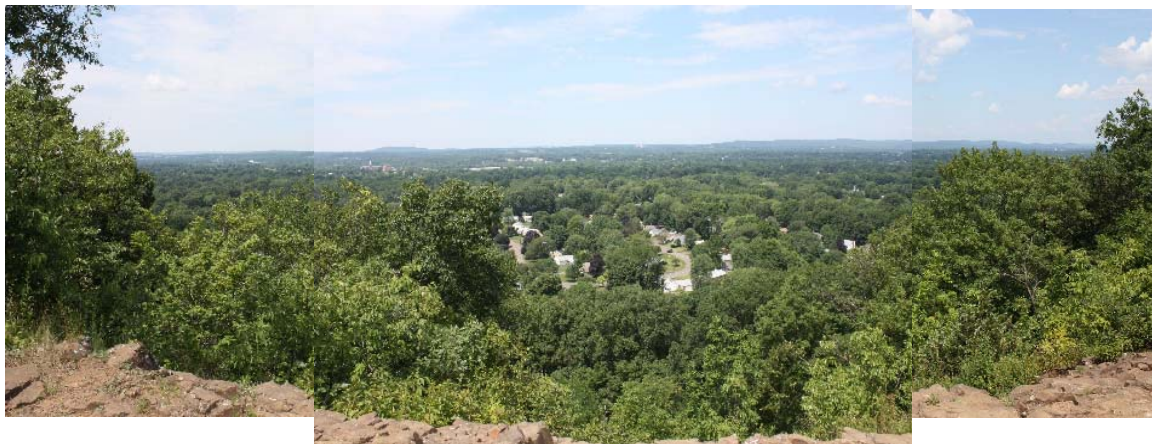
Figure 1. Panorama of view from cliff-edge at top of Cedar Mountain (images by Amanda Fargo-Johnson). Skyline is made up of Metacomet Ridge (Bell, 1985, p.22; LeTourneau, 2008). Toward the northwest (right side of panorama) is Avon Mountain and Talcott Mountain. Toward the west (just to left of center) is Rattlesnake Mountain.

The parcels (Marcap and Balf) straddle a trap-rock ridge underlain by the Holyoke Basalt near the center of the Connecticut Valley. The Holyoke Basalt (colloquially referred to as trap-rock) is gently tilted downward toward the east. Toward the east, the basalt layer gradually is covered by younger layers of sedimentary rock (East Berlin Formation) and glacial soils. Toward the west the basalt layer was eroded by glacial ice during the last Ice Age and forms a steep slope with local cliffs. The cliff-top at Cedar Mountain stands well above the tree height and provides a vista to the west-northwest (Figure 1).

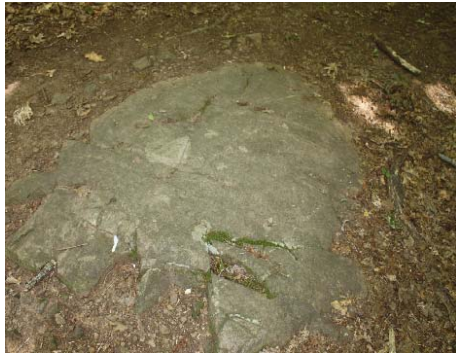
Figure 4. Faint glacial striations tread diagonally across the rock. Image by Amanda Fargo-Johnson.

During the last Ice Age glaciers scraped across the surface of the basalt. Rocks frozen into the base of the glacial ice gouged the underlying bedrock and left glacial scratches on the rock. The scratches, called striations by geologists, record the direction of ice movement when it was thick enough to flow. In this area the ice moved toward the southwest (see Stone and others, 2005). Post glacial weathering has obliterated most of the glacial striations on the parcels, but faint striations may still be found (Figure 4).

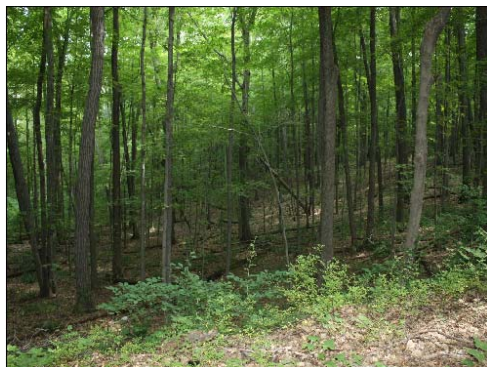
Figure 5. Amphitheater like area near boundary between two parcels, at head of unnamed, north-flowing stream. Stream flow is downward toward the left. This image shows only the eastern side of the amphitheater. Image by Amanda Fargo-Johnson.

The amphitheater like valley (Figure 5) just north of the boundary between the Marcap and Balf parcels is interesting. Most of the valley has characteristics of modern stream valleys, but this one does not have a stream currently flowing through it that could have caused the erosion. The stream valley was likely excavated by a glacial melt-water stream. The head of the stream is abrupt at the amphitheater-like southern end. This reviewer suggests that meltwater flowing on the surface of the glacier found a fracture through the ice and fell through the ice. It therefore began eroding the underlying rock at by creating a plunge-pool at the amphitheater.

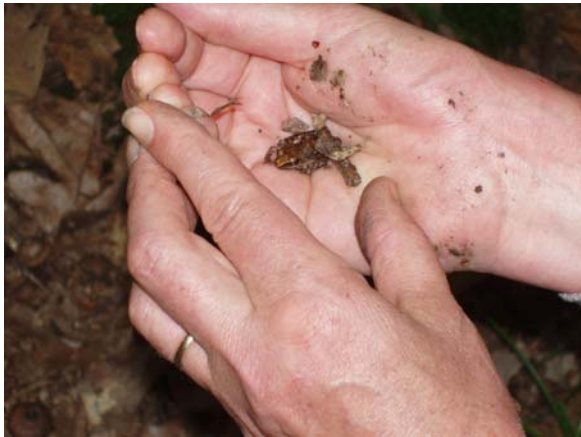
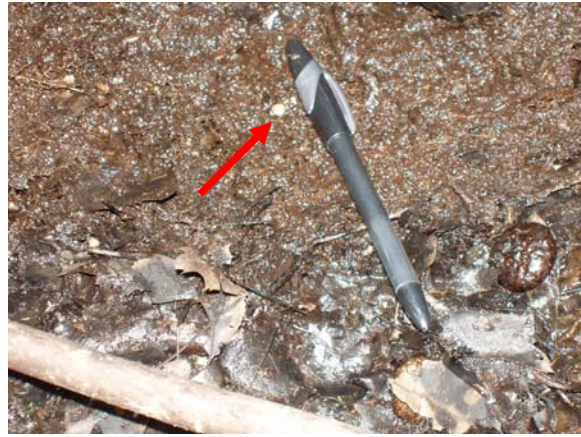
The northeastern wetland is an isolated vernal pool of approximately 1,720 square feet. Vernal pools are small, temporary bodies of standing fresh water that are typically filled in spring and dry out most years. There is no inlet or outlet, and therefore fish are not found in these pools. Vernal pools are important to the survival of many species of reptiles and amphibians that utilize wetlands for reproduction. For some species, such as the wood frog (during the site walk, an adult was observed in the pond and a juvenile was observed in the forest (*see photo below left*)) and the spotted salamander, vernal pools are critical because it is the only type of wetland in which they will successfully breed. These species are also dependent on the presence of healthy forested uplands surrounding the vernal pool, because, when not breeding, this is where they spend the balance of their life cycle. Spotted salamander egg masses have been reported for this pond (Dru Associates, Inc., Herpetological Assessment). The development plans call for this wetland to be filled in order to accommodate housing lots.
