Norwich Hospital Property NRI

Eastern Connecticut Environmental Review Team Report

Report #625

April 2010

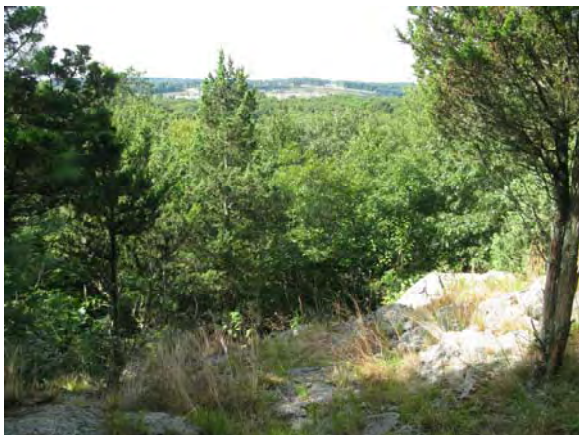
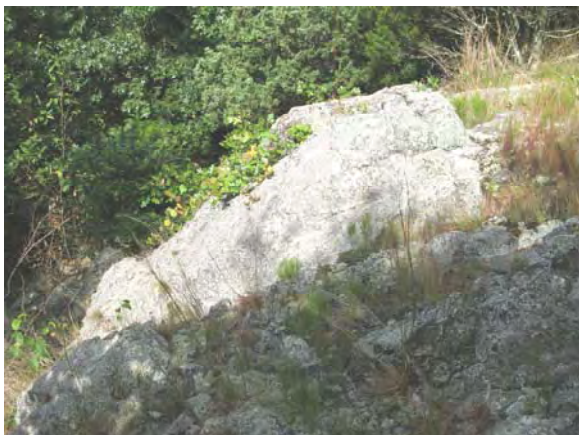
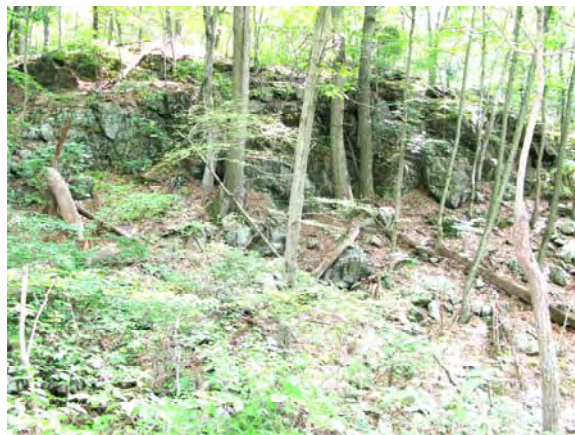
Figure 1. Topography on the northern portion of parcel. A. View from top of steep topography and bedrock outcrops, looking west-southwest across the Thames River (not visible). Mohegan-Sun parking area can be seen in the distance. B. Outcrop of bedrock in area of steep topography. In places bedrock outcrops form cliffs (C).

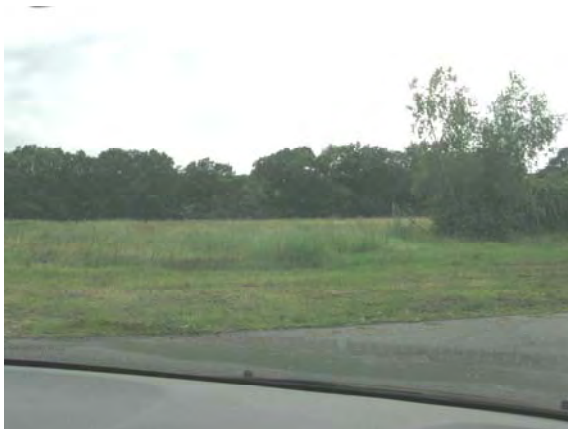
Figure 3. A. Flat terrace upon which main campus is built. B. Hummocky topography south of main campus. C. Steep slope along western edge of terrace at main campus. Thames River at base of slope.

reach a maximum elevation of about 130 feet with generally gentle slopes. The western perimeter of the main campus, however, is bounded by steep slopes that drop to the Thames River (Figure 3c).

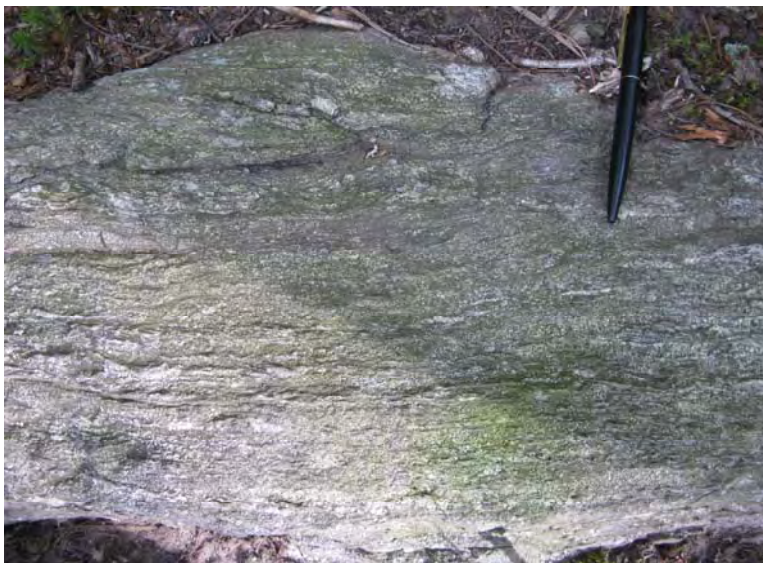
Figure 4a. Biotite gneiss of Tatnic Hill Formation exposed along trail in northern portion of the parcel. It consists of biotite (dark colored) and feldspar with minor quartz. Note that mineral grains are all stretched out parallel to the foliation (grain) of the rock which suggests that the rock was at one time hot and deformed, behaving somewhat like taffy. Pen is 5.5" in length.

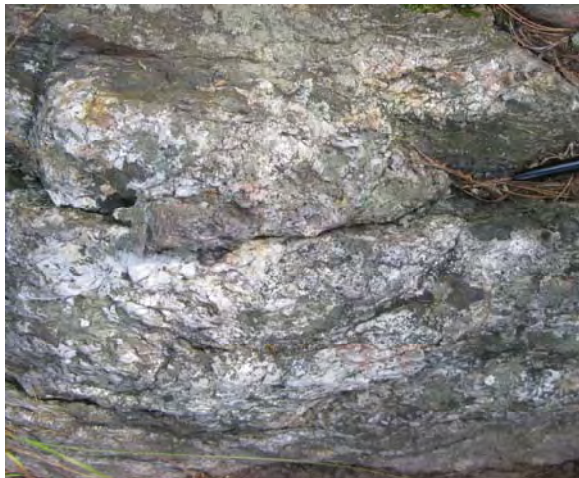
Figure 4b. Pegmatite in Tatnic Hill Formation. Pegmatite is more coarsely crystalline than the gneiss. Pegmatite results from slow crystallization of molten rock formed when the metamorphic temperatures were hot enough to cause partial melting of the gneiss. Pen for scale.

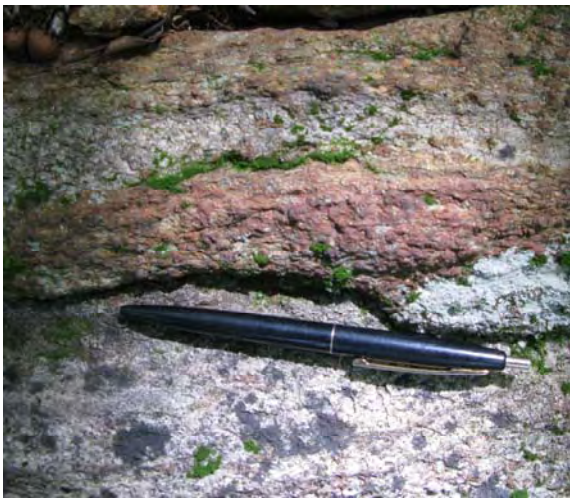
Figure 4c. Rusty weather layers in Tatnic Hill Formation. This stain probably results from weathering of garnets.

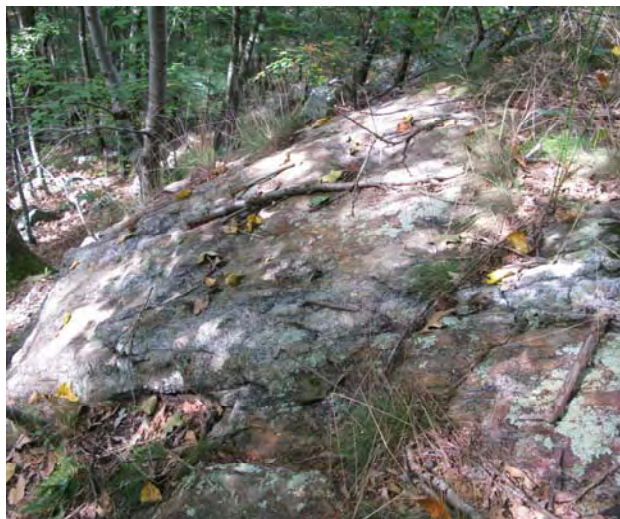
Figure 4d. Garnet concentration associated with rusty weathering layer of Tatnic Hill Formation. Garnets are small nobby areas just above pen.

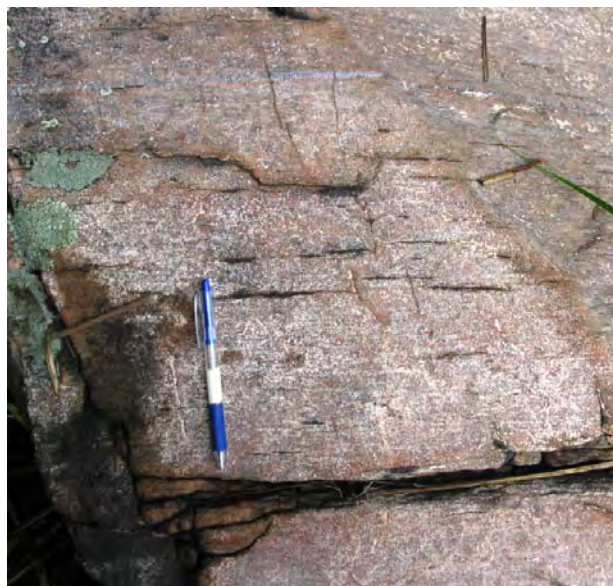
Figure 4e. Alaskite gneiss of the Hope Valley Formation. It is composed of flesh-colored microcline feldspar and quartz with traces of muscovite mica.

South of the fault, Avalon Terrane consists of gneisses that were formed almost a billion years ago. The Waterford Group consists of light colored granitic and more grayish colored biotite-quartz feldspar gneiss, and the Hope Valley Formation (Fig. 4e) consists of alaskite gneiss (quartz and feldspar with minor amounts of mica). These formations strike parallel to the Honey Hill Fault. There is an abrupt topographic change associated with the fault in this area. Apparently the schist and gneiss of the Tatnic Hill Formation were less easily eroded by glacial erosion and other weathering processes than

The rock could be a useful resource if quarried and crushed. The Hope Valley Alaskite Gneiss (labeled **Zsh** on Figure 3) is probably the better rock for crushing into sharp-edge particles because it contains less mica and its foliation is less well developed.

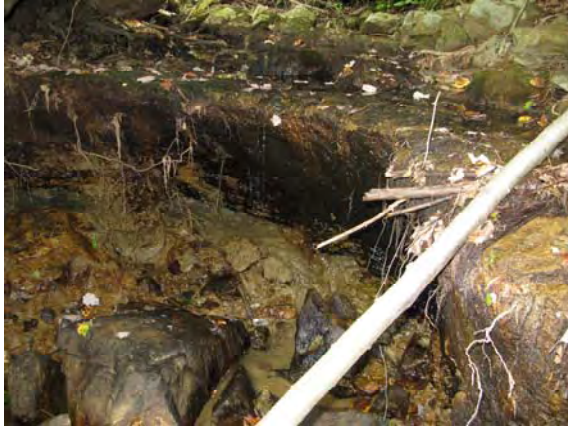
Figure 6. A. Glacial till exposed in gully south west of former water supply reservoir. Particle size of the till ranges from rocks up to 2' in length to silt and clay matrix. View shows nick-point in what may be a hardpan in the till over which overflow rain-water flows. B. Kettle just off Rte. 12 on south end of parcel. Slopes are natural except where road was excavated. This kettle has a shallow pond in its bottom. The pond farther west is likely a kettle also. C Thin gravel layer overlying fine-grained sand along excavated road at edge of kettle. D. Gravel excavation in esker west of kettle on south portion of parcel. E. Fine and medium grained sand adjacent to excavated area. This sand is contains shells and may be dredge spoils placed in the abandoned gravel pit.

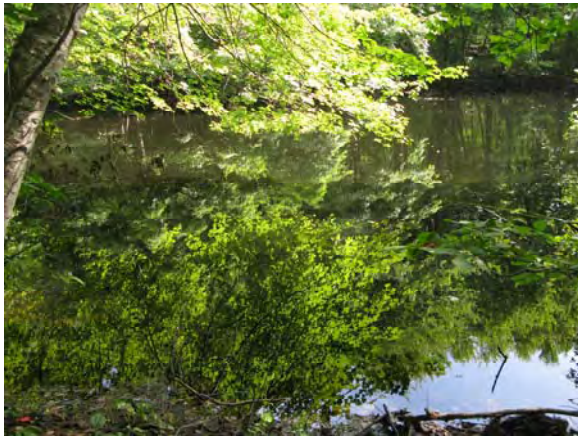
Figure 7. Impoundment near top of watershed has clear water and healthy ecosystem.

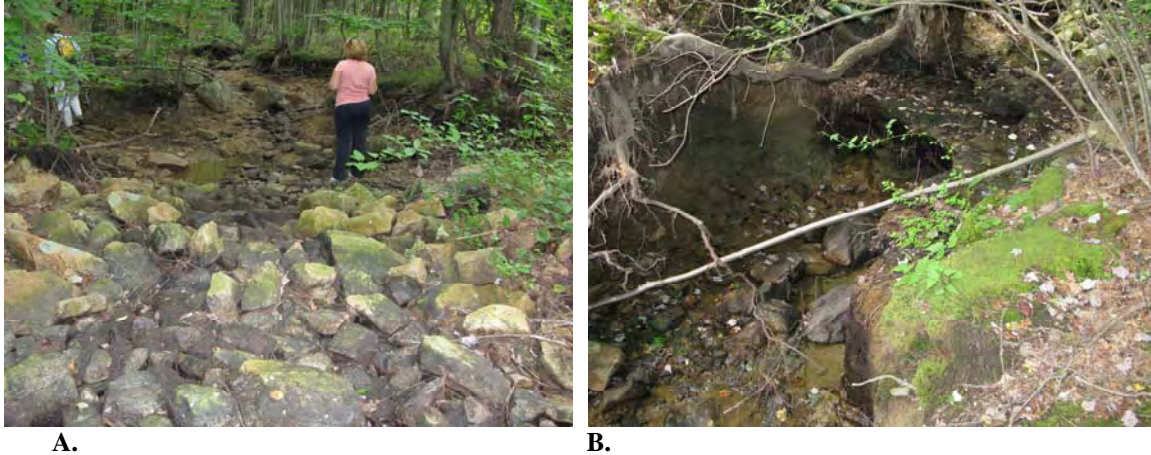
Figure 8. A. Cobble armor revetment protects spillway channel from erosion. This view looks downstream at end of protected section. Downstream the stream gradient increases. Lack of protection and the increased gradient result in accelerated channel erosion. B. Nick-point in eroded channel below revetment area presents a dry waterfall when no water flows out spillway. Channel incision is almost 4' at this point.

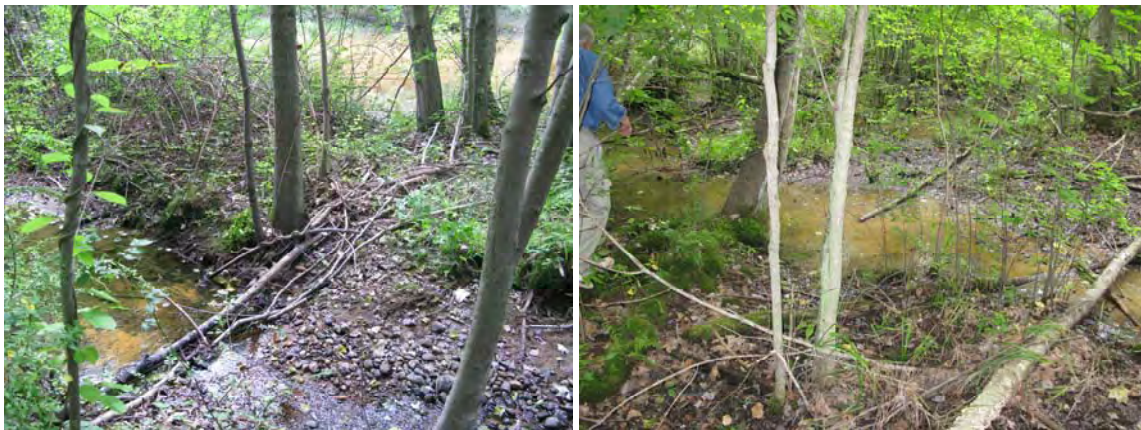
Figure 9. A. Overflow channel on lower left near its confluence with original drainage, which flows through small pond seen in background. Pond in background, however, supports little amphibian or insect life. It is murky orange colored with visibility of only a few inches. Algae grows on the bottom and on sticks protruding from the water. B. Stream channel below pond. Stream is murky orange.

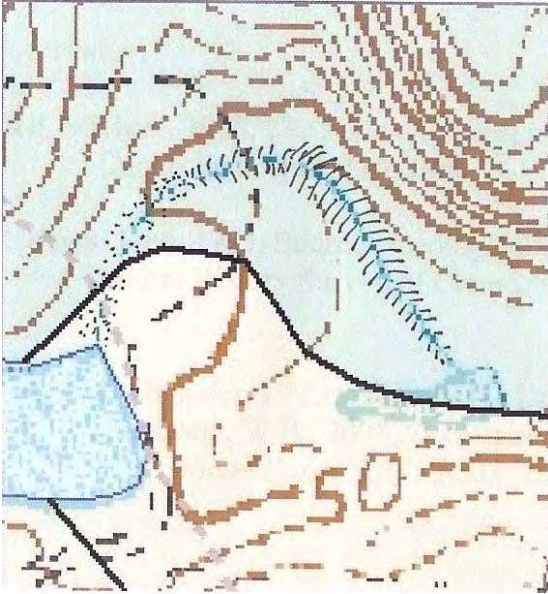
Figure 10. Detail of erosion near spillway area for former water-supply reservoir. Stipple area indicates channel armor-revetment and hachures indicate approximate area of channel erosion; length of hachures approximates depth of erosion. Green area underlain by till; yellow area underlain by sand and gravel.

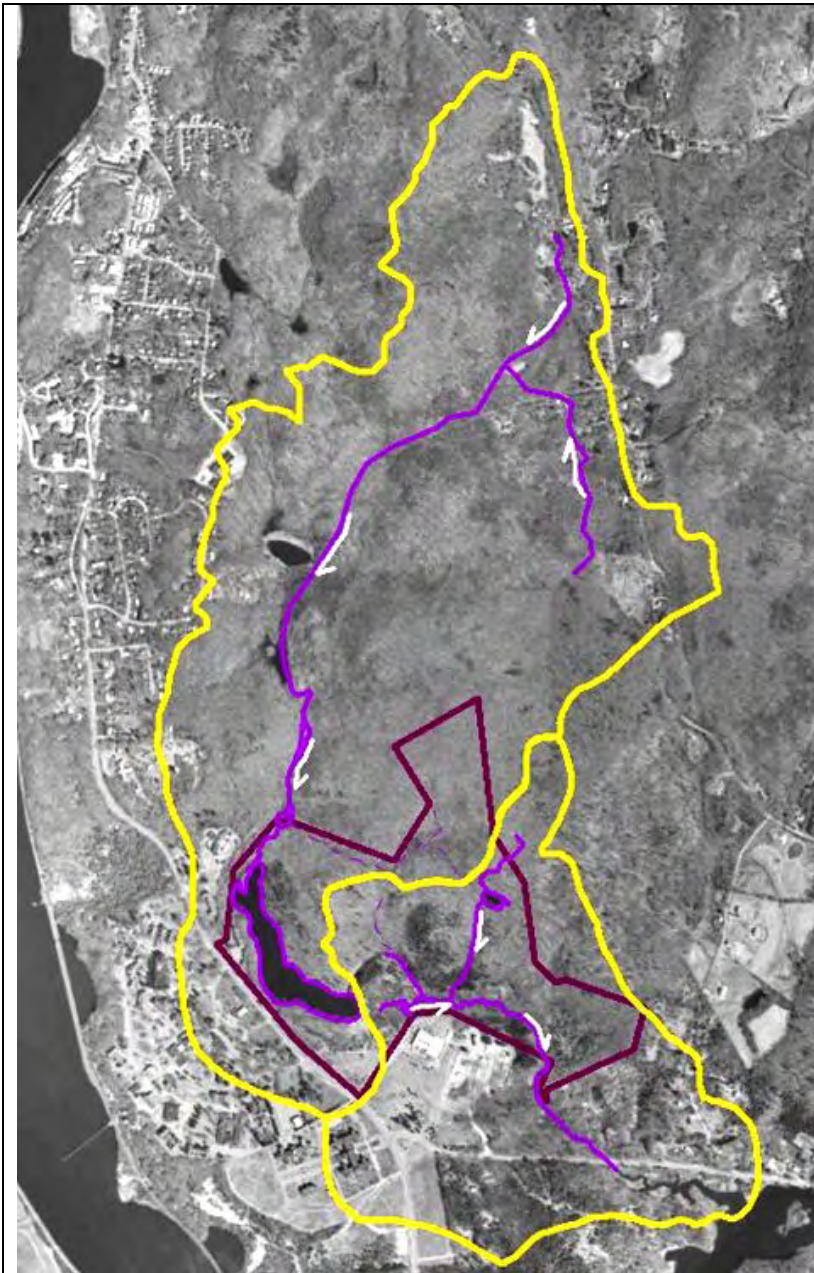
In this graphic the two watershed delineations are in yellow, the primary watercourses that drain the landscape are shown in violet and the half arrows indicate direction of flow. The outline of Parcel 1 is seen here in dark red.

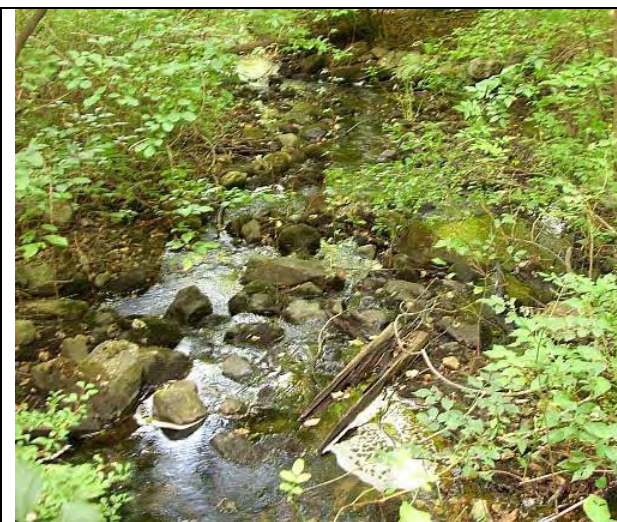
This is a photograph of the unnamed stream that connects a large forested wetland upstream from the reservoir to the reservoir. Being rocky and dropping 8-10 feet between the two entities it is well aerated, clear, without odor and alive with aquatic insects.

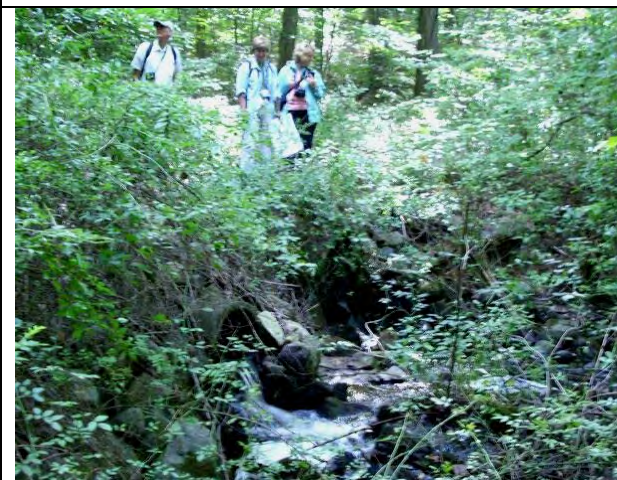
Team members view the unnamed stream as it passes through two reinforced concrete pipe culverts, one of which is clearly visible in this photograph. The culverts are just downstream of the above image.

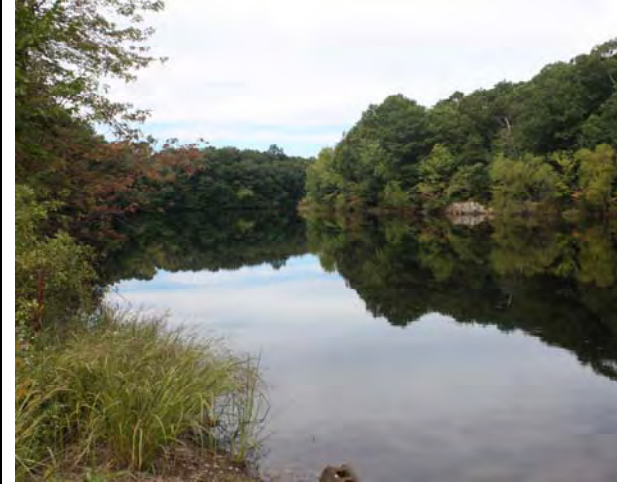
Two hundred seventy feet downstream from the culverts the stream ends its 1.6 mile run through the watershed by flowing into the ten acre reservoir.

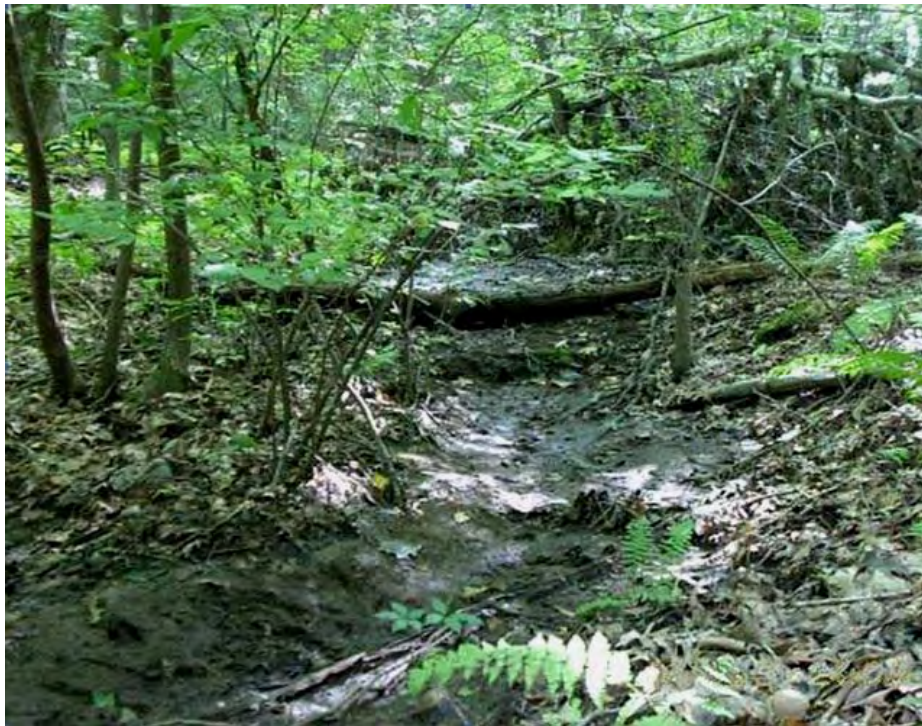
This intermittent waterway was encountered about 500 yards east of where the unnamed stream passes through the culverts. Notice the log down across the flow path. Throughout the wetland complex and throughout the forested watershed, coarse woody debris decreases water speed (minimizing erosion), increases aerial extent of flooding, and allows for absorption into the groundwater.

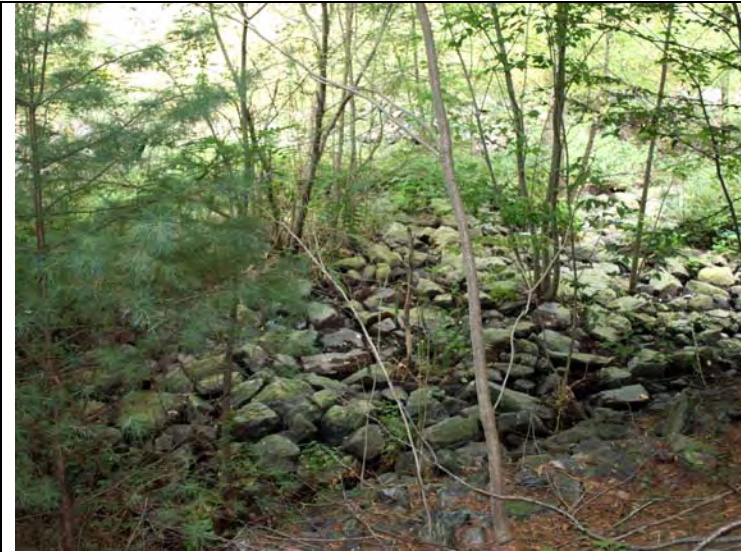
On aerial photographs it can be difficult to see the riprapped, channelized, outfall spillway from the 10 acre reservoir. The channel is shaped as such: \backslash _____/ \wedge and this photograph was taken looking down a short sideslope into the bottom of the channel.

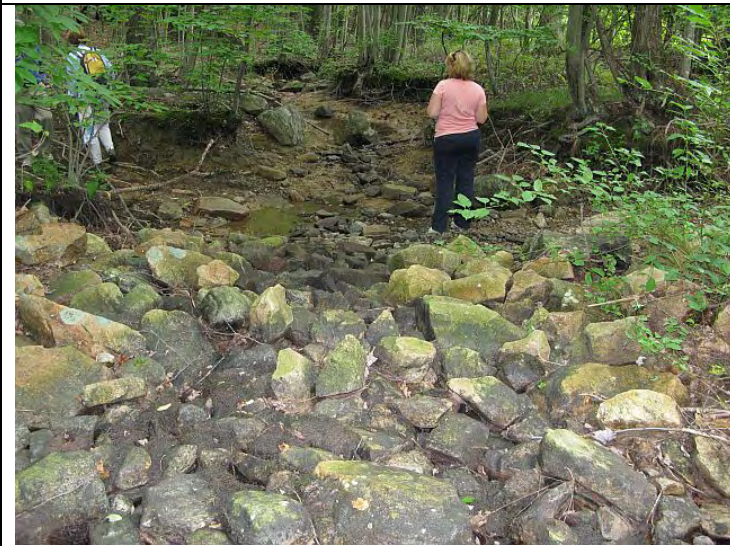
After 550 feet the energy absorbing riprap in the channel comes to an abrupt end. Immediately upon its termination, the water flow begins its erosion and downward cutting. As a result, gullying begins.

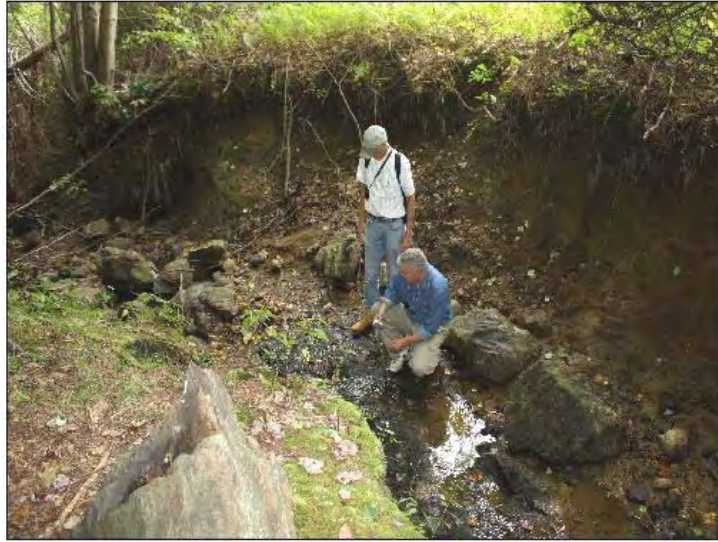
The gullying cuts through the till based soils to depths of 5 and 6 feet providing a diverse array of erosion based vignettes both within and abutting the stream course.

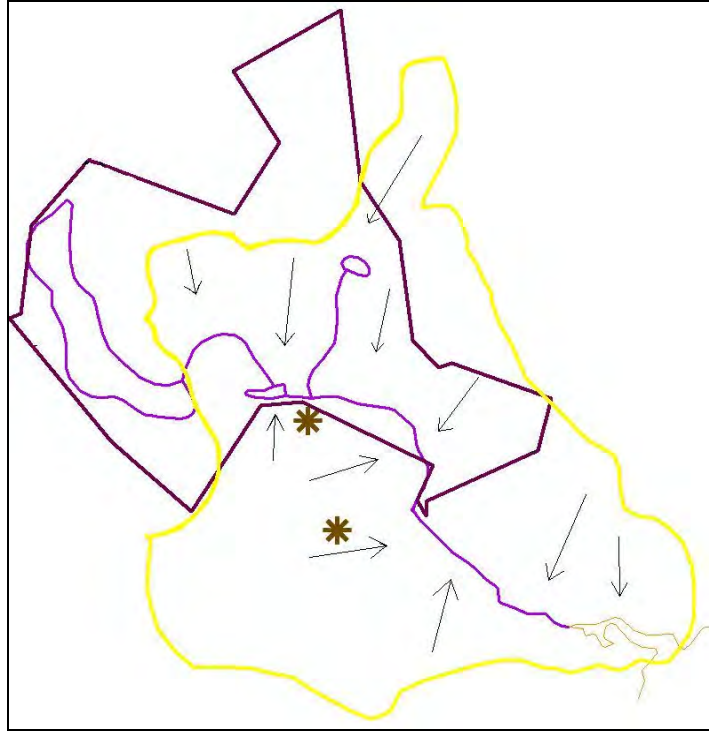
In this graphic the Parcel 1 property boundary is depicted in dark red, the drainage area in yellow, and the water courses in purple. The rust colored stars are the two points of known Leachate and Wastewater Discharge sources in the watershed. Both are no longer active and are alternatively known as Preston Landfill and Preston Transfer Station. The arrows indicate general direction of surface and ground water flow. In a typical scenario, the downhill direction of the flow would intercept pollution from the two landfills and deposit it in the watercourse down gradient thereby degrading the water quality. (Leachate and Wastewater Discharge source information: DEP GIS, 2009)

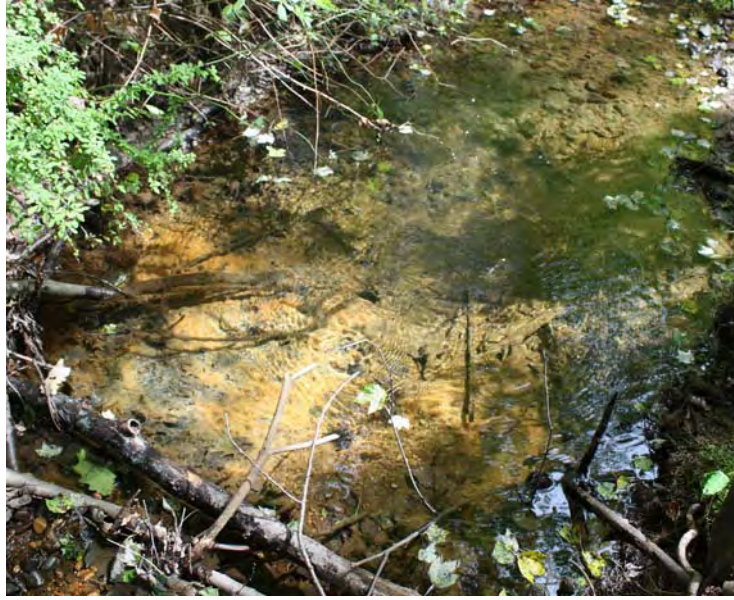
This photograph shows the end of the arcing spillway tributary just before it empties into the small oblong pond. The clarity of the water is readily apparent here at the end of the stream's run despite traversing large runs through eroded areas. Despite the erosion problems seen above, the forested watershed still does a good job of keeping sediments from impacting that water quality.

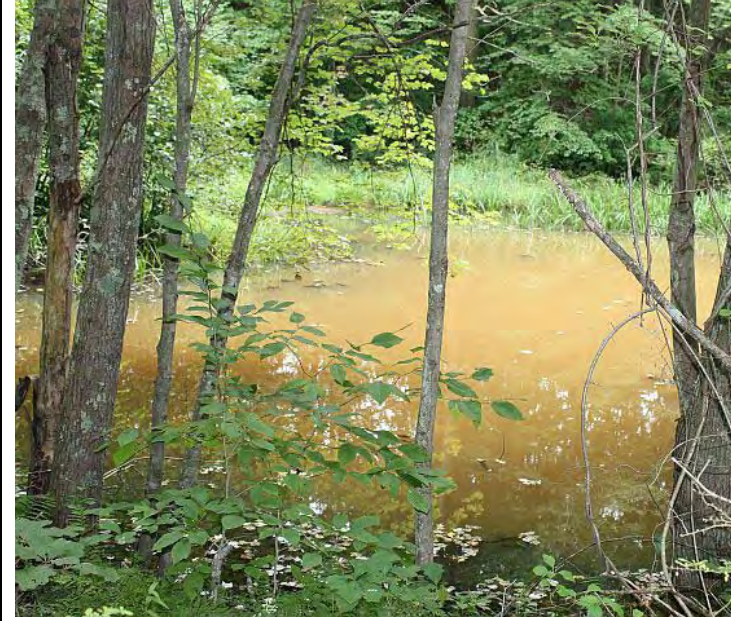
This is the oblong pond into which the arcing spillway tributary empties. The brown color likely indicates suspended sediments and compromised water quality. This pond is situated just below the hill upon which the landfills are present.

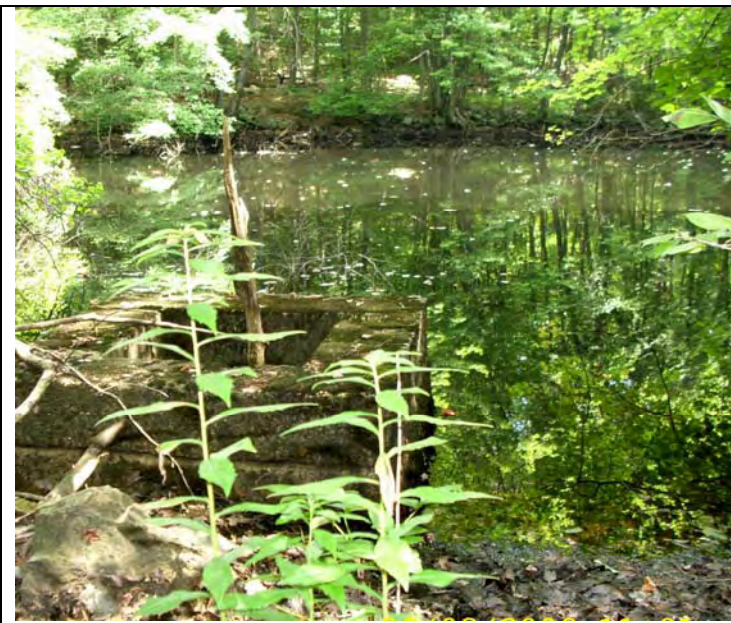
This photograph of the Oval Pond was taken from the road which impounds it. The nonfunctioning outlet structure is seen in the foreground and the pond itself, which is home to frogs and reptiles, is undoubtedly used by other wildlife in the area.

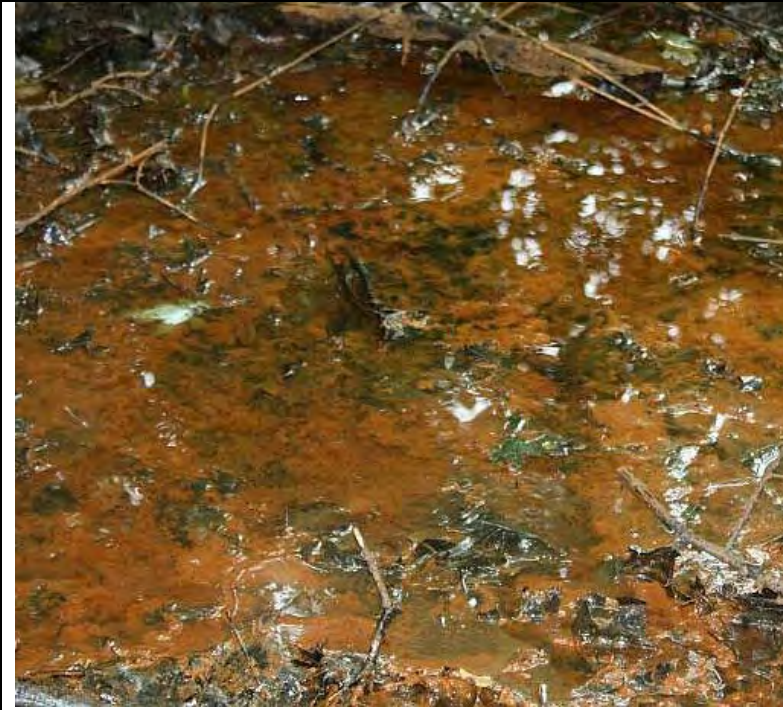
This orangey color is caused by bacteria which thrive on iron in the soil and water. Lying beneath crystal clear water, a puffy bottom mass looking somewhat like mold broke up readily when frogs leapt into it and under it at our approach.

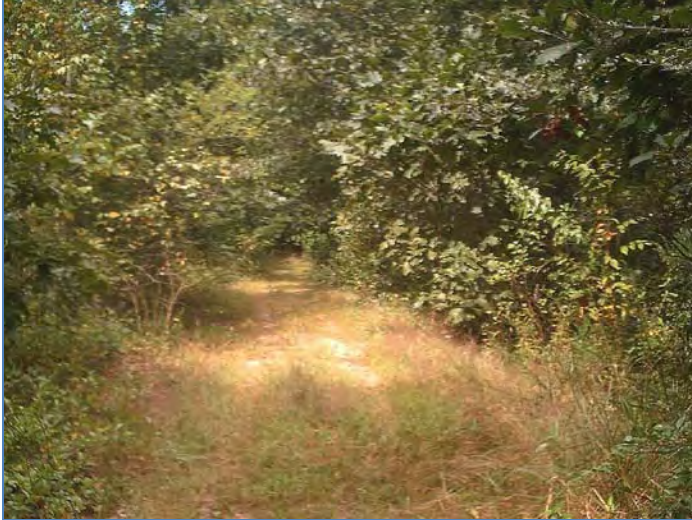
This is the view across the top of the dam. The pathway is surrounded on both sides by dense vegetation which inhabits both side slopes of the dam. Root penetration into the earthen dam structure by large vegetation has always been seen as a potential threat to the long term stability and safety of the dam structure.

Members of the Team have strongly suggested that the dam which impounds the 10 acre reservoir on the property be reviewed by a professional familiar with dam maintenance and safety. It is a long held rule of thumb that vegetation larger than grasses should not be growing on an earthen dam. However, on the field review the team observed a thick brush and small tree community firmly established on the dam side slopes. Clearly in the past some maintenance has cut back this vegetation but, left to its own for several years, it has continued its efforts to reestablish itself. As a result it is strongly suggested this situation be reviewed immediately.

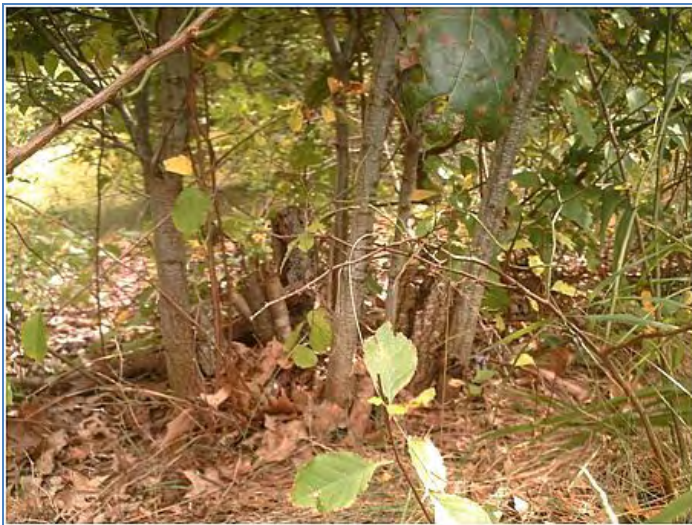
This photograph was taken on the top of the dam looking east with the water behind the photographer. The vegetation measures one to two inches in diameter. This well established growth surrounds an interior core of previously cut stumps, a sign of maintenance in the past.

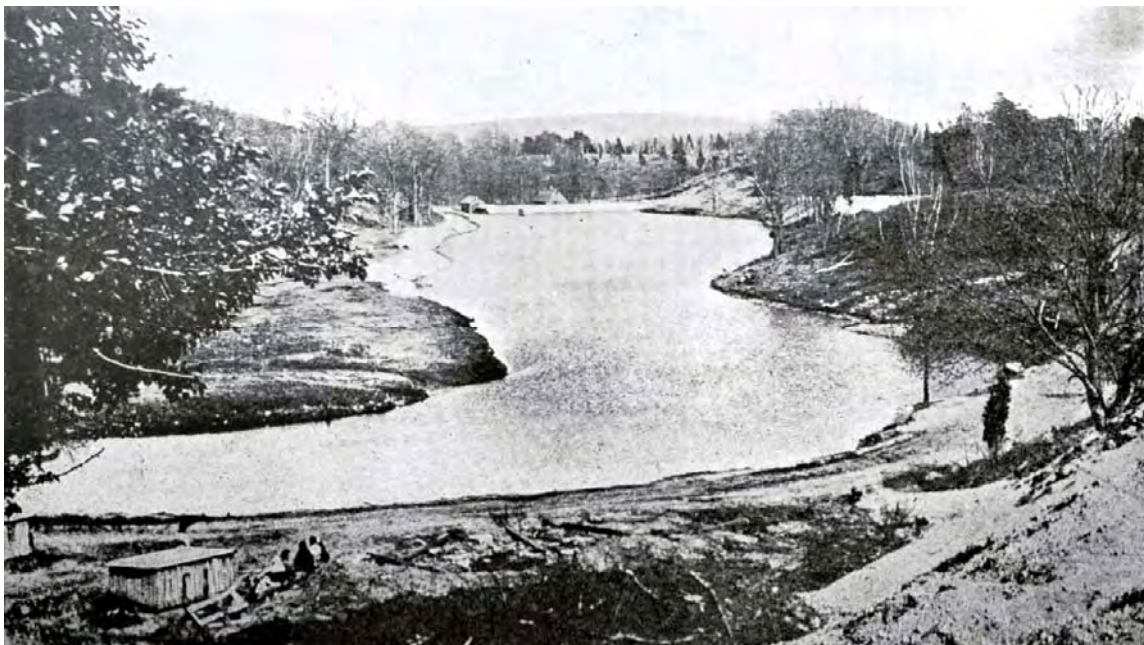
Historic photograph of storage reservoir.
