Transylvania Pond

Southbury, Connecticut

Environmental Review Team Report

Report #348

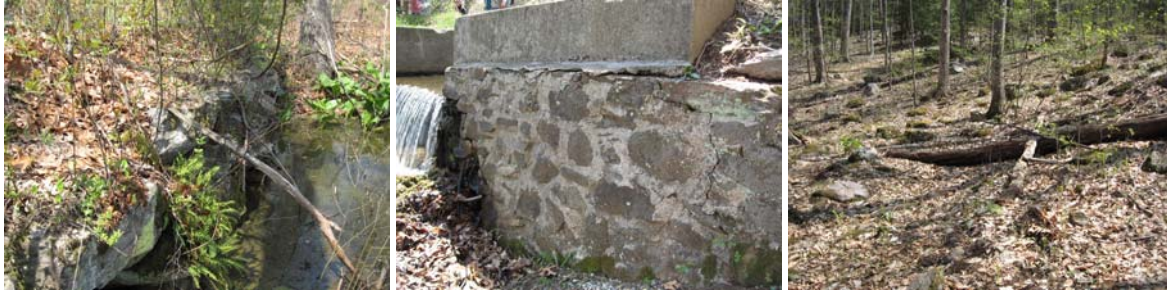
Figure 3. (Left) Large granofels boulders were used to construct the dike that impounds Transylvania Pond. (Center) In contrast, smaller boulders and cobbles of arkosic sandstone were used to construct the dam part of the impoundment. (Right) Arkose was likely derived from mining the hill slope immediately east of the dam.

Rocks that form the western part of the Transylvania Pond watershed consist of Paleozoic metamorphic rocks referred to as the Ratlum Mountain Schist by Rodgers (1985). They consist of quartz-mica schist and gneiss and granofels. Although the Ratlum Mountain formation does not crop out in Pierce Park, it crops out near the base of the western slopes and was quarried there for use in constructing the western dike that impounds Transylvania Pond (Figure 3).

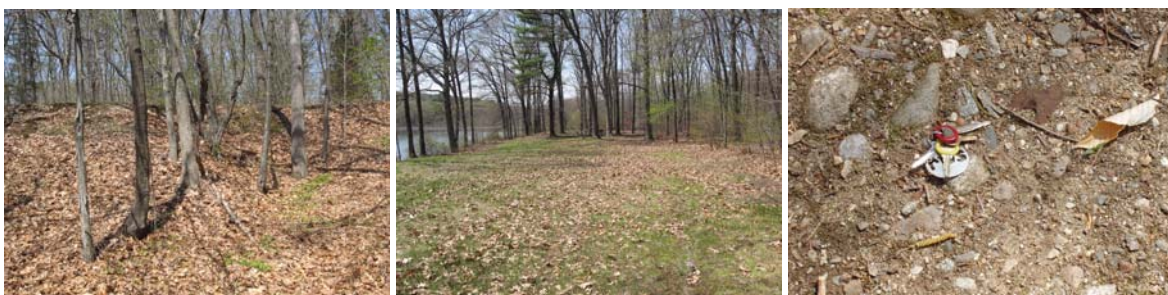
Figure 5. (Left) Flat topped terrace deposited by meltwater streams. Deposits consists of sand and gravel that at this location were mined, possibly to construct the dam. (Center) Top of meltwater stream terrace. (Right) Trail traverses top of terrace and exposes rounded river rocks, indicating the terrace is composed of stream-deposited sand and gravel.

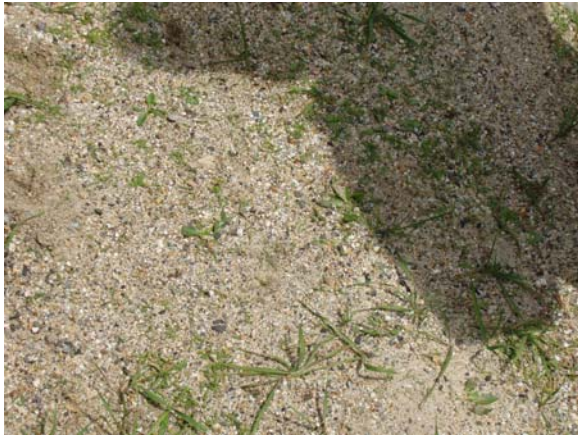
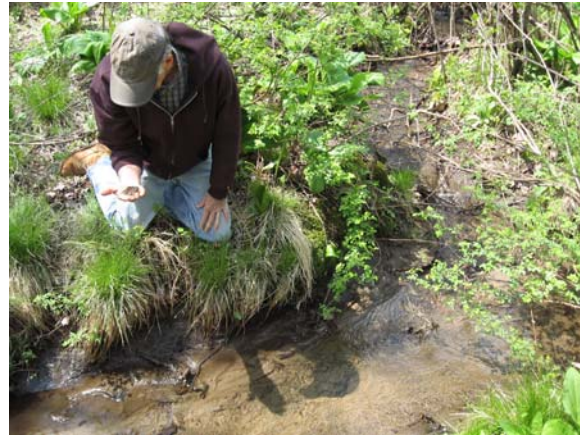
Figure 6. (Left) Winter road sand at side of Transylvania Road, spring, 2008. (Right) Team geologist with a hand-full of coarse-grained sand from tributary stream near its entrance into Transylvania Pond. 90% of the stream bed-load consists of fine-grained micaceous sand and silt that is eroding off the adjacent hill-slopes. 10% of the bed is coarse-grained sand that is likely derived from the winter road side.

Three more or less perennial streams enter Transylvania Pond. The sediment load of the streams that drain the hills to the west consists of fine-grained sand. The composition of the sediment includes appreciable muscovite mica. Two of the streams cross under Transylvania Road. Winter sand application to the road works its way into the streams. Winter road sand is coarse-grained (Figure 6). In addition to the fine-grained mica-rich sediment, coarse-grained sand is found in one of the streams just prior to its entering into the pond.

Run-off does make its way into the pond. Run-off has carried coarse-grained road sand into the pond's tributaries. Dissolved materials from developed areas can reach the pond more quickly. It is possible that some of the stimulus for recent plant growth in the pond is the result of nutrients washing into the pond through both surface and subsurface (groundwater) flow.

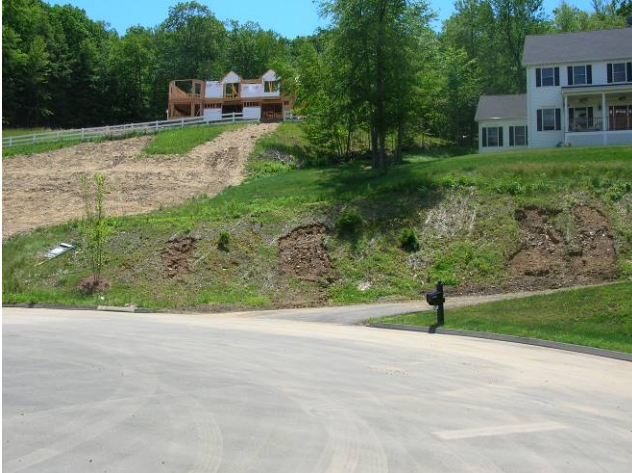
Slope Failure on Country Woods Lane

The Country Woods subdivision did not implement major concepts described in the 2002 Connecticut Guidelines for Soil Erosion and Sediment Control and the 2004 Connecticut Stormwater Quality Manual. This created major shortfalls in the implementation of the soil erosion and sediment control plan as well as the stormwater management plan. As a result major soil erosion and sedimentation has occurred and continues to be a problem. There is a failing stormwater basin on site, and it is only 900 feet from Transylvania Pond. Stormwater pollutants and sediments could have been kept out of the Pond if the following issues were addressed.

- 1) This development did not work with existing topography to minimize cut and fill slopes.
- 2) House lot density was likely too ambitious for such a steep site with highly erodible compact till soils. Therefore roads and driveways could not follow contours as recommended by the 2002 Connecticut Guidelines for Soil Erosion and Sediment Control.
- 3) There does not appear to be any use of temporary sediment traps.
- 4) Slope stabilization techniques are failing and require upgraded slope stabilization measures.
- 5) Silt fence barriers are being used below areas that require additional/redundant silt barrier measures (i.e. silt fence / dirt berm or silt barrier with sediment trap or diversion swale to sediment trap)
- 6) It appears that “clean” stormwater runoff from undisturbed areas above was not diverted around exposed soil areas.

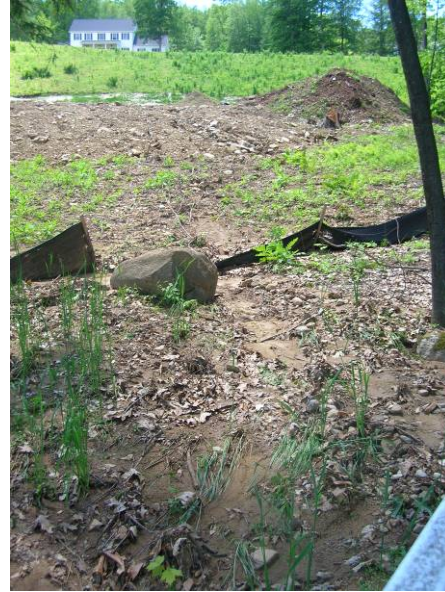
Silt Barrier Failure on
Country Woods Lane

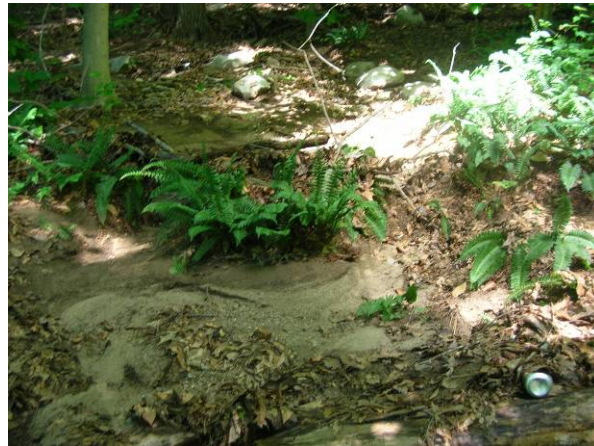
Sediment Deposition from Eroded Channel

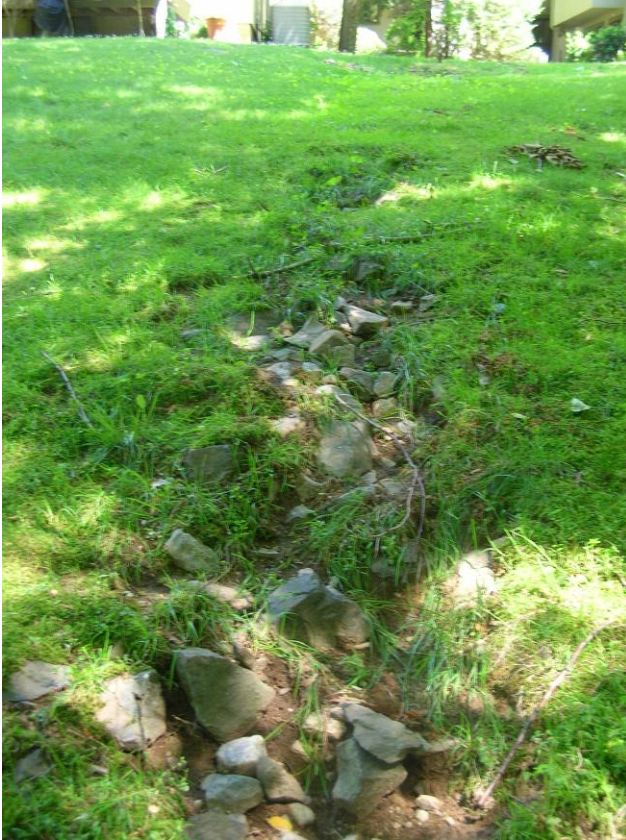
In addition, the uncontrolled runoff generated by the lawns below the lower units on Fox Run and Deer Hill are eroding soils and depositing sediments into Transylvania Pond (see photos below). If any fertilizers, herbicides or pesticides are being applied to these lawn areas, all the excess is being washed directly into the pond. There are no stormwater renovation measures in place to mitigate the negative impacts of stormwater from the area of concern. If any of the measures mentioned in the LID section of this chapter were retrofitted into the Fox Run and Deer Hill neighborhood sections of the Woodlake Development, it would go a long way towards protecting water quality in Transylvania Pond. If dredging is to take place in the pond retrofits should be in place first.

Lawn Area Runoff Eroding Soils

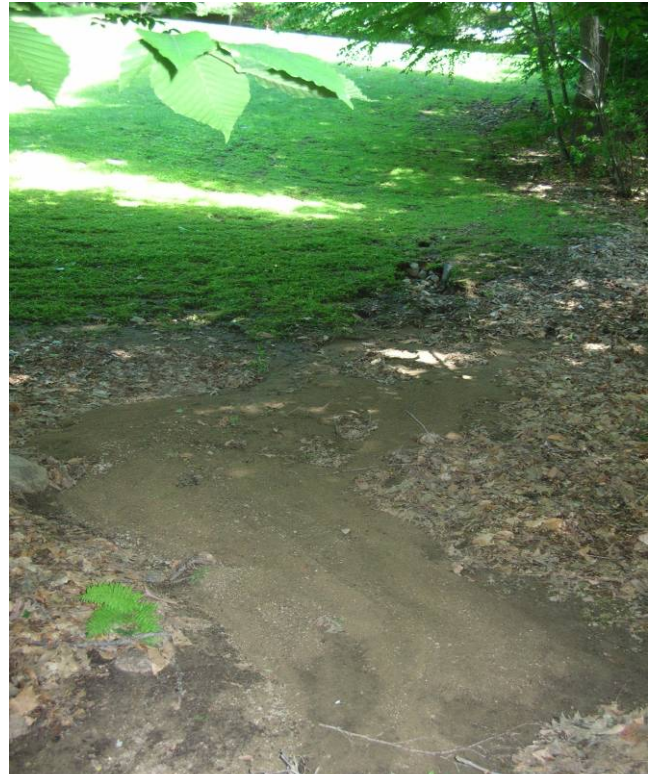
Lawn Area Runoff Depositing Sediments

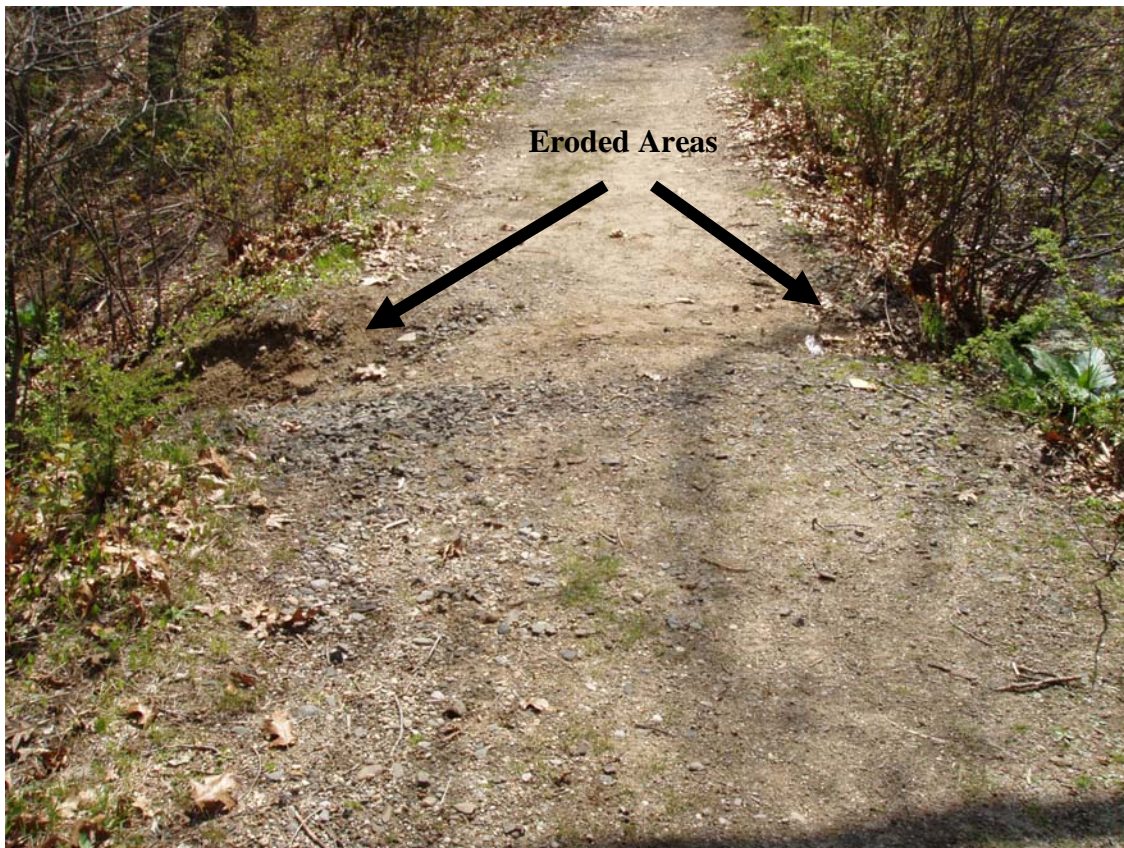
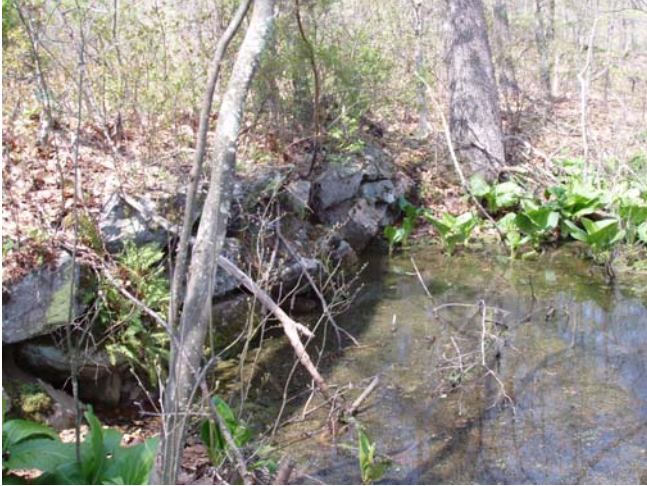
The dike section is 80± feet long and 6± feet in height. There are numerous trees and brush growing throughout the upstream and downstream embankments. There is a gravel crest along the top of the dike. There were eroded areas observed along the embankment.

There is a masonry wall on the downstream side of the dike embankment where numerous voids were observed and its stability is questionable. The dike section has reportedly overtopped during significant rain events in the past. The top of the dike section is a foot or more lower than the top of the main dam section.

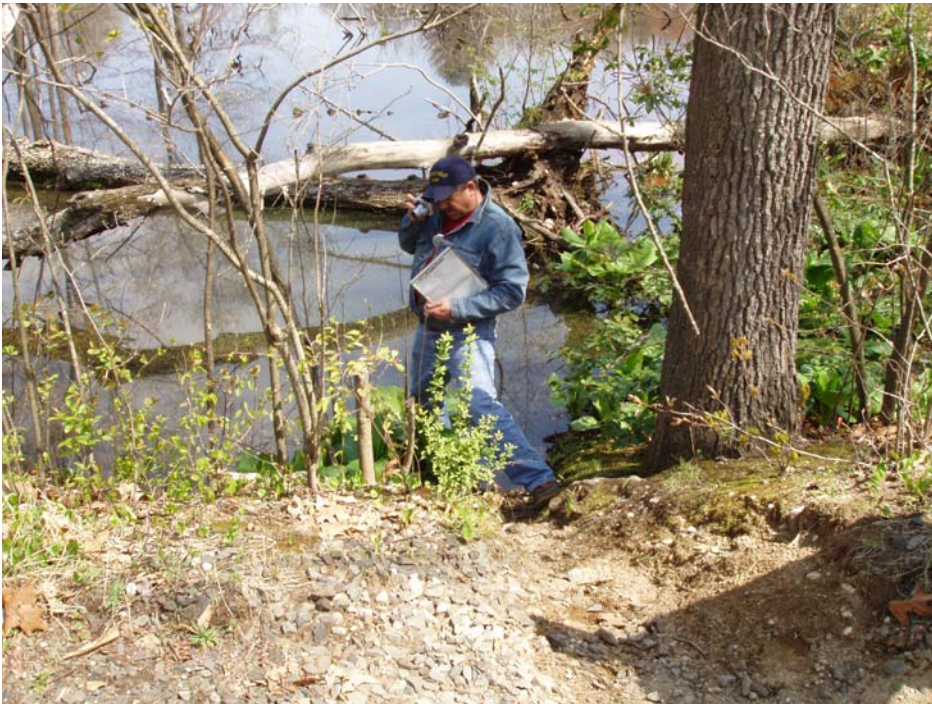
Bank erosion and trees and brush growing along the embankments.

A hydraulic and hydrologic study should be performed to assess the dam's spillway capacity to safely pass the 100 year storm event**. The dam and dike sections are in poor condition and the above mentioned inadequacies should be addressed to ensure the integrity of the structures. These tasks will require the services of an engineer familiar with dams and dam construction to undertake the engineering investigation and design of repairs necessary.

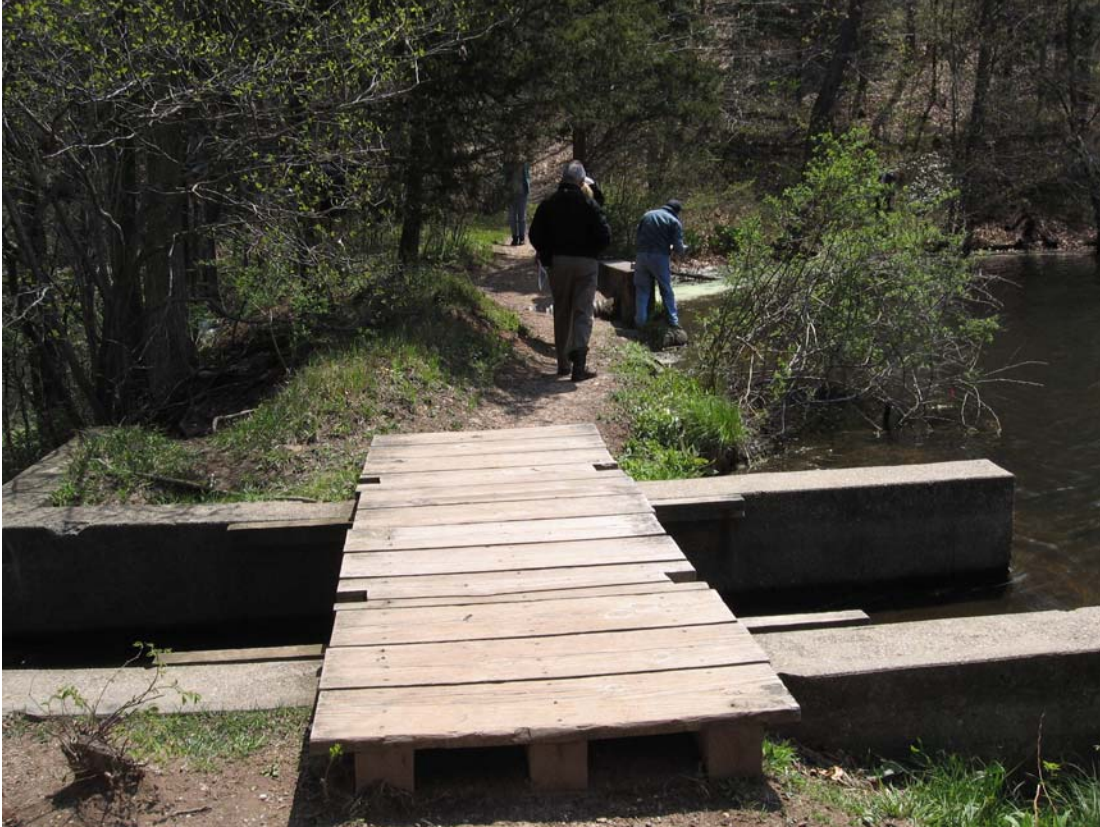
Walkway over spillway section.

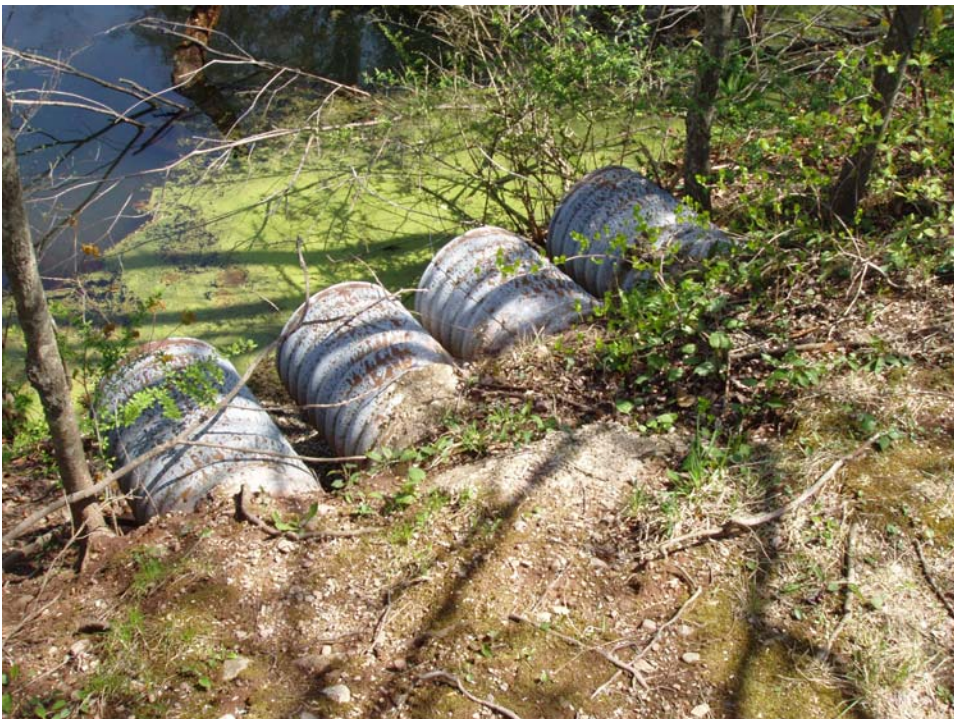
The main dam section is 100± feet long and 8± feet in height. There are many trees and brush growing on the upstream and downstream embankments and along the crest. There is significant embankment erosion along the upstream and downstream embankments and along the crest as much as 2± feet deep in some areas. The crest of the main dam section has an irregular profile. There is a 30± foot long downstream masonry wall located on either side of the spillway section which has various cracks throughout the concrete. There is a walk bridge located over the spillway section. There are also four 18 inch corrugated metal pipes located to the right of the spillway, which serve as an emergency spillway. There is a concrete headwall on the upstream side of the auxiliary spillway and the outlet portion of the corrugated metal pipes has corroded.

Outlet portion of corrugated metal pipes.

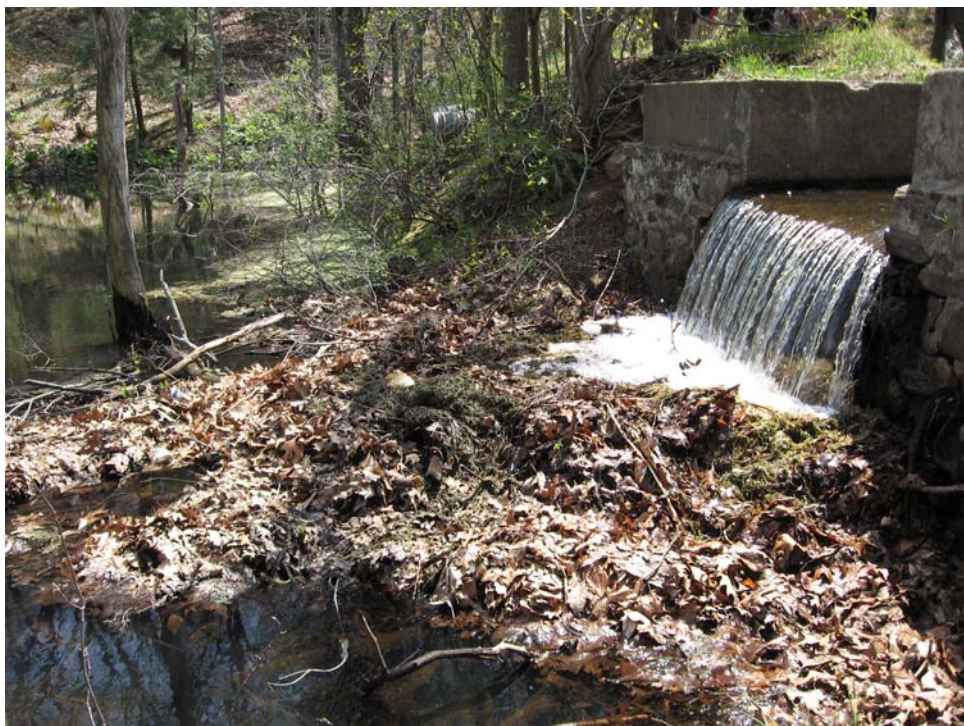
Main dam section with spillway.

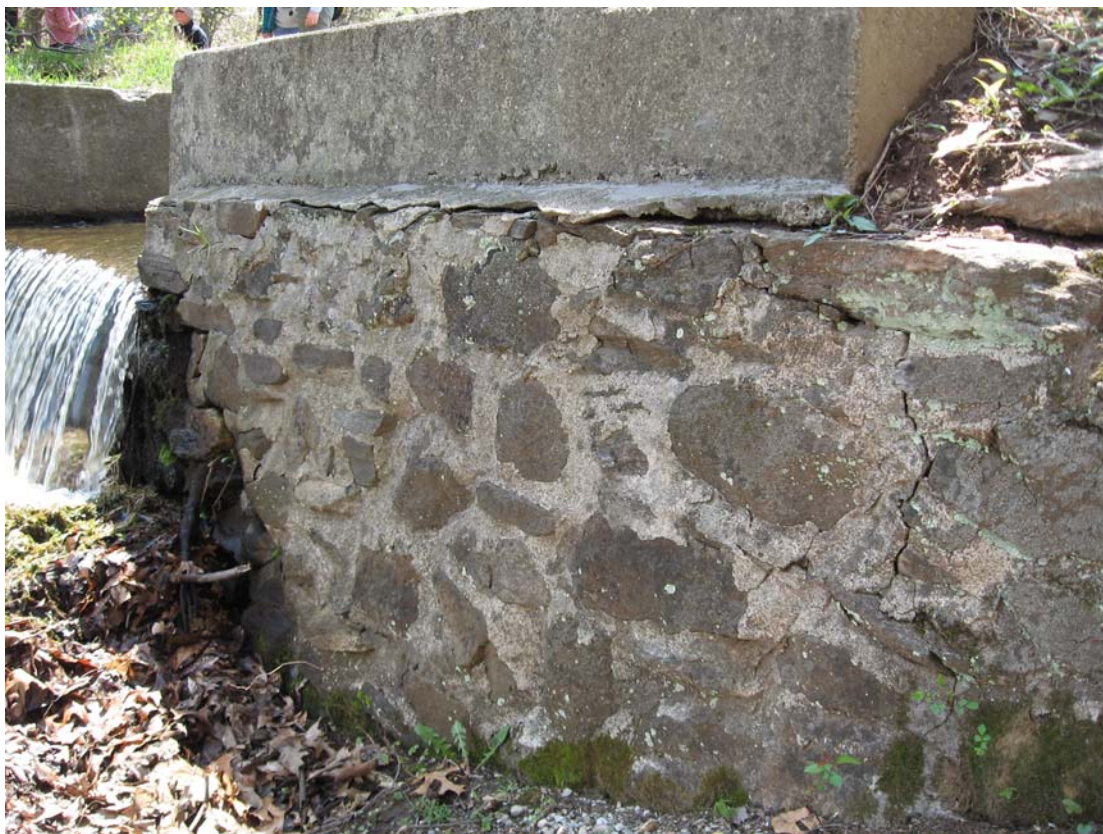
Downstream masonry wall with cracks and voids.
