**995 East Center Street
Open Space Property
Wallingford, Connecticut**

**King's Mark
Environmental Review Team Report**

Environmental Review Report

Report #359

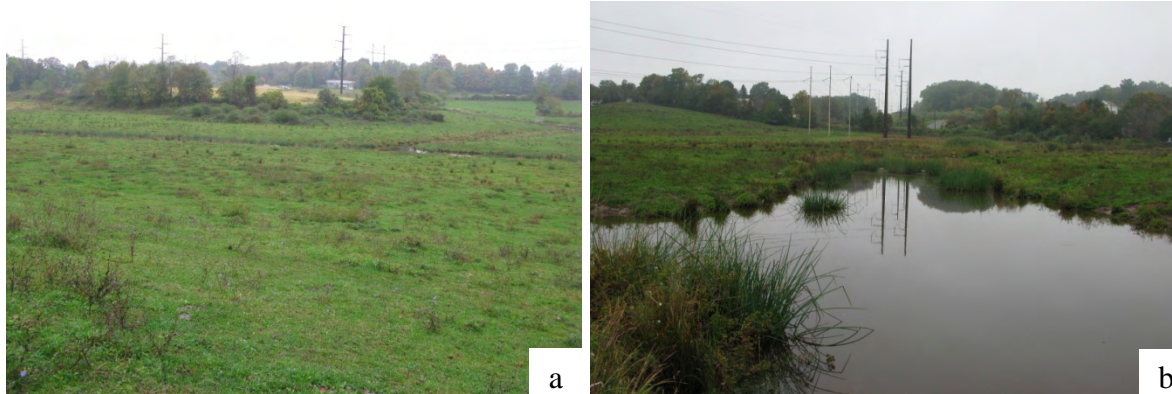
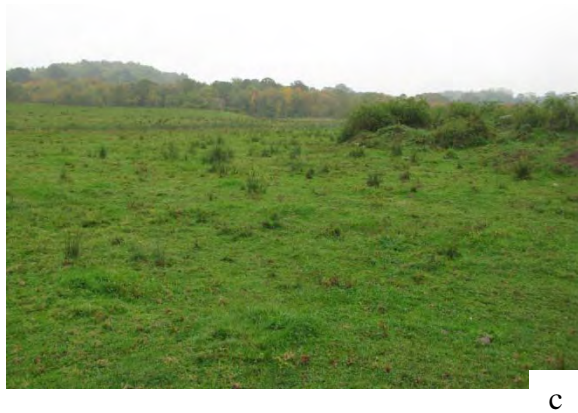
Figure 2. a. Confluence of tributary stream (flowing from right to left) with perennial stream (entering picture from upper right and exiting on left). Surrounding area is low and wet spring and much of the early summer but is said to be hayed in mid to late August. b. Dredged area is pond-like. c. Dredge-spoils on right; tributary stream in background. Figure 5 shows detail of hillside in near distance.

An unnamed perennial stream with headwaters north of I-91 (it drains about ¼ square mile north of the highway) enters the property from the northwest and runs straight downhill to a wetland area (the highway altered the natural course of the stream somewhat and is said to add roadway runoff from adjacent areas outside the natural drainage area). The stream was flowing at the time of this review. A small intermittent tributary stream heads just northeast of the parcel and flows southwesterly through the low area, joining the perennial stream in the center of the parcel. Recently parts of this stream have been dredged forming a pond-like area that is said to be a favorite area for livestock to cool themselves during hot weather (see Figure 2). This tributary stream was also flowing at the time of the review and may be perennial.

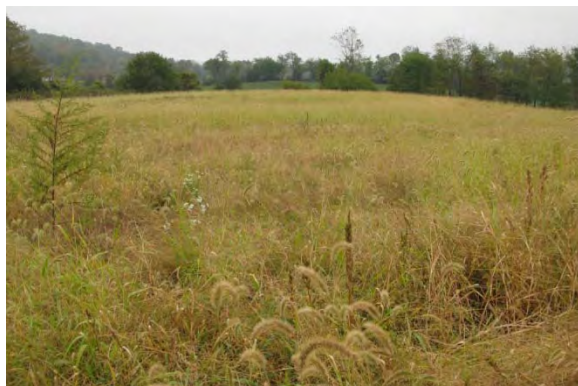
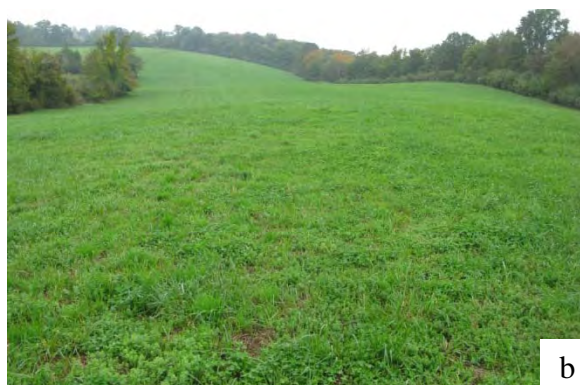
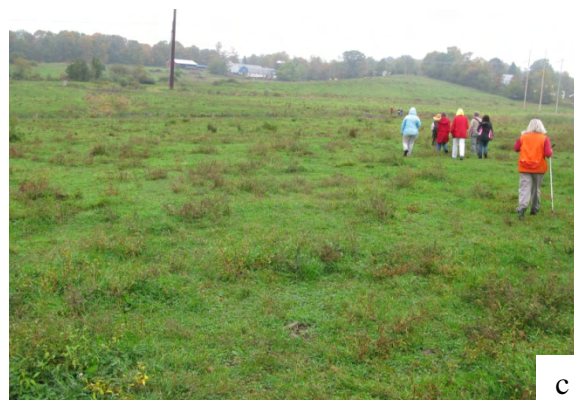
Figure 3. a. Relatively flat grass-covered area used in the past for row crops. b. Gentle-sloped area at south-eastern part of parcel that is used as hayfield. c. Pasture land, looking north toward farm buildings in north corner of parcel.

Much of the parcel is amenable to farming of one sort or another. Approximately 10 acres in the west-central portion is relatively flat (see Figure 3a) and has in the past been planted with row-crops. At the time of the review it was grass-covered. A large area on the southeastern end of the parcel has gentle to moderate slopes and is used as a hay-field (see Figure 3b). This area is a bob-o-link nesting area and haying is done only at the end of summer. The remaining area is used as pasture land (see Figure 3c).

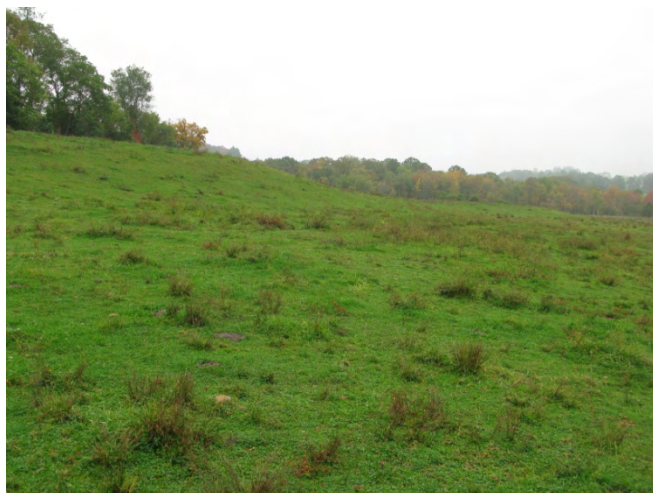
Figure 5. Steeper slope on western side of hillside near eastern boundary of parcel. Increased steepness is interpreted as the result of meltwater stream erosion of the hillside prior to filling of glacial pond. They were probably steeper erosion scarps at one time but have since slumped to the slope we see today. The elevation of the hill is approximately 220', the same as the flat area that has been used for row-crops. Perhaps the two surfaces were connected prior to stream erosion.

The hill along the eastern border of the parcel has a slope slightly steeper that is characteristic for the area (see Figure 5). It is hypothesized that the steep slope owes its origin to melt-water stream erosion prior to or during the filling of the shallow short-lived pond.

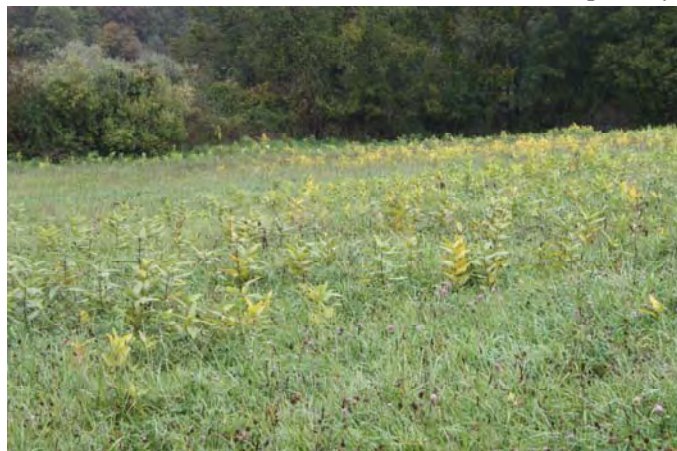
An additional concern is the milkweed (*Asclepias syriaca*) that is taking over areas of the

hayland and reducing the quality of the forage produced. Possible control measures include either performing a minimum of 3 cuttings a year or applying roundup (glyphosate) with a weed wiper (or wick applicator). The hayland is currently managed for bobolink habitat, which requires delayed mowing, and pesticide use is not allowed on the property. An alternative control is hand pulling several times a year to ultimately weaken the plant. One possibility would be organizing a volunteer activity for a

group like scouts or 4H, which would include education about wildlife habitat and organic agriculture in addition to the milkweed pulling task.

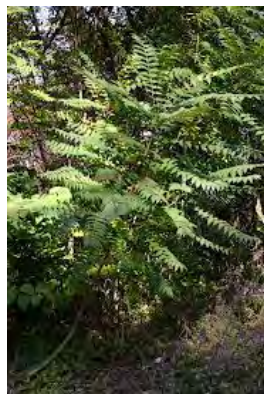
Tree-of-heaven (*Ailanthus altissima*) was seen on the ridgetop property boundary at the northeast end of the tract. As of now this is not creating a problem. However, it has the potential to spread by seeds (from trees with female flowers) and by root sprouts, particularly if the main trunk is injured. Tree-of-heaven should never be cut down unless there is planned follow-up control of root suckers. Care should be taken to not get exposed to the sap as it has been reported to cause myocarditis (a dangerous inflammation of the heart muscle).

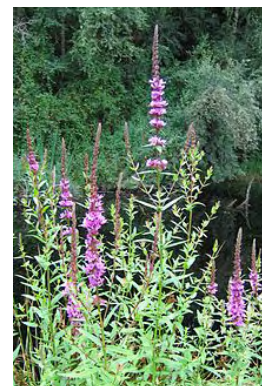
Purple loosestrife (*Lythrum salicaria*) was seen in the CL&P easement near the northeastern boundary. This has the potential to spread throughout the wet soil. In some situations it is possible to control this species by pulling. Pulling is recommended for young plants that are not well-rooted in stands of no more than 100 (or however many plants there is the enthusiasm and people power for the required careful pulling). Generally plants over 2-3 years old will be too well established to pull. Pulled plants should

be bagged and care should be taken to not leave root fragments behind. Note that digging is not recommended because it leaves disturbed soil and too many root fragments.

Some people recommend control with herbicides. Note that if herbicides are used in aquatic situations (“where your feet are wet”), a permit from the Connecticut Department of Energy and Environmental Protection is needed. Contact Bradford.Robinson@ct.gov or call (860) 424-3369 for more information.

An alternative to attempted eradication is biological control with *Galerucella* beetles. While these beetles do not eliminate the Purple loosestrife, they keep the population in check. The University of Connecticut Integrated Pest Management Program website (currently undergoing reconstruction) has information on “Beetle Farmers” including a powerpoint slide show and a video. Visit <http://www.hort.uconn.edu/ipm/> or contact Donna.Ellis@uconn.edu or call (860) 486-6448 for more information.

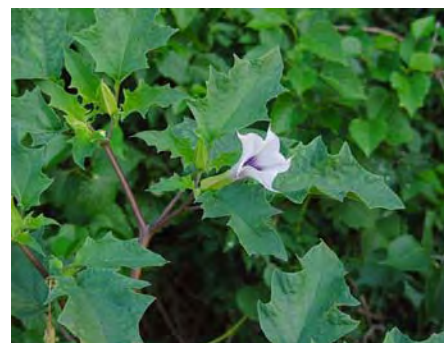
Jimson weed (*Datura stramonium*) was seen along the roadside between Tamarac Swamp Road and the farm pond. Despite its shrub-like appearance, this plant is an annual. It is considered toxic to all classes of livestock. In small infestations, seedlings may be weeded by hand or with a hoe. Care should be taken to avoid spreading its seeds to areas that are hayed.

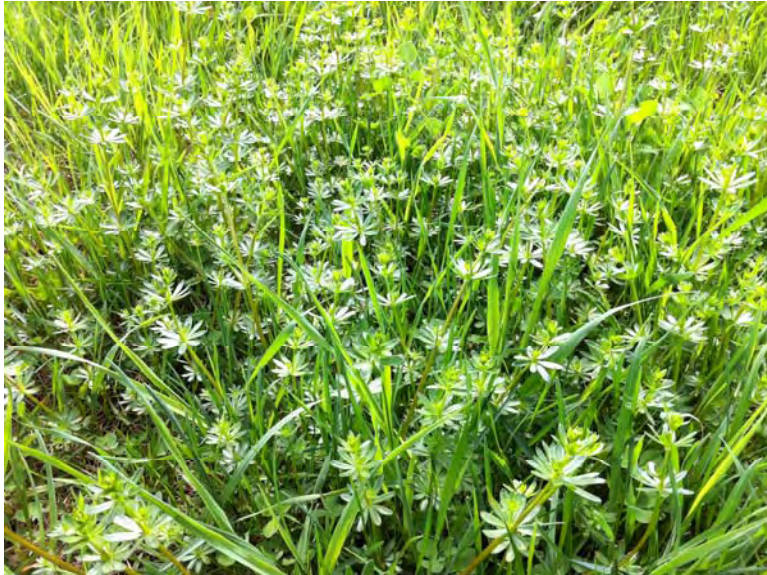
Bedstraw (*Galium* sp.) is a problem in the hayfield. The species was not determined. (None are included on the Connecticut list of Invasive and Potentially Invasive Plants because Bedstraws typically cause problems in agricultural landscapes rather than minimally managed natural

habitats.) Bedstraws are agricultural weeds that will reduce the quality and quantity of the hay crop. Additional advice on species identification and suitable site management should be sought.

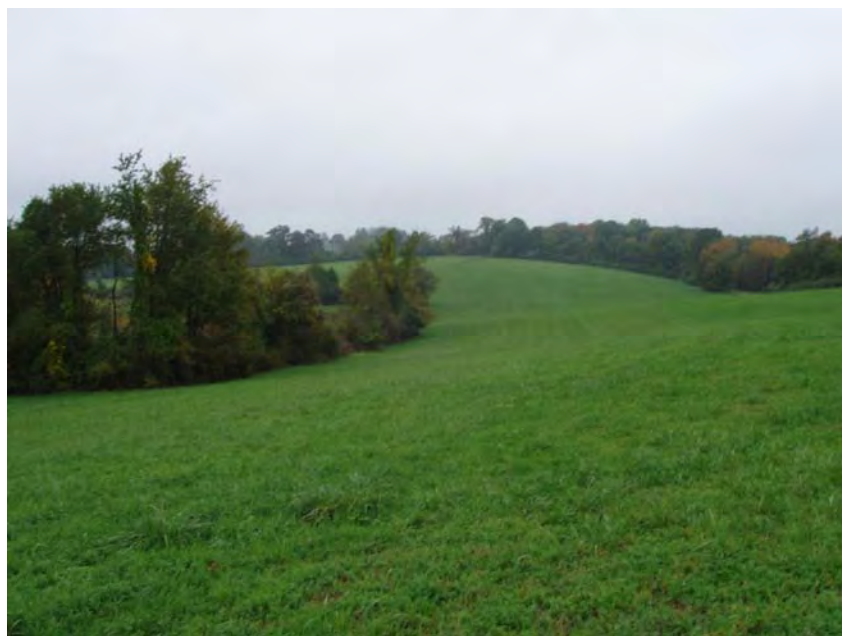
Agricultural Fields

A large L-shaped field is located in the high-elevation western and southern portion of the property, following the bend in Tamarac Swamp Road. This field is approximately 23 acres and is currently planted to hay, with a mowing regime requiring (per terms of the lease) hay harvest to occur from field edges first, progressing inward later in the season, in order to promote grassland bird nesting. Bobolinks have been observed nesting in this field by the Wallingford Conservation Commission,

reportedly arriving in May and nesting in the field slopes. According to information provided at the ERT, mowing in this field is currently done at the end of July; with the western portion mowed first, followed by the high meadow (bobolink nesting area). There is also a small field (approximately 6 acres) along the entrance driveway planted to corn and pumpkins, with autumn olive, goldenrod and foxtail grass present. This field was last mowed in 2010.

The habitat value of the existing hayfield is likely maximized given the current management regime required by the Farmland Lease Program. The limitations placed on field management by the lease are those recommended to maximize benefits to wildlife, while still allowing usable harvest. Should the property come out of the Farmland Lease Program and be managed solely to benefit wildlife, there are several management activities that could increase the habitat value of the existing fields. Because agricultural fields do provide valuable habitat to wildlife, one option is to keep the field in hay. Altering the management regime by mowing only a portion (on a rotating schedule) of the field, at the end of each winter, would improve the value to wildlife by retaining winter cover. Given the size of the field, a second option would be to convert it to a small (10-75 acre) native warm-season grassland. While agricultural grasses such as hay are beneficial for wildlife and provide valuable habitat, native warm-season grasses, such as switchgrass, indiangrass, big bluestem, and little bluestem have certain ecological advantages. They grow best in summer heat, and produce high-quality, dependable forage. They are less influenced by severe weather fluctuations, are more disease and insect resistant, and provide excellent nesting and rearing habitat. In the fall, warm-season grasslands provide food for migrating sparrows, larks and warblers. Additionally, there are increasing concerns over declining grassland-specialist bird species, including, but not limited to bobolinks (reported nesting on site) and meadowlarks, both of whom for which this field is an appropriate size and can provide critical summer habitat for nesting.

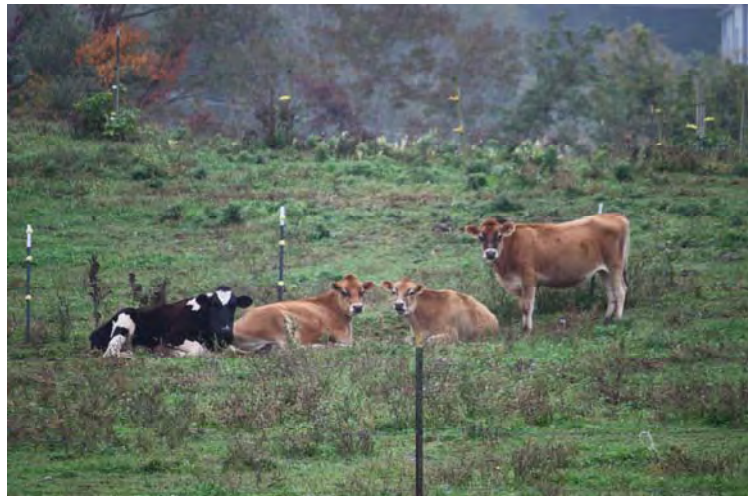
Most of the northern and eastern portions of the property are used for pasture. Moderate amounts of grazing can benefit wildlife habitat by keeping grasses at varying heights and

reducing ground litter. In order to maximize benefits to wildlife, grazing should be kept to moderate levels and a rotational grazing regime should be utilized, which can create a diversity of plant species and structure.

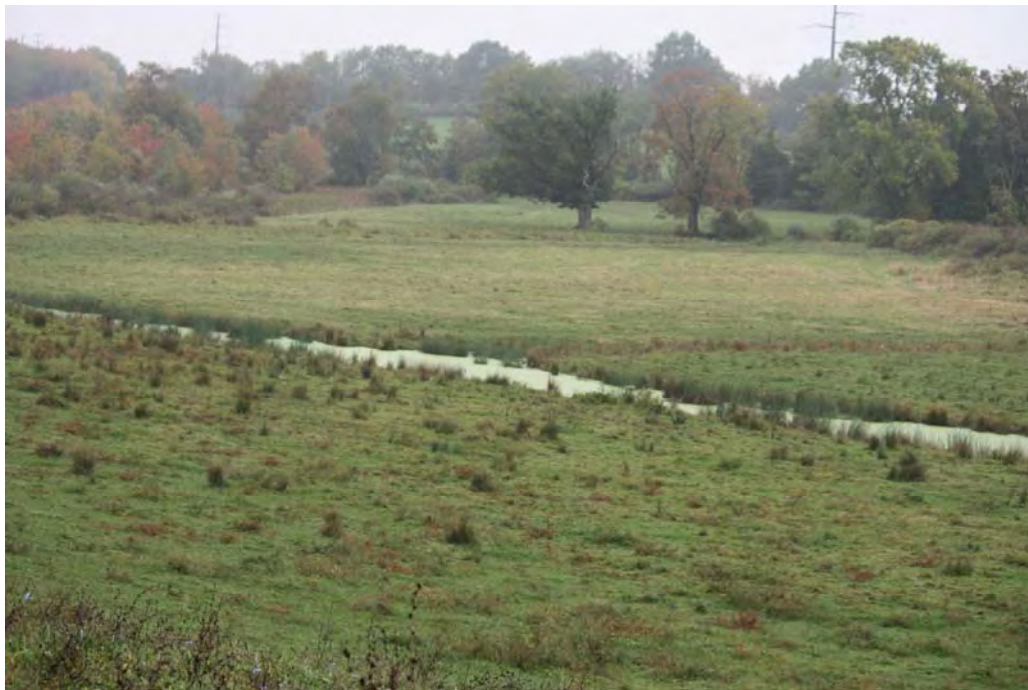
The parcel is 93+ acres that are currently in agricultural use. The property is bounded by East Center Street on the north, Tamarac Swamp Road on the west and a 1,000- acre town owned Tyler Mill Preserve on the east. Currently the property is part of the Town of Wallingford's Farmland Lease Program and is being used for hay and cow pasture. The property contains hayfield, tillable cropland, wooded swamp, wet meadow, and an unnamed stream.

This stream has a small watershed that originates a short distance on the other side of I-91 and is subject to low flows during the summer. The fish community consists of a typical assortment of warm-water species, dominated by the sunfish and minnow families. While this fish community does not provide great opportunity for angling, it is an important contribution to the biodiversity of the parcel and contributes to its value and appeal to local residents. Furthermore, the stream flows into the Muddy River, a much larger stream with substantial aquatic resources. The DEEP Inland Fisheries Division stocks nearly 2,000 trout annually into Muddy River and it is a popular public resource. This small unnamed stream on town property should be properly managed to protect it and its ecological values as well as protecting those of Muddy River into which the stream flows.

The Fisheries Division review has indicated two significant perturbations along this stream that could be addressed with a proper management scheme by the Town: siltation and warming of water. A major concern is the free access to this stream by livestock. Traditionally, farmers have used pasture brooks to water

Our management recommendation is two-fold:

- 1) **Eliminate all direct access to the stream by livestock.** Fencing is the usual approach and alternate provision of water (troughs, etc.). We will not speculate on the best way to do this but trust that the Town and the lessee can determine the best way to accomplish this. It would be good to consider projects to repair any severely eroded stream banks (Eagle Scout projects?) but experiences shows that even without restoration, the exclusion of livestock from the stream will show immediate and demonstrable benefits.
