**Naugatuck River Greenway
Waterbury, Connecticut**

Environmental Review Team Report

June 2006

Report #334

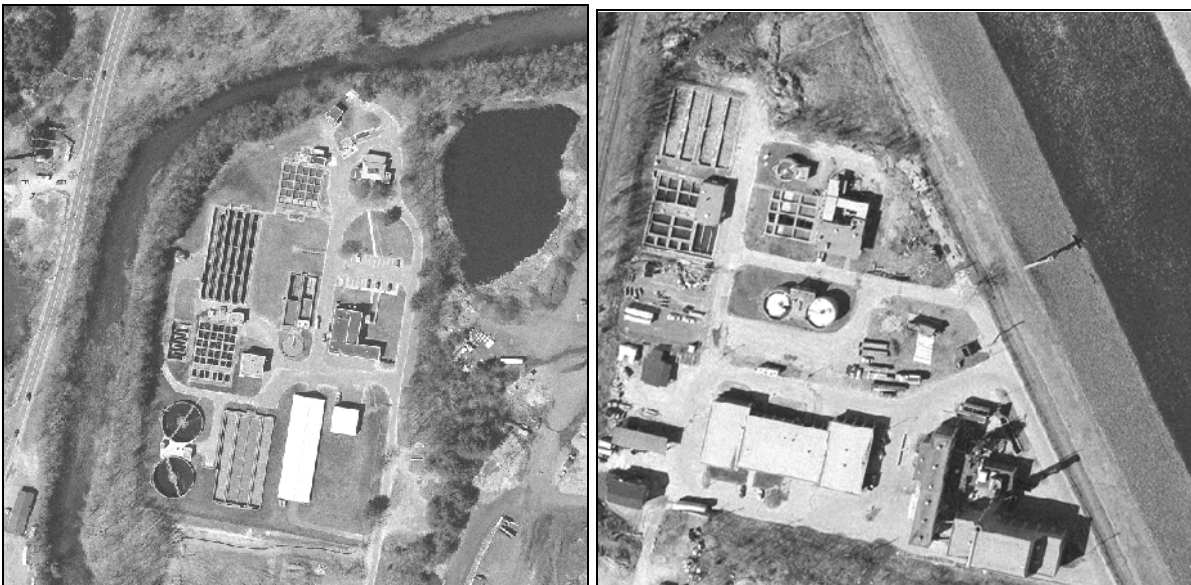
Two Sewage Treatment Facilities: The left hand image is in Harwinton near the top of the watershed and on the right is the facility in Ansonia near the bottom of the basin.

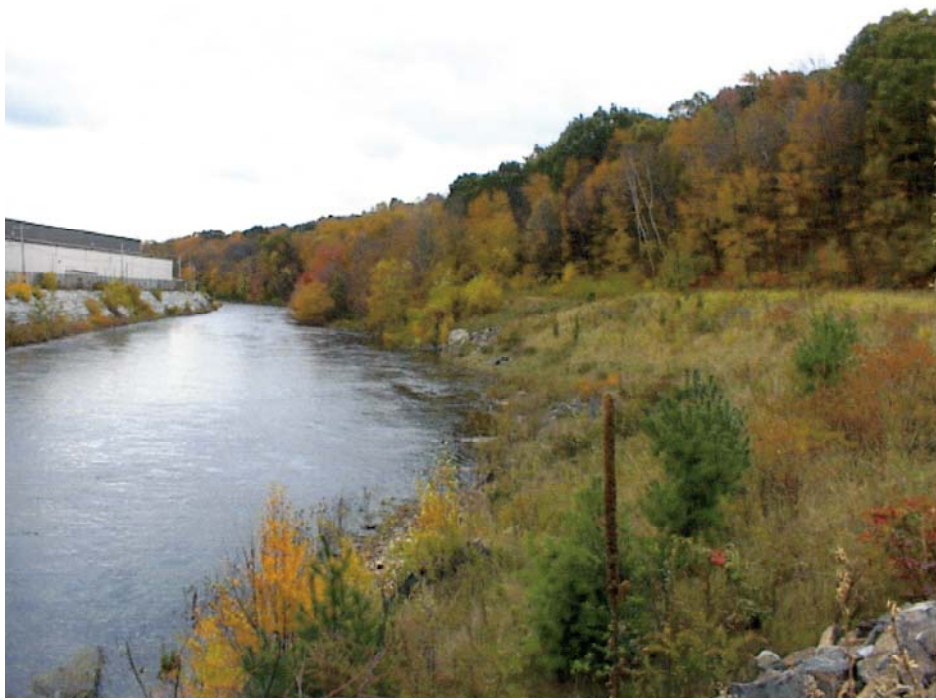
P4 - Footbridge area and restored site.

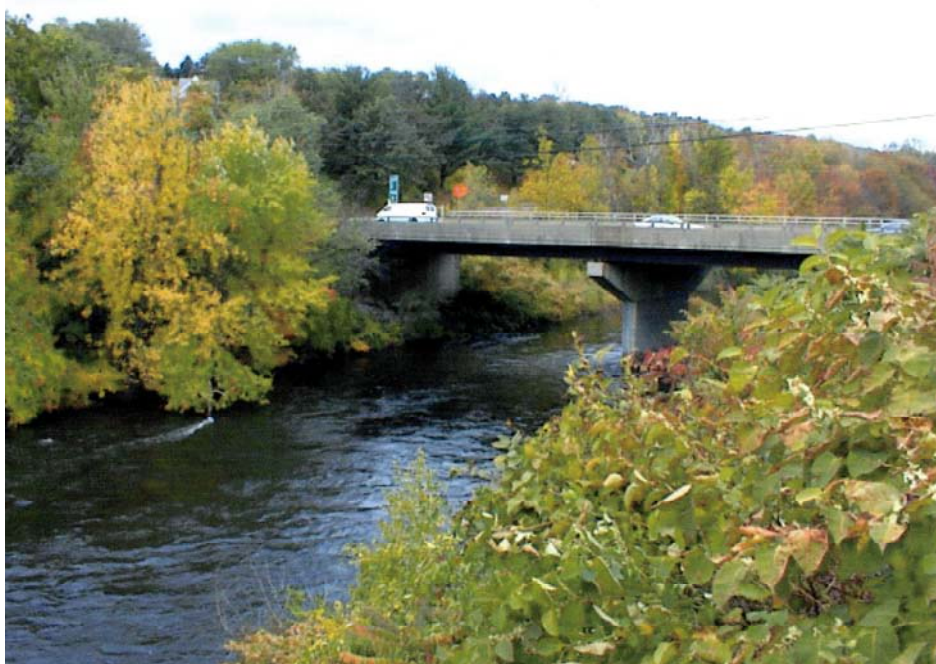
P5 – Huntingdon Avenue Bridge East bank.

Huntingdon Ave. Bridge (P5). South of Huntingdon Ave; the eastern bank provides a higher vantage point, which is out of the floodway, which intersects with a very limited use railroad bed that parallels the river and Thomaston Ave. The soils in this area consist of various soil textures that have been previously disturbed or filled. (Soils # 306 & 60D)

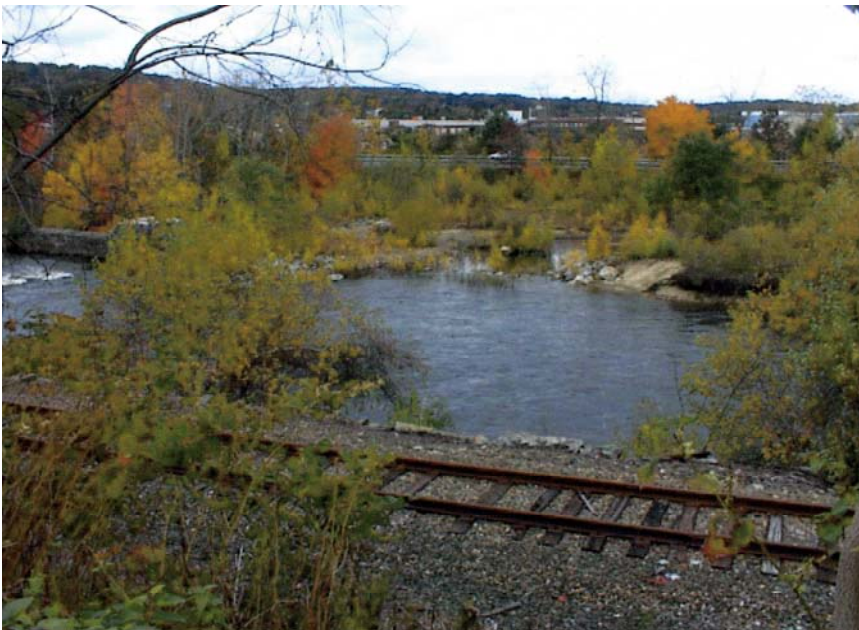
Trending south from the railroad bridge and confluence of Hancock Brook and the Naugatuck, the trail could follow the rail-bed along the river. (P6) Generally these soils are Udorthents and Urban Lands - # 306,307 & 308.

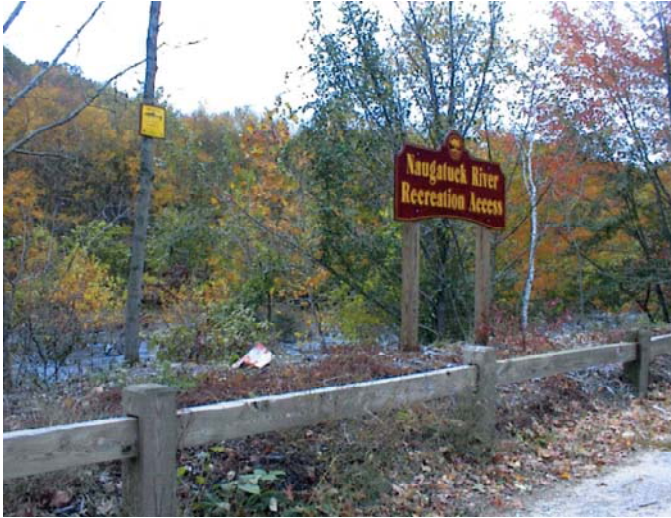
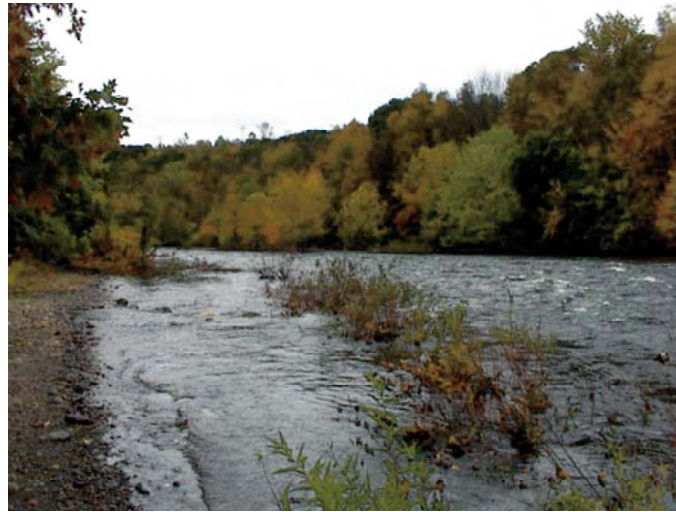
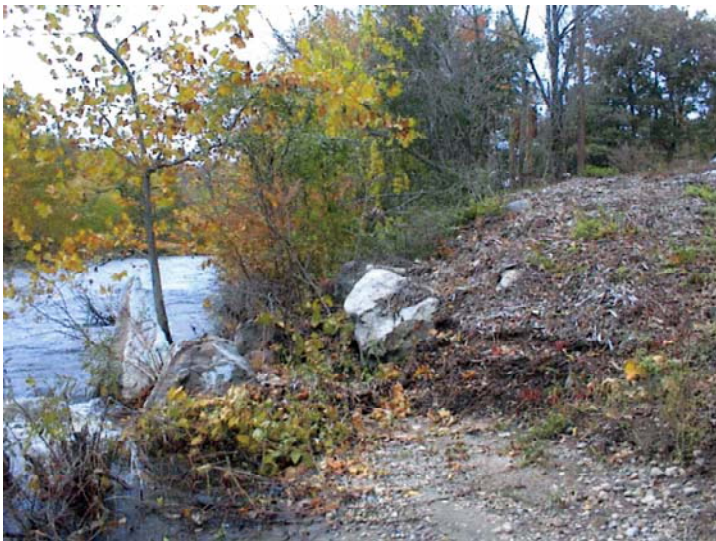
P9–P11

The Leonard Street crossing would bring the trail back to the west side of the river, which would follow Municipal Road south (P8). The proposed trail could utilize the Water Treatment Facility properties or elect to cross the river at its narrowest point with an arched footbridge that spans the river and reconnects to the east bank. The trail could then parallel South Main St. or the riverbank to the trails terminus at a selected area along Platts Mill Rd. (P9 - P11)

The soils along this section of the river vary greatly depending on which side of the river is utilized for the trail. Constraints to developing the trail in this section revolve around the steepness of slope, proximity to the river, maintaining the stability of the riverbank and the safety of the public regarding the busy thoroughfare.

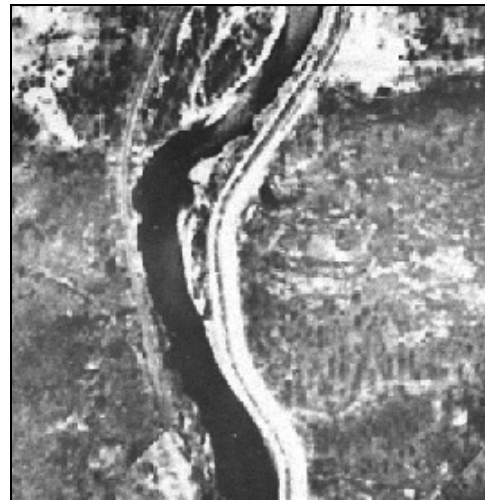
1934 aerial image

The Team observed an old roadway on the landscape at the time of our visit. In the 1934 aerial photograph below it is easy to see the white ribbon of the trolley line between the dark river and the wider, white road.

For the length of this reach the slope from the road down to the water is precipitous, rocky and wooded. There is no floodplain to speak of and the steep slopes are well vegetated thereby keeping erosive forces in check. This reach is crossed by one bridge.

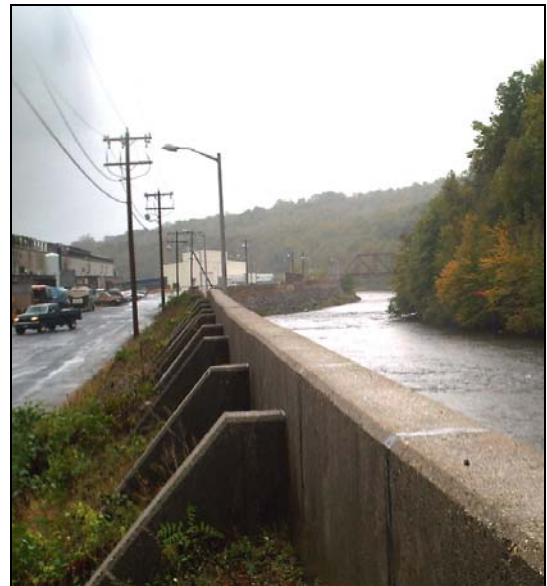
The team stood at the flood wall and looked across the river to the wooded hills in Watertown.

The elevation of the Watertown hills undoubtedly forced flood waters onto the Waterbury side of the river. At some point the city chose to wall off the floodplain and channel the flow. The long term result has been a total isolation of the river for the entire 1.4 mile length of this reach. The foot bridge over the river in the distance in the above photo provides access to the opposite shore, but that is in Watertown. The footbridge is one of two bridges in this reach. There is also an area that appears to have been a low level dam across the river. It shows up as a white line about a quarter of the way down in the above image. As in the reach above, there is no floodplain to deal with here since the floodwall poses a vertical barrier for the entire 1.4 miles.

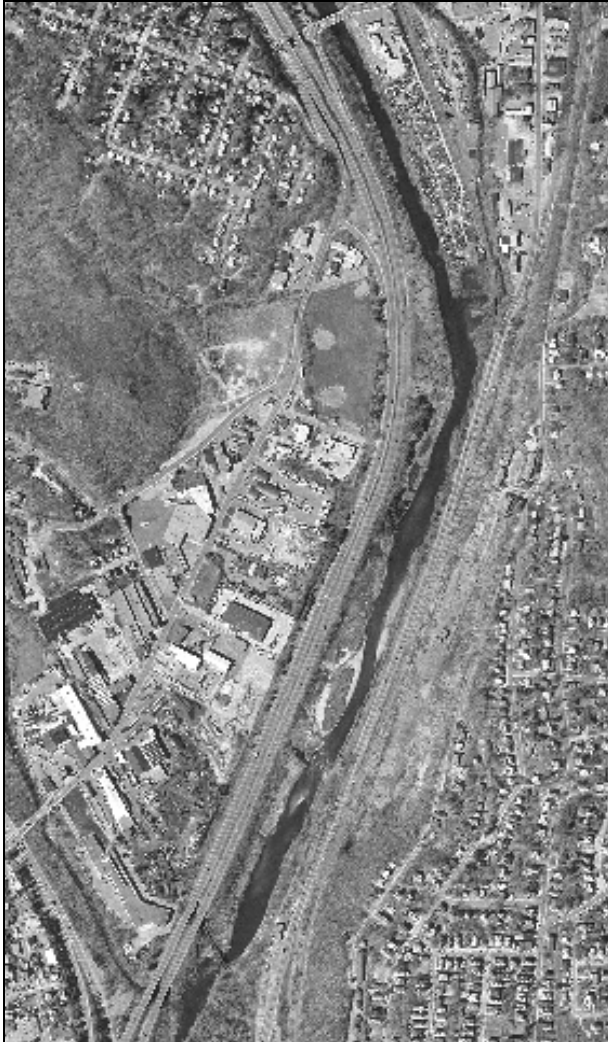
This reach is the third most northern in the study area. The length of 1.25 miles runs from the Huntingdon Avenue bridge to the confluence with Steele Brook which enters from the west.

The first three tenths of a mile are dominated by commercial industrial and an automobile junk yard. Any hope of access to this side of the river could only be realized in the distant future, and the potential for petroleum product pollution on site could be quite high due to its current use. At first sight it would seem that the west side would be favorable for access, but the width of the highway right-of-way comes into play. The steepness of slope would be an additional factor. In this area, a 20 per cent slope to the river would preclude most activities.

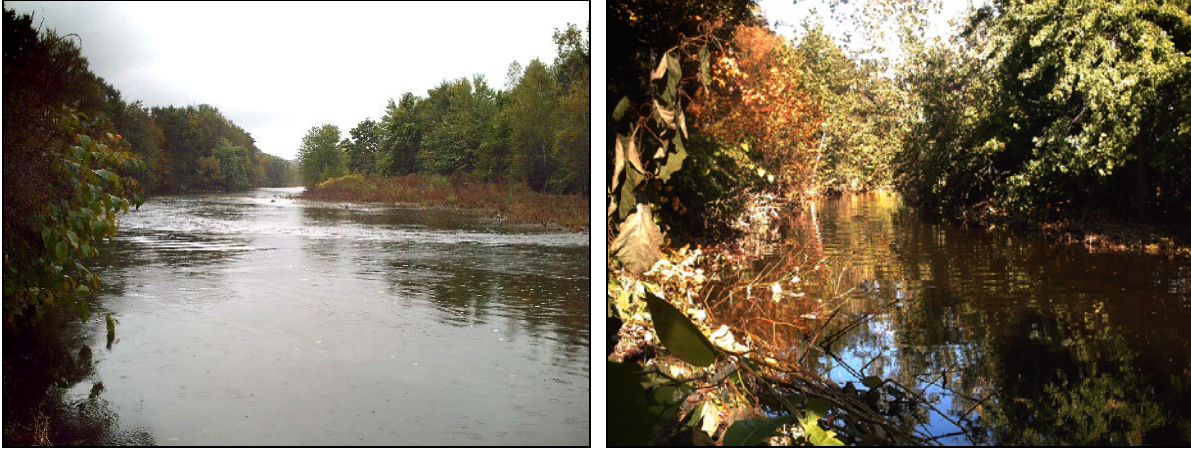
The left hand image is the view upstream along the Naugatuck from the confluence of Hancock Brook. This view provided a pleasant aesthetic surprise to Team members. On the right is Steele Brook about 30 yards upstream from the Naugatuck.

Two bridges cross this reach of the river. As can be seen in the photo the river has some room to meander within its floodplain.

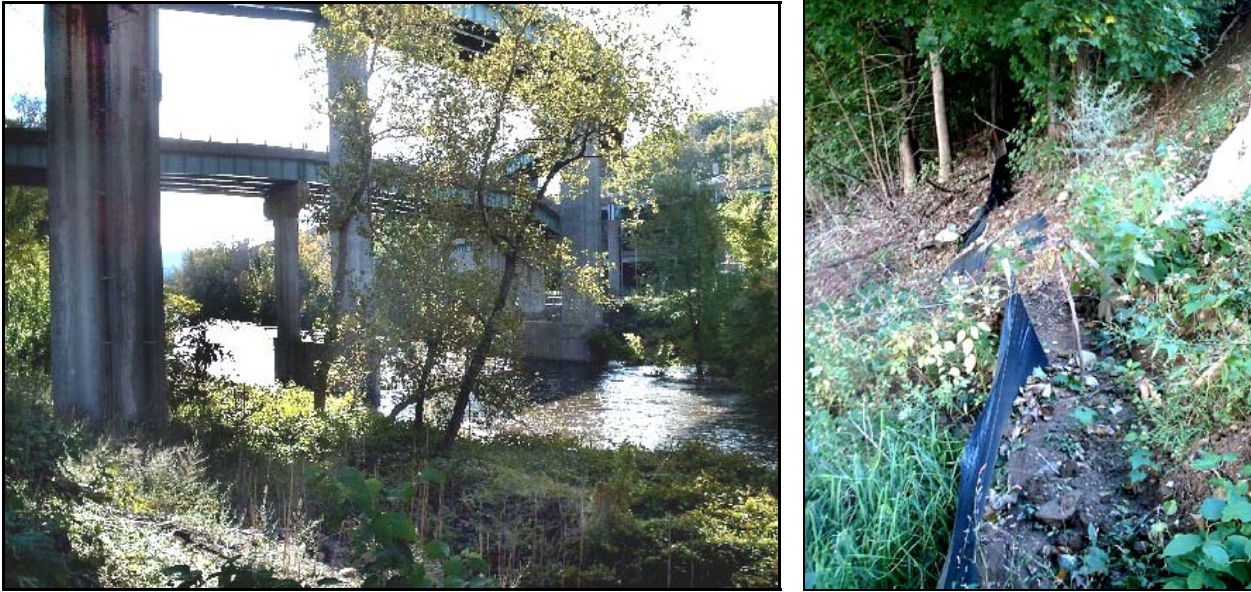
This view under the mixmaster shows lush vegetation and the isolated nature of the river. The view to the right shows the dramatic failure of the erosion control allowing a fan of soil to move downslope to the river. This occurrence is just below the materials recycling operation.

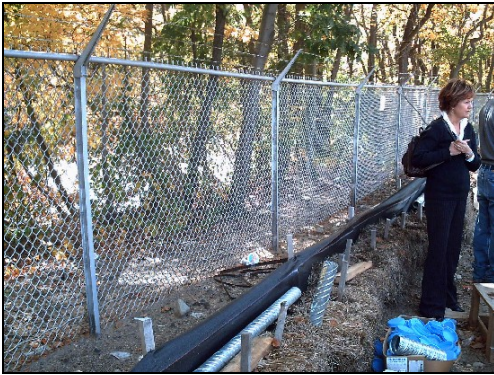
The above photo shows the staked haybale/ silt fence, the chain link fence with barbed wire and a narrow width of surface before the land drops off to the river level. On the right, the Washington Street Bridge is the northern most with the Eagle Street bridge in the center.

One of the major challenges to the linear pathway will be the Yankee Gas property on the west bank just north of South Leonard Street. Their property borders the river for approximately 1,750 feet or one third of a mile. Issues of security were brought to bear here. The property is separated from the river by a chain link fence. The location of the fence is at the narrow top-of-the-slope, up from the river level. There is very little width for the possibility of a formal trail or pathway.

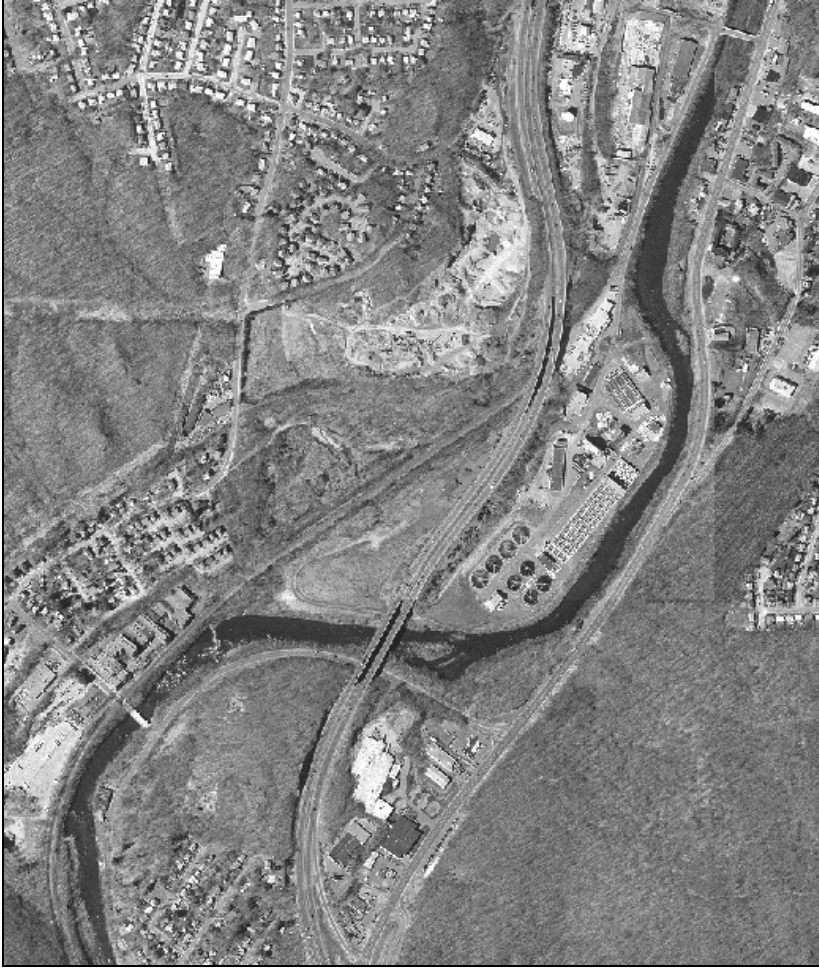
Here the river widens and is free enough to meander through its own channels creating a few islands. We did not see that upstream in the study area as there was literally no lateral space to widen that much, and the confines of the neighboring land use channels the river for much of its run through the City. Previous islands in the river occur about 2.5 miles above the start of the study area.

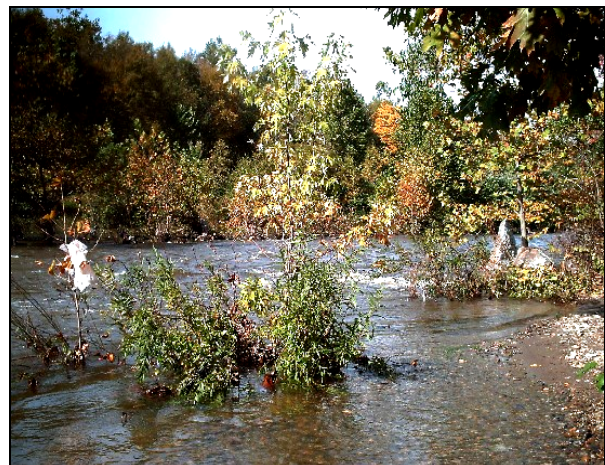
The left hand figure shows the Naugatuck as it passes by a concrete obstruction ~200 yards north of the Bristol Street bridge. On the right is a view of the Naugatuck looking north along its shore at our final stop.
