# ENVIRONMENTAL REVIEW TEAM REPORT

## OLD QUARRY NATURE CENTER DANBURY, CT

**OLD QUARRY NATURE CENTER  
DANBURY, CT  
SEPTEMBER 1984**

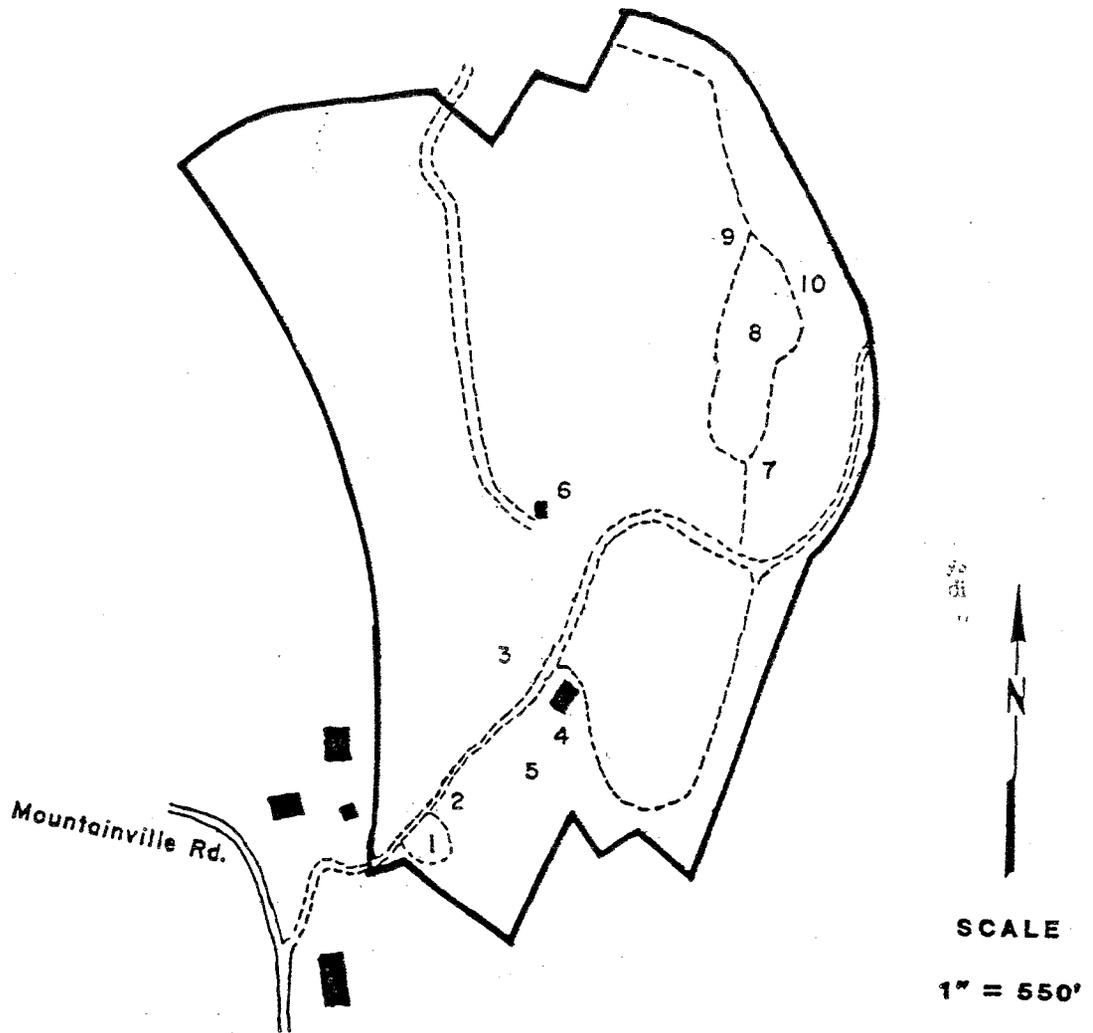
# FIGURE 2 LANDMARKS

- = road/driveway
- = trail
- = boundary
- 1 = parking lot
- 2 = Indian mortar
- 3 = amphitheater
- 4 = field house
- 5 = old dump
- 6 = ranger's house
- 7 = small quarry pit
- 8 = large quarry pit
- 9 = community fireplace
- 10 = "Giants Chair" rock outcrop

In the southcentral portion of the site just south of Maple Lane, is an activities building with nature displays and a meeting room (see Figure 2). In the central portion of the property, just north of Maple Lane, is a ranger house which is accessible from the north off Overlook Road. The ranger residing in the house is responsible for patrolling Rogers Park which, as noted above, is located just north of the Old Quarry Nature Center. Additional landmarks, including several trails, are also identified in Figure 2.

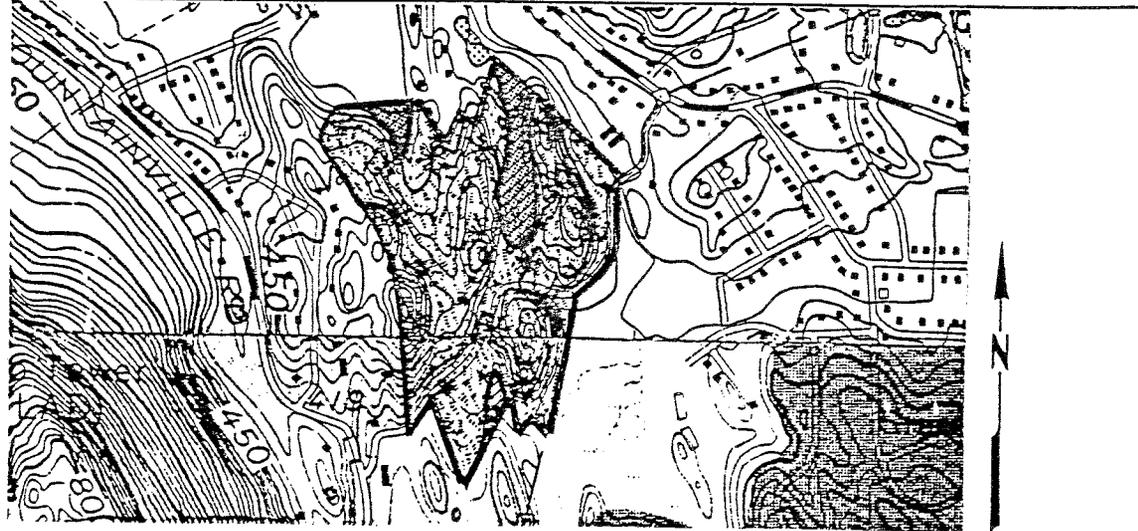
# FIGURE 3 SURFICIAL GEOLOGY

Till

Lake bottom sediments

Areas overlain by swamp sediments

Most of the site is covered by a relatively thin blanket of glacial sediment called till (see Figure 3). "Till" refers to a nonsorted, nonstratified sediment that was deposited directly from the glacial ice sheet. These sediments consist of rock particles and fragments which were derived from the local bedrock: gneisses, schists and marble. As the glacier moved across the area, it churned up the pre-existing soils and scraped, gouged, and broke up bedrock surfaces. Because the glacier collected rock particles of all sizes, and because these particles were not reworked by glacial meltwater streams, the till deposits contain everything from clay to boulders. Till is also variable in texture. It is generally fairly loose, coarse-grained and stony in the upper few feet, but at depth (3-5 feet) commonly becomes finer-grained, less stony and siltier. Where the compact zones are encountered, till is commonly called "hardpan". The thickness of the till ranges from zero, where bedrock is exposed at the ground surface, to probably not more than 10 feet at various points in between on this site.

Another type of glacial deposit, found in the low-lying topographic swales in the northern portions of the property, are lake bottom sediments. These sediments, which were deposited approximately 12,000 years ago by meltwater streams flowing into a former glacial lake in Danbury, consist of fine grained sediments such as sand, silt and clay. The ancient lake occupied the low-lying areas that are now drained by the Still River.

Overlying the lake bottom sediments in the northern portions of the site are "swamp sediments". These sediments consist of sand, silt, clay and a high percentage of organic material (e.g., decayed plant matter) which formed in areas of sluggish-moving water. Swamp sediments are delineated by the symbol Sb (Saco soils) on the accompanying soils map (see Figure 6). A small area in the southern part of the site also contains swamp sediments. The sediments in this area are probably underlain by till and/or bedrock.

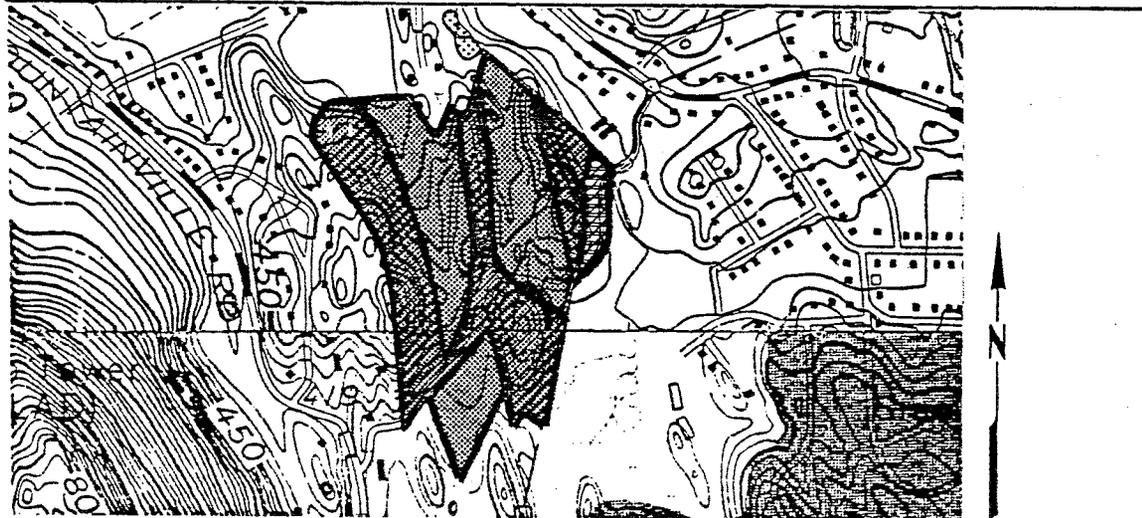
# FIGURE 4 BEDROCK GEOLOGY

Manhattan formation

Inwood marble

Areas where bedrock is at or near ground surface

Numerous bedrock outcrops are visible on the site, primarily in those areas delineated as HrE (Hollis-Rock outcrop-Charlton complex) and NfD (Nellis-Farmington) in Figure 6. According to Quadrangle Report No. 7, the principle rock type which underlies or crops out on the site is a member of the Manhattan formation (see Figure 4). This rock consists of sillimanite-garnet-biotite gneiss which, in places, grades into a mica schist and also into quartzite. The main minerals in the rock include quartz, andesine, biotite, garnet and sillimanite. A "gneiss" is a banded or streaked crystalline rock. A "schist" is a structurally layered crystalline rock in which platy or flaky minerals (micas) have aligned to form wavy surfaces of parting. A "quartzite" is a rock which consists wholly of quartz sand cemented with quartz. The Manhattan formation rocks were deposited during the Ordovician geologic period (approximately 510-465 million years ago). All three rock types (i.e., gneisses, schist and quartzite) are metamorphic; that is, they were all subjected to great heat and pressure within the earth's crust. It should be pointed out the new updated State bedrock geologic map will be changing the Manhattan formation mapping in this area to the Walloomsac Schist. The Walloomsac Schist is described as a dark, fine-grained schist composed of the minerals quartz, albite and commonly garnet.

The other rock type found in the eastern limits of the site is the Inwood marble. This rock consists of a white to gray dolomitic marble. Accessory minerals present in the rock are phlogopite, tremolite, diopside, forsterite, quartz, microcline, zircon, tourmaline and antigorite. The term "marble" refers to a metamorphic rock composed essentially of the mineral dolomite. According to the "Geology Trail Guide", prepared by Jon Pawloski for the Old Quarry Center, the marble rock had been mined in the eastern limits of the site primarily for agricultural lime. It should be noted that the Inwood marble formation has also been mined commercially for agricultural lime in an area north of the Danbury city limits just east of U.S. Route 7.

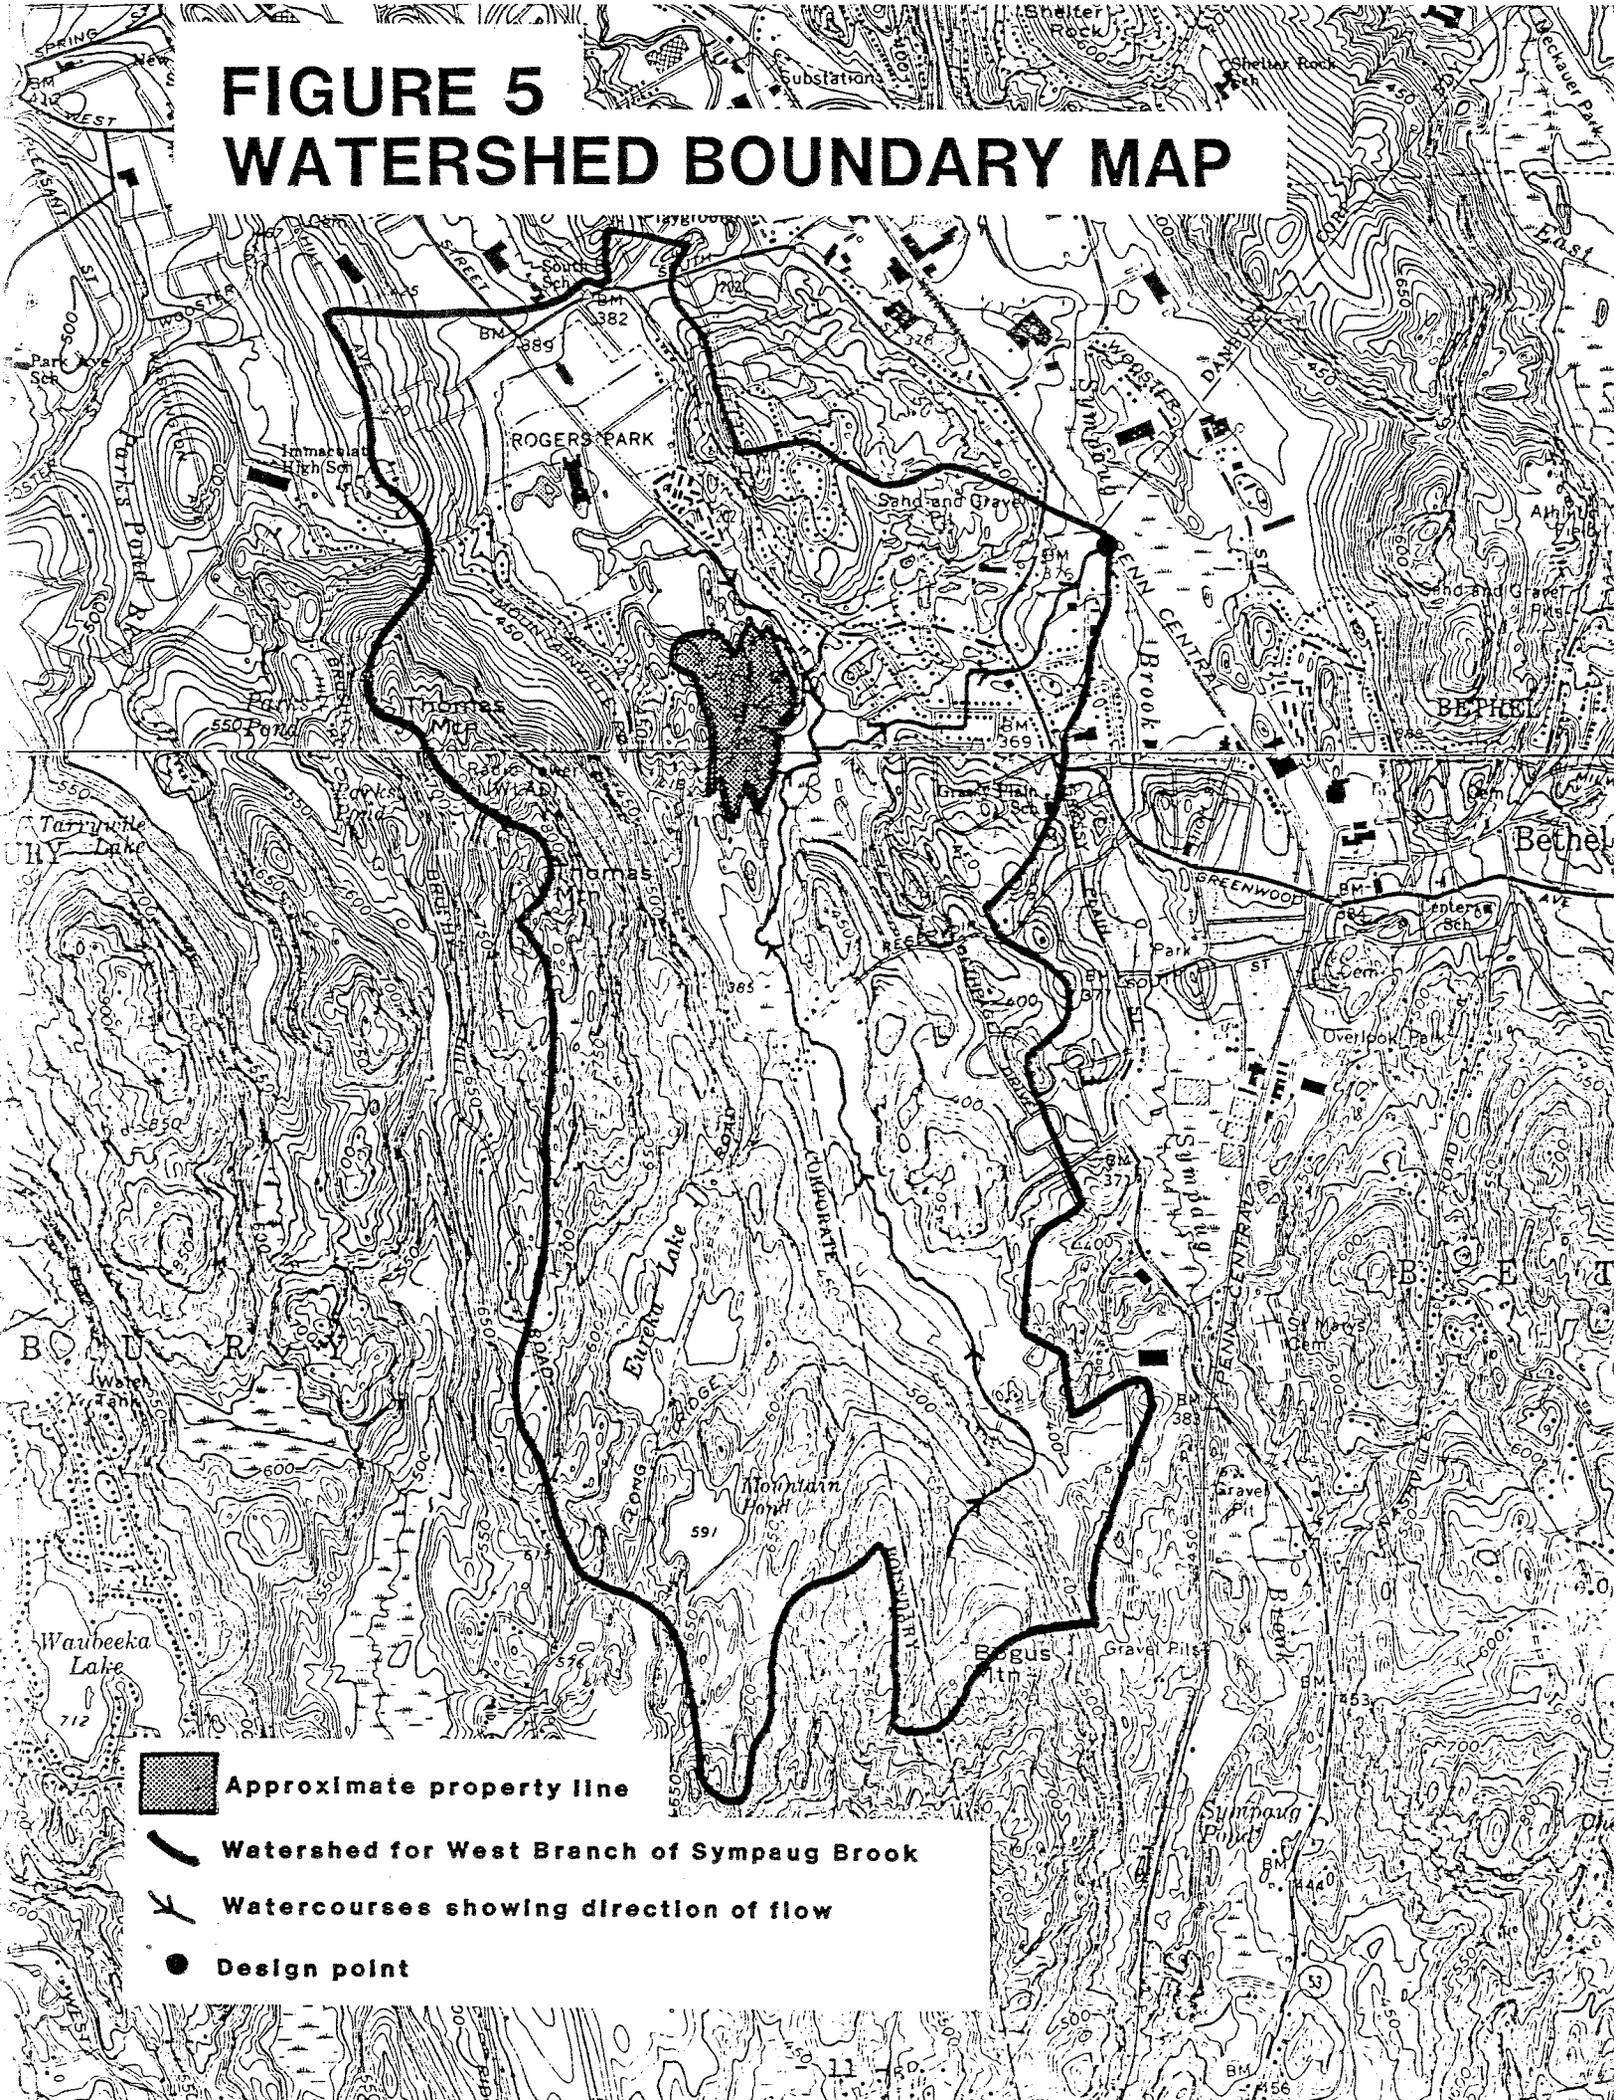
# FIGURE 5 WATERSHED BOUNDARY MAP

Approximate property line
-

Watershed for West Branch of Sympaug Brook
-

Watercourses showing direction of flow
-

Design point

The "Old Quarry Nature Center" lies within the watershed of the west branch of the Sympaug Brook (see Figure 5). This watershed drains an area of approximately 2.2 square miles or  $\pm$  1,408 acres. Surface runoff in the northern half of the site is directed towards two topographic swales. Water is then routed northward via the swales towards an unnamed tributary of the west branch of Sympaug Brook. Surface runoff in the southern half of the site is directed into an intermittent drainage channel which ultimately empties into the west branch of Sympaug Brook or flows by sheet flow directly into the brook.

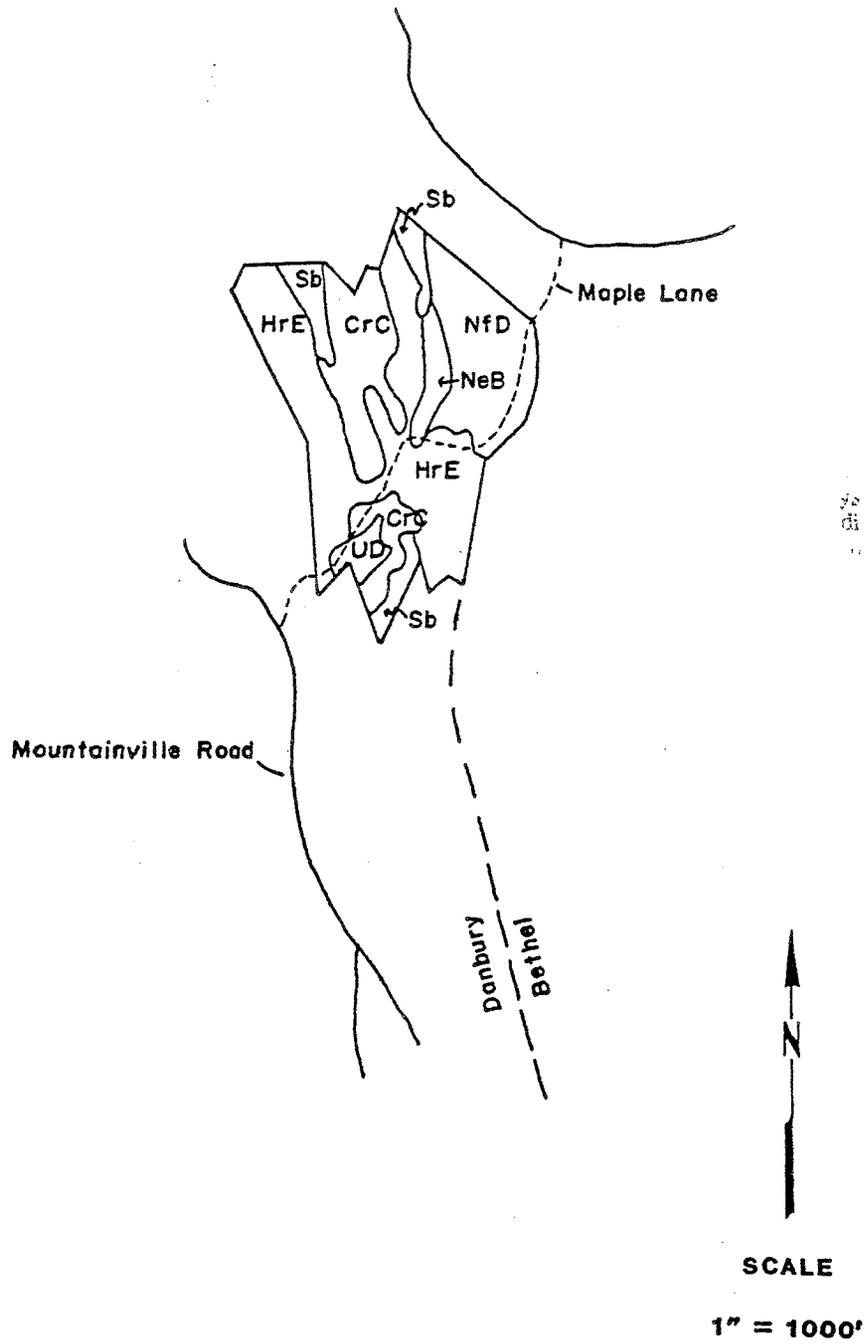
# FIGURE 6 SOILS MAP

Figure 6 and the following narrative are a revision of data contained in the Soil Survey of Fairfield County, Connecticut. The symbols on the map identify map units. Each map unit has a unique composition of soils. Areas with the same symbol have the same composition.

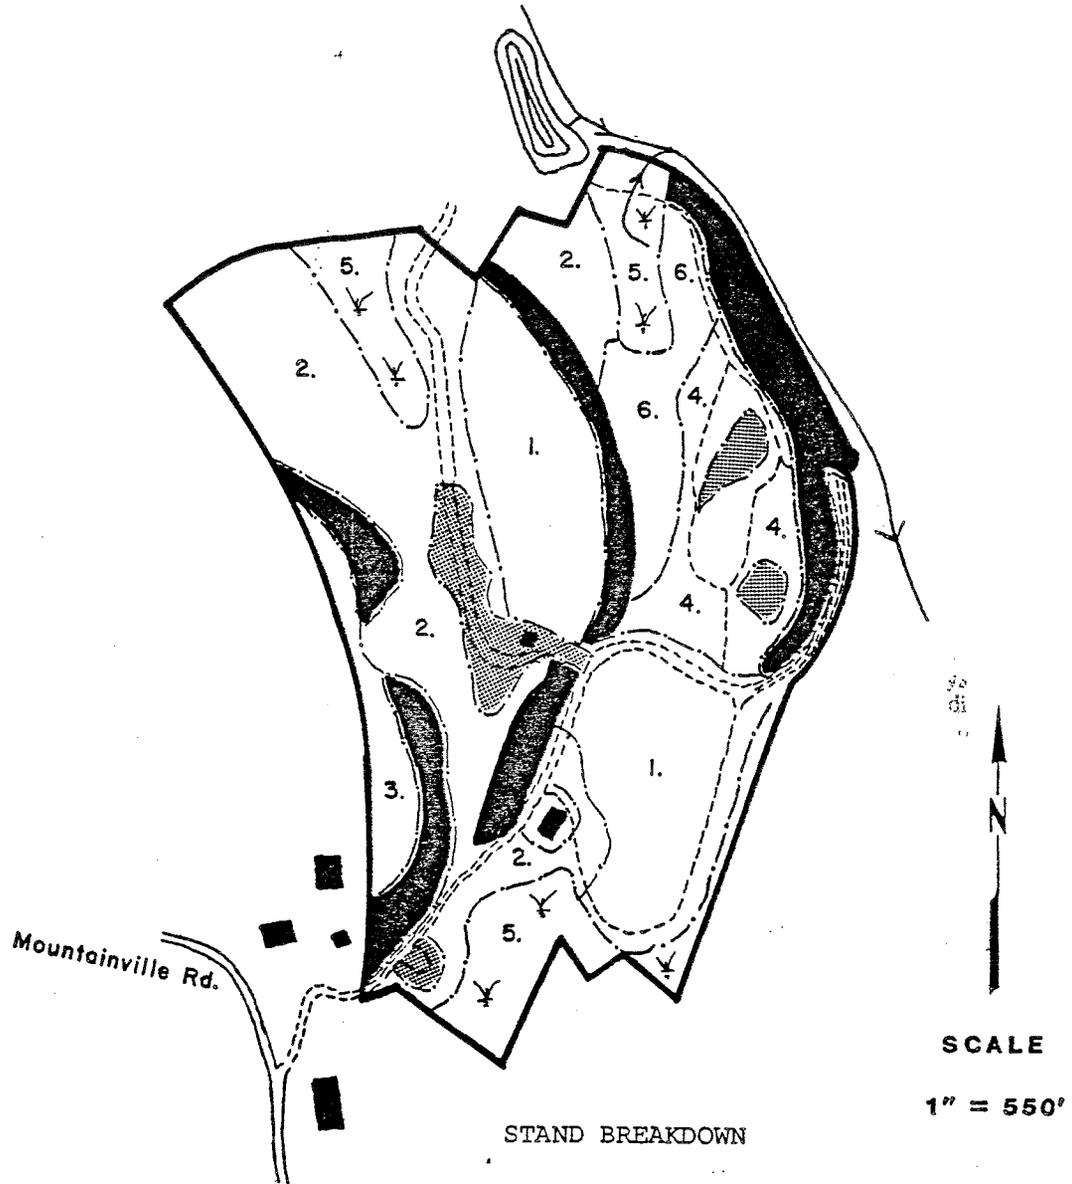
# FIGURE 7 VEGETATION TYPE MAP

- ==== Road
- Woods Road
- Trail
- .-.- Stand boundary
- Building
- ~ Stream
- ∇ Wetland
- ⊖ Pond

It should be noted that physical and topographic features encountered in the northeastern quarter of the property, (areas 4, 5, 6, and open areas in Figure 7), seem to indicate that a larger area than previously reported has been actively quarried in the past. Vegetation found in stand 4 is fairly young in nature and appears typical of the species normally associated with disturbed ground. The remains of what appears to be an old access road can be found leading into area 5 from the north central boundary through the smaller piece of area 2. Additionally, the rock faces found in the central north-south running inaccessible/inoperable area (see Figure 7) seem to bear indications of having been the result of man-caused fractures. Similar rock faces can be found in some of the western most inaccessible/inoperable areas. The Team Geologist has speculated that these additional areas of disturbance were exploratory in nature, where hopeful prospectors searched in vain for additional marble deposits of some significance.

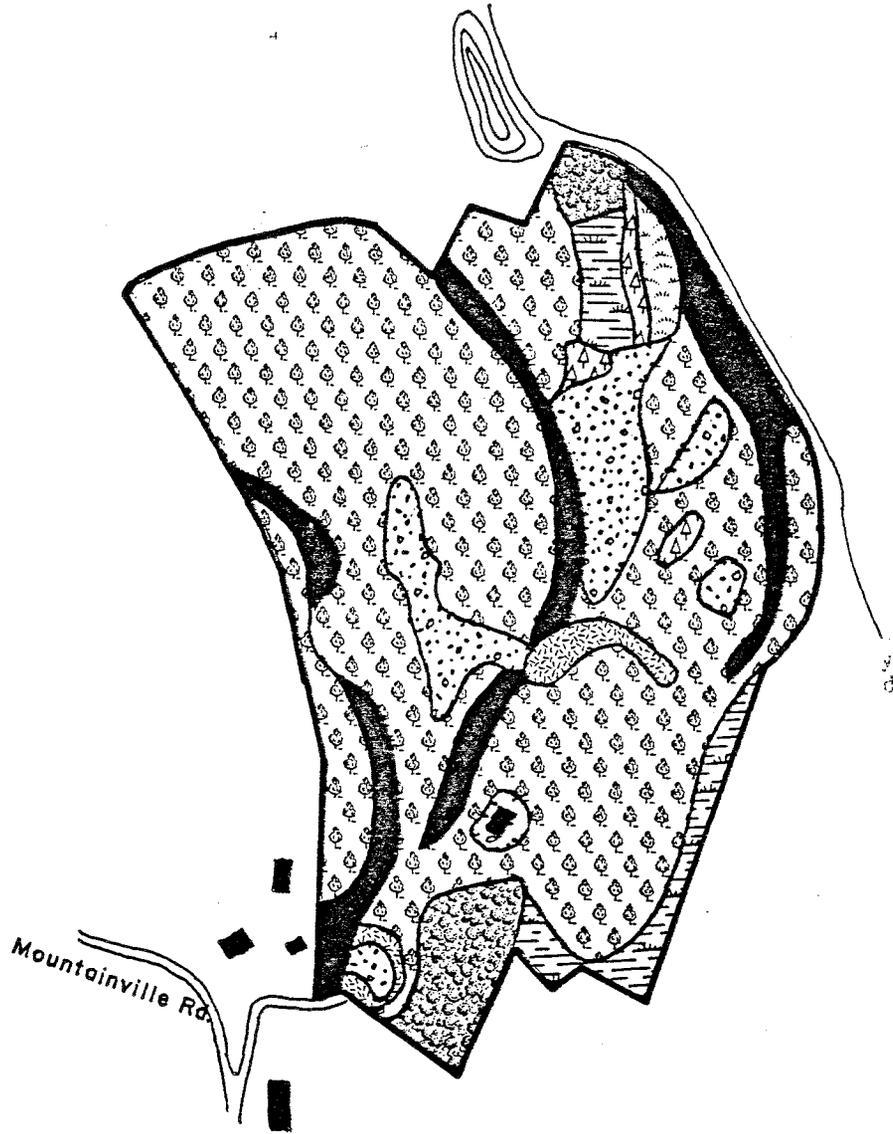
# FIGURE 8 WILDLIFE HABITAT MAP

Within the Old Quarry Nature Center there exist 4 major wildlife habitat cover types (see Figure 8). These are up-land mixed hardwood forest, bottomland mixed hardwood forest, old field, and wooded swamp. An additional unique habitat on the area is a small grassland slope. These cover types are described in the following section. Typical wildlife species, special habitat features, and possible management techniques for each type are also presented.
